Memorandum

RE: Memo # 18 - Results RTA-1
Former Turning Basin 1
Archaeological Monitoring for and the Documentation of Bulkhead and Cribbing
Gowanus Canal Remediation Project
Brooklyn, Kings County, NY

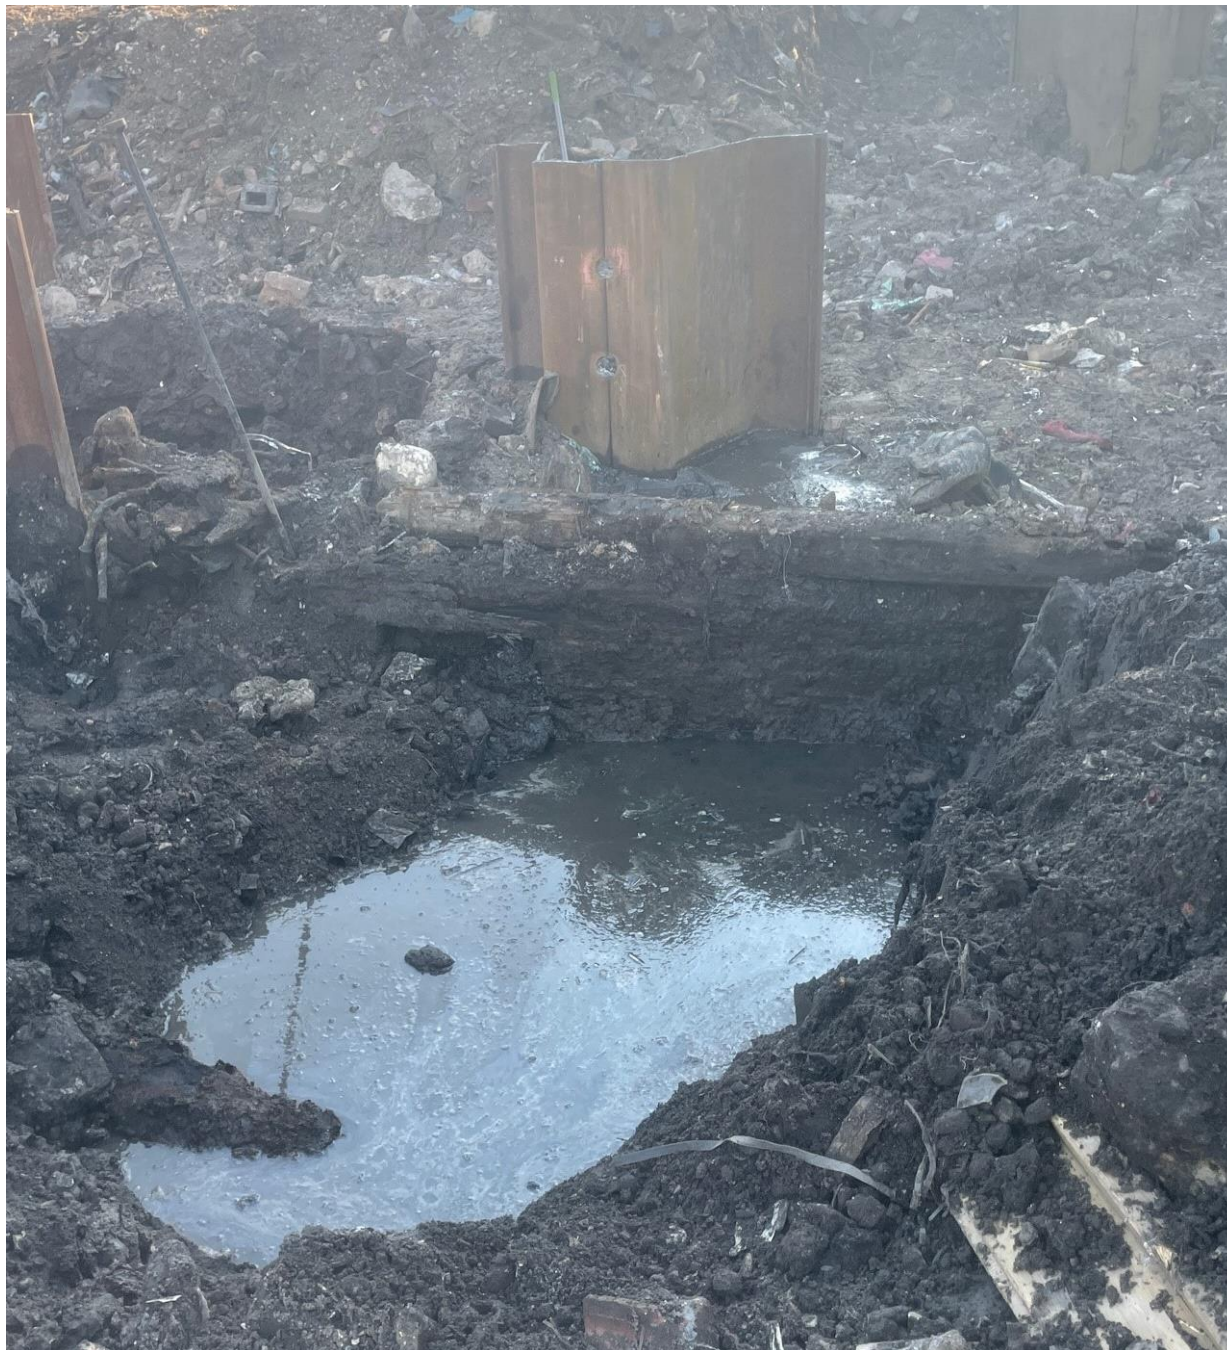
Once exposed, AHRS archaeologists Nicholas Zeitlin and Jonathan Weiner conducted archaeological bulkhead and cribbing documentation on February 9 and 10, 2022 of the wooden bulkhead and cribbing uncovered by the piledriving activities. An 8-foot length of intact bulkhead and cribbing running north to south, parallel to the wall of the canal, was identified. Four vertical feet of this bulkhead was observed during excavation, before water levels rose (Photograph 1). The

Photograph 1 – View of exposed bulkhead wall during excavation before flooding, facing east.
Photograph taken by Benjamin Romagnoli, February 9, 2022.

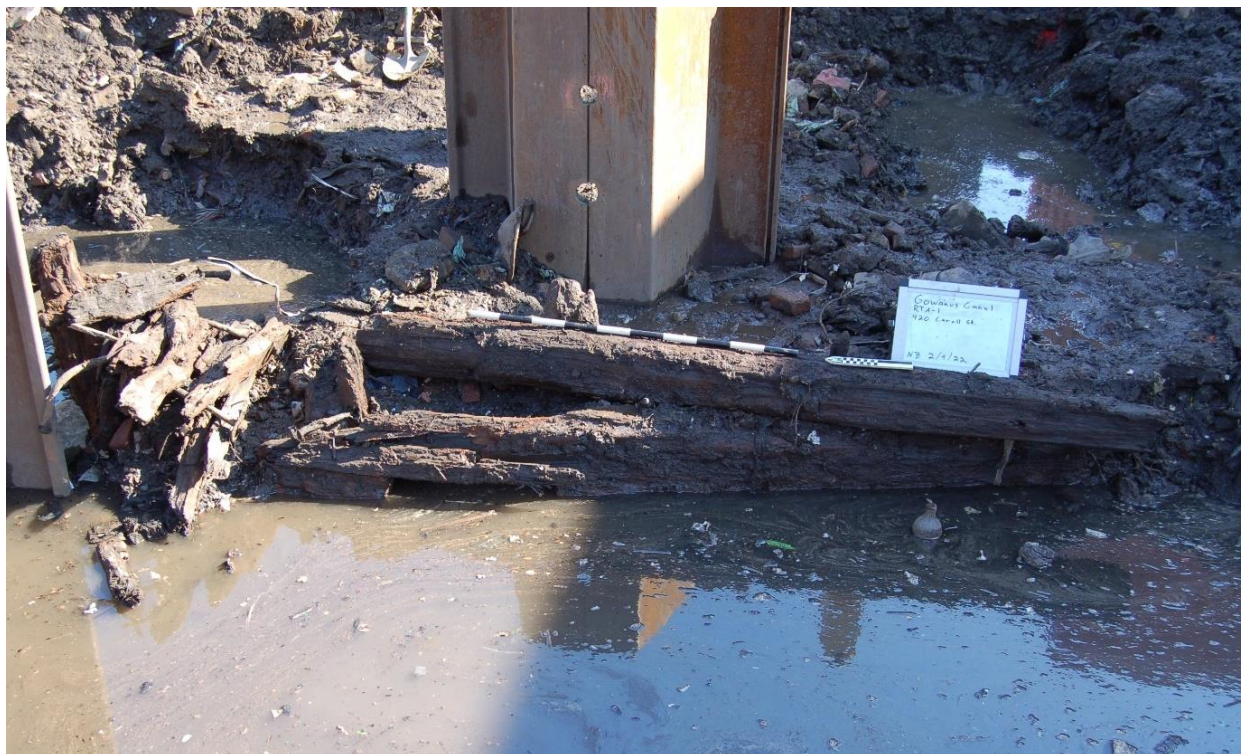
northern extent ended in a vertical post with timbers attached, which originally ran east that was disturbed and damaged by activities conducted prior to this project. The southern extent of the bulkhead ended in a joint turning east with timbers running east for approximately four feet until they terminated from previous damage and disturbance. Additional trenches were excavated to search for returning timbers running perpendicular to the bulkhead and cribbing. No returning timbers were identified along the northern extent. A disturbed timber was identified along the southern extent, but could not be accurately documented due to rising water levels. An additional trench was excavated approximately 50 feet east of the intact bulkhead and cribbing. This trench encountered industrial fill and groundwater; no historic bulkhead or cribbing was observed. The identified bulkhead appears to be part of the retaining wall constructed when Turning Basin 1 was filled in during the 1950's as seen on the 1961 Aerial Photograph (Figure 1).

Photograph 2 – View of bulkhead wall and northern perpendicular timbers, facing east.
Photograph taken by Nicholas Zeitlin, February 9, 2022.

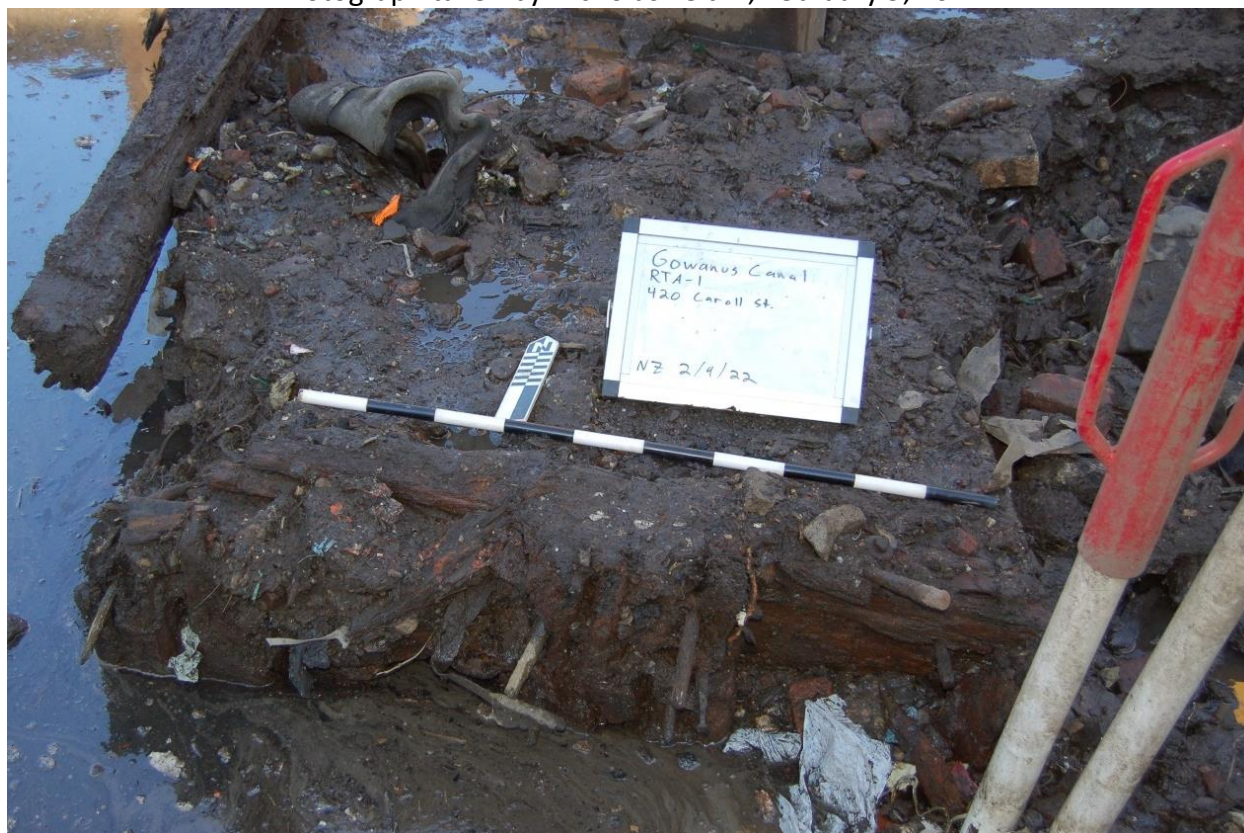
Photograph 3 – View of southern returning timber, facing north.
Photograph taken by Nicholas Zeitlin, February 9, 2022.

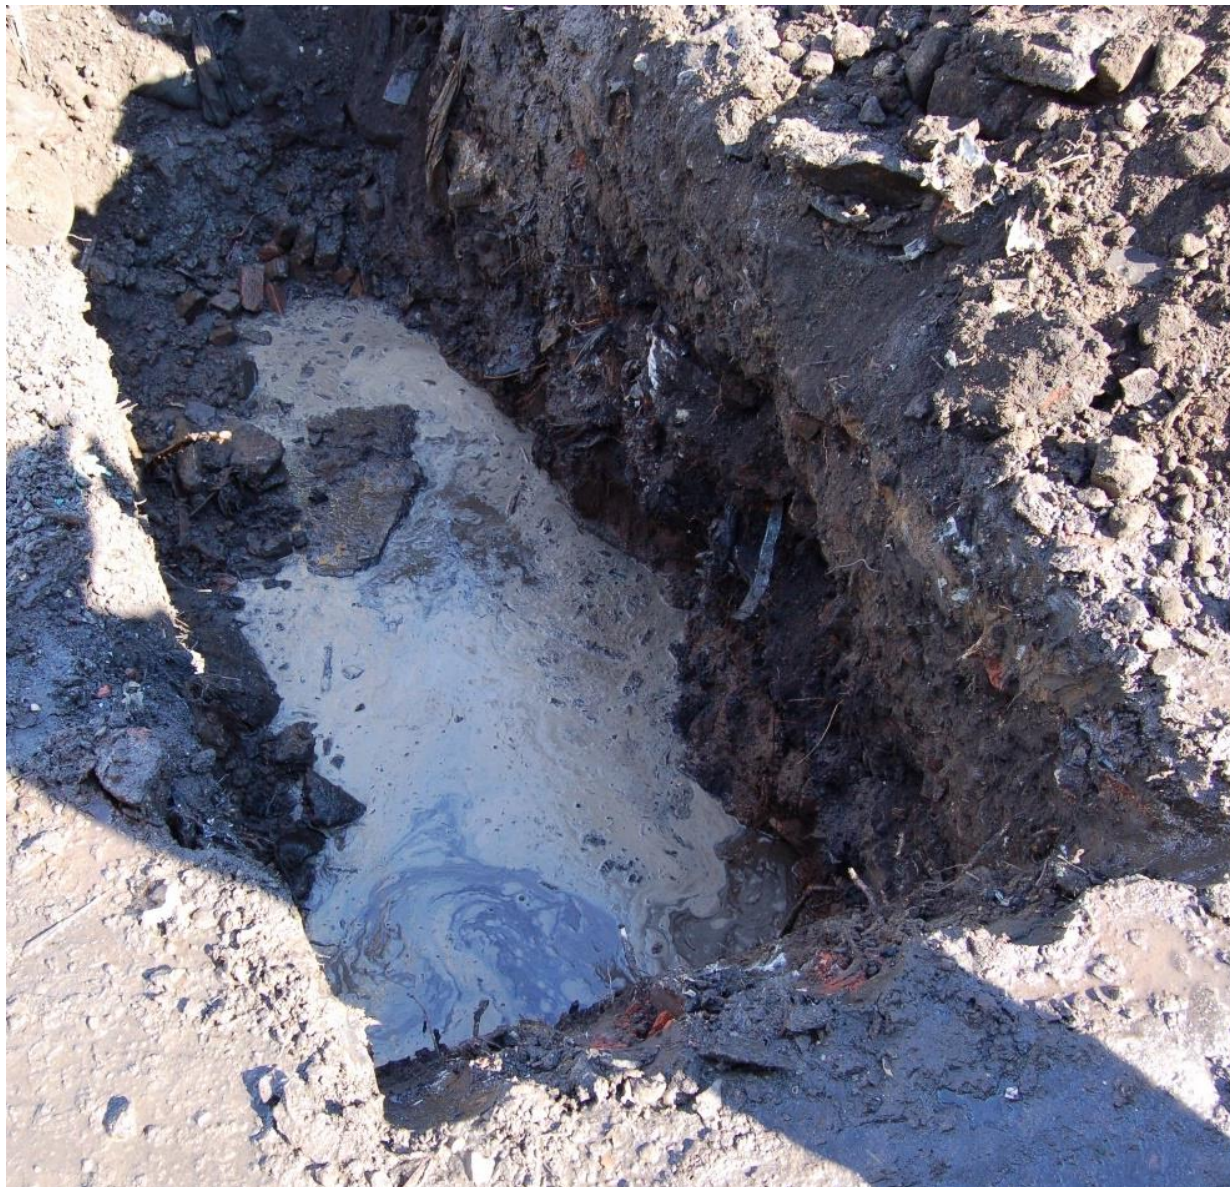
Archaeological monitoring and bulkhead documentation was completed on Feb 10, 2022. Documentation of the site was limited due to water level rise within the site that was not tidally influenced because of the new seawall at the canal end of Turning Basin 1 preventing drainage into the canal. The 8-foot section of bulkhead and cribbing identified in Turning Basin 1 was documented. Exploratory trenching did not identify any other intact bulkhead or cribbing.

Photograph 3 – View of eastern trench flooding with ground water, facing north.
Photograph taken by Nicholas Zeitlin, February 10, 2022.
