# Memorandum

To: William Lee, Gowanus Environmental Remediation Trust From: Kathryn Whalen, Ph.D., RPA- Principal Investigator, and Ed Button, M.A., RPA- Field Director Date: August 6, 2024

RE: Memo #4- Summary of CleanEarth Visit, July 29, 2024

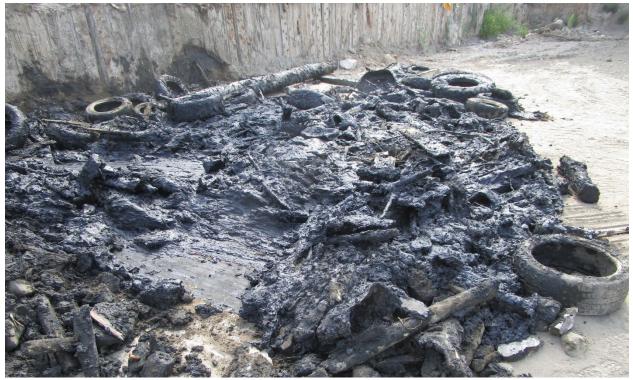
The dredged material had previously been through a 4-inch shaker (screener) machine and set aside in a pile on a paved/gravel surface for inspection by an archaeologist on July 29, 2024. The inspection process utilized a CAT excavator to draw material from the pile and spread it out over the surface for closer inspection (Photograph 1).

The inspected material largely comprised automobile tires, automobile parts (MacPherson struts, bumpers), and splintered canal timbers. The inspected material was largely dry, with dirt and clay adhesion.

Photograph 1. An excavator was utilized to spread material out for inspection. Note high frequency of automotive tires and canal timbers (Chronicle Heritage, July 29, 2024).

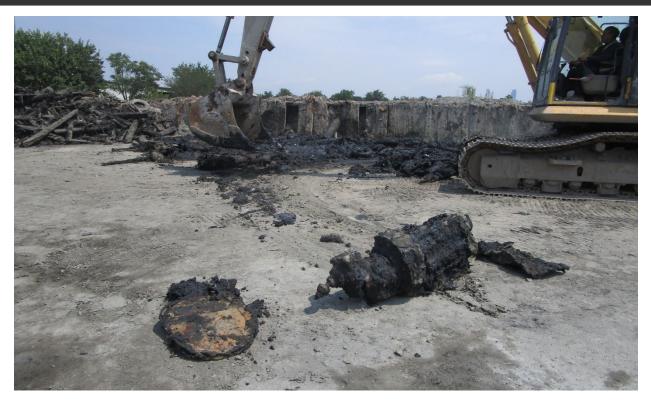
Two objects representing potential artifacts or objects of local interest were identified and set aside by the archaeologist for examination (Photograph 2). The first was an inline four-cylinder engine with reducer and an output shaft; the other was a metal vessel/container hatch. The two objects were washed off with a hose to facilitate a closer inspection.

Photograph 2. Items set aside for further cleanup and evaluation (Chronicle Heritage, July 29, 2024).

Chronicle Heritage does not recommend retention for the two objects investigated in this memo. The diesel engine is common in industrial use and as an inboard boat motor. This type of engine is prevalent after 1949 and used into the present day. In its current damaged condition, it cannot be definitively placed in time or usage, and, therefore, has little research potential. Similarly, the equipment hatch is too fragmented to determine application or usage.

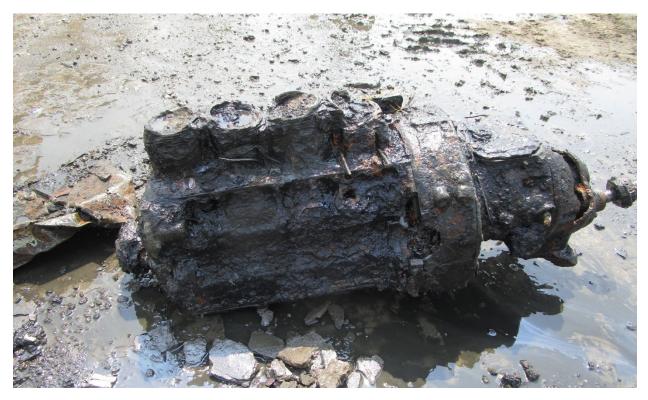
The engine represented a potential boat engine. The incomplete engine exhibits two pairs of cylinders with cooling fins, remnants of a cast-metal pan, and no discernable markings (Photograph 3). The motor is 22-inches long including reducer and output shaft, and 3-5/8-inch diameter cylinders. Research suggests the engine is similar to both a Deutz-type inline diesel commercial/industrial engine (introduced in 1949 and currently manufactured (Deutz Diesel Engines - Stauffer Diesel), or common 4-cylinder diesel inboard boat motors. Due to the engine's damaged and incomplete condition, proper identification with any acceptable degree of confidence is problematic.

Photograph 3. Four-Cylinder diesel engine, incomplete (Chronicle Heritage, July 29, 2024).

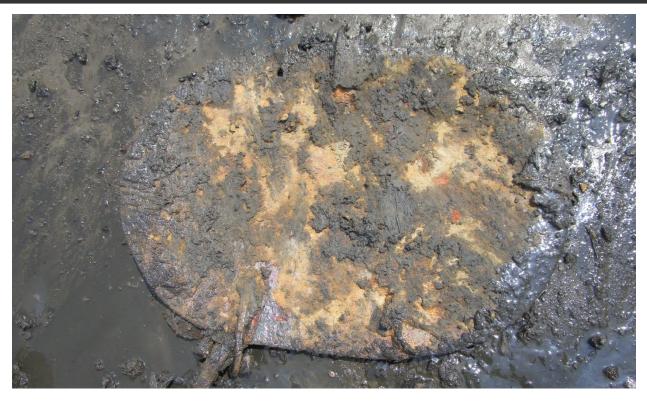
The hatch, initially thought to potentially represent a part of a boating vessel, was hosed with water and inspected (Photograph 4). The hatch measures 20.5 by 28 inches and is 3/8-inch thick. One of two left hinges is missing, and the hatch is damaged on the right side where a handle is missing. A rubber/synthetic seal is partially attached on the back side (Photograph 5). The hatch is neither large enough nor thick enough to represent a boat passage hatch. The damaged hatch is likely an equipment access door, of unknown maritime or terrestrial application.

Photograph 4. Possible equipment hatch, top (Chronicle Heritage, July 29, 2024).

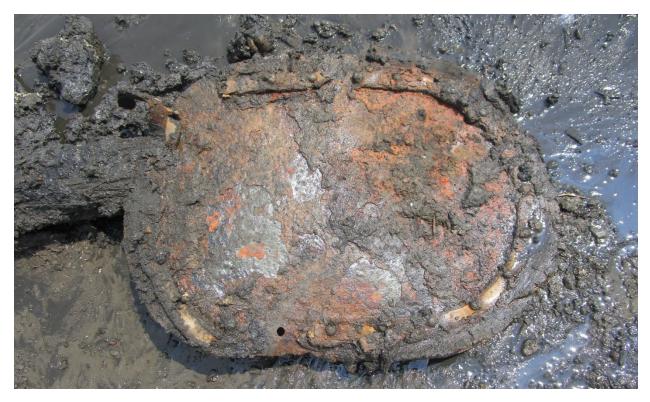
Photograph 5. Possible equipment hatch, bottom, with partial seal still attached (Chronicle Heritage, July 29, 2024).
