Memorandum

RE: Memo #5- Summary of visit to Cashman Yard, Staten Island, NY, on August 7, 2024

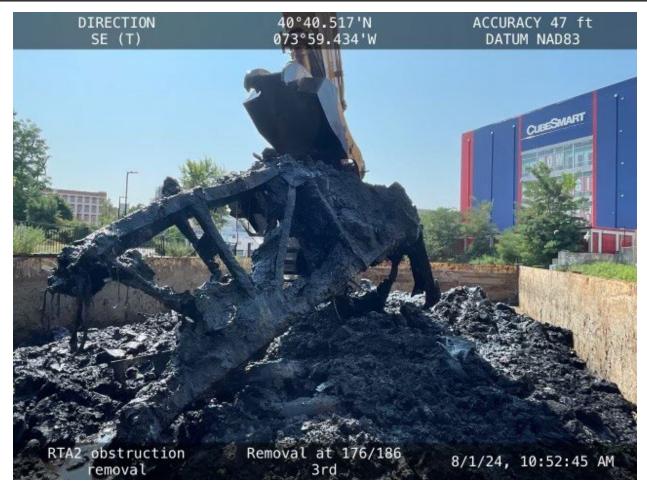
Photograph 1. Steel Truss identified in Level 1 monitoring of dredging within TB-6 (Geosyntec Consultants/GZA, August 1, 2024).

Chronicle Heritage does not recommend retention of the steel truss discussed in this memo as it is not an object of local interest or artifact. The constructed truss section is in very poor condition with unknown previous function. In its current damaged condition, it cannot be definitively placed in time or usage, and, therefore, has little research potential.

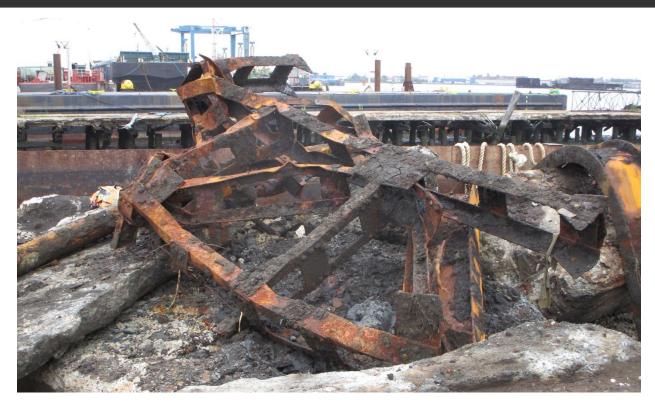
The truss is in a poor state of preservation, heavily twisted and corroded (Photograph 2 and 3). The truss appears to be four-foot tall and 18-inches wide, constructed using C-channels, I-beams, and iron/steel rivets. The truss segment is approximately 15-foot long. No markings or attached information plates were observed.

Photograph 2. Steel Truss: Recovered in vicinity of sonar target 31c (Chronicle Heritage, August 7, 2024).

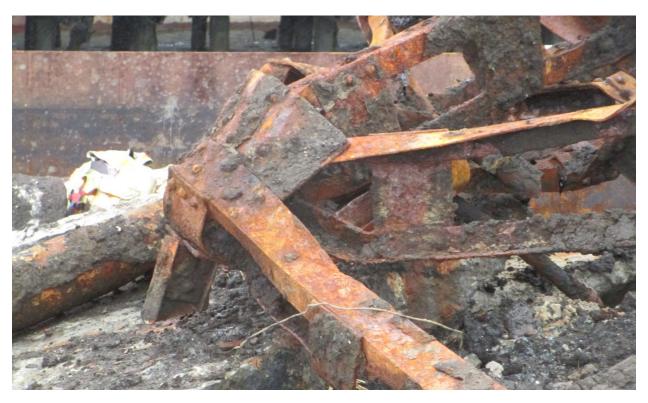
Photograph 3. Steel truss: Detail of angle iron and rivet construction (Chronicle Heritage, August 7, 2024).
