Memorandum

RE: Memo #5- Summary of visit to Cashman Yard, Staten Island, NY, on August 7, 2024

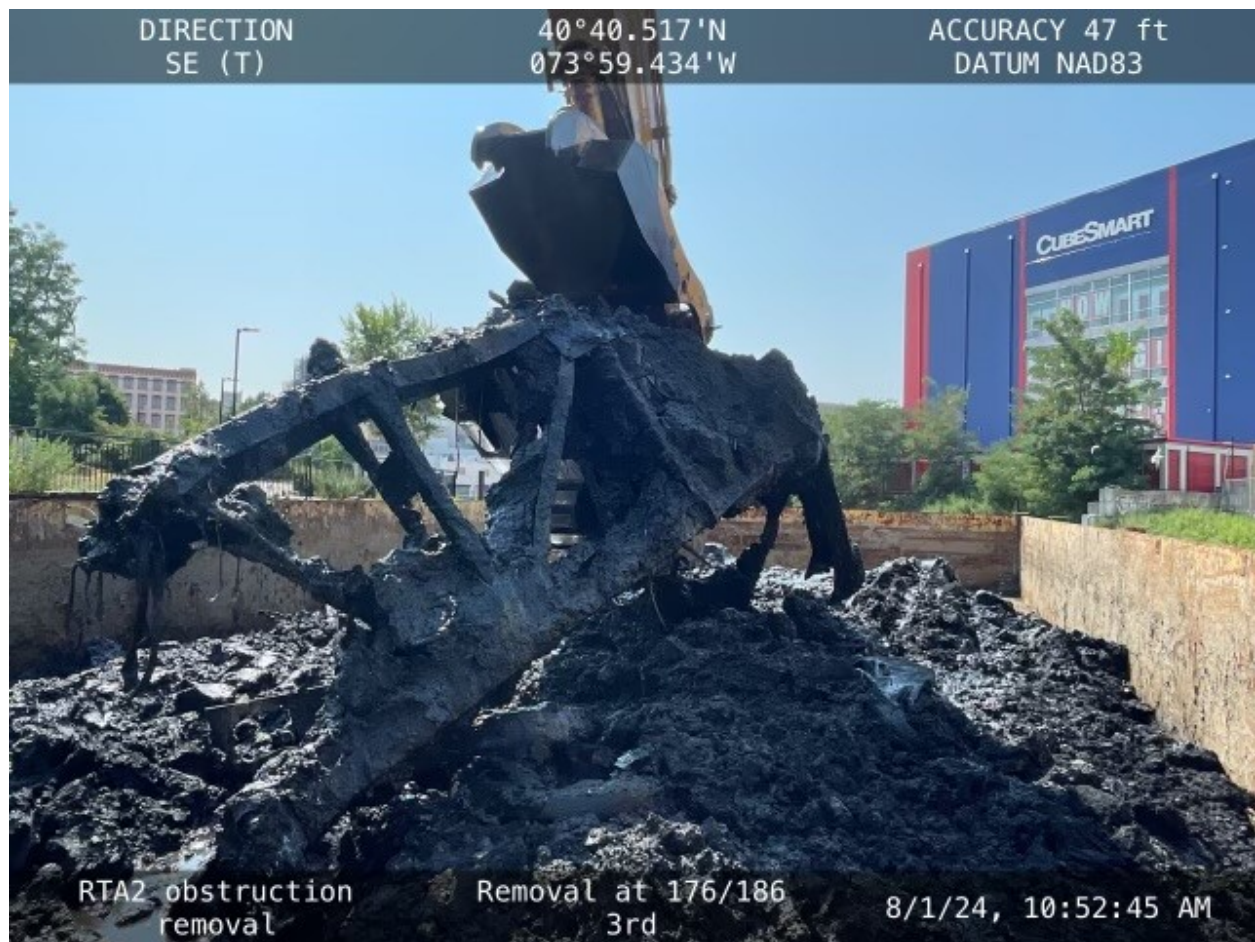
Photograph 1. Steel Truss identified in Level 1 monitoring of dredging within TB-6 (Geosyntec Consultants/GZA, August 1, 2024).

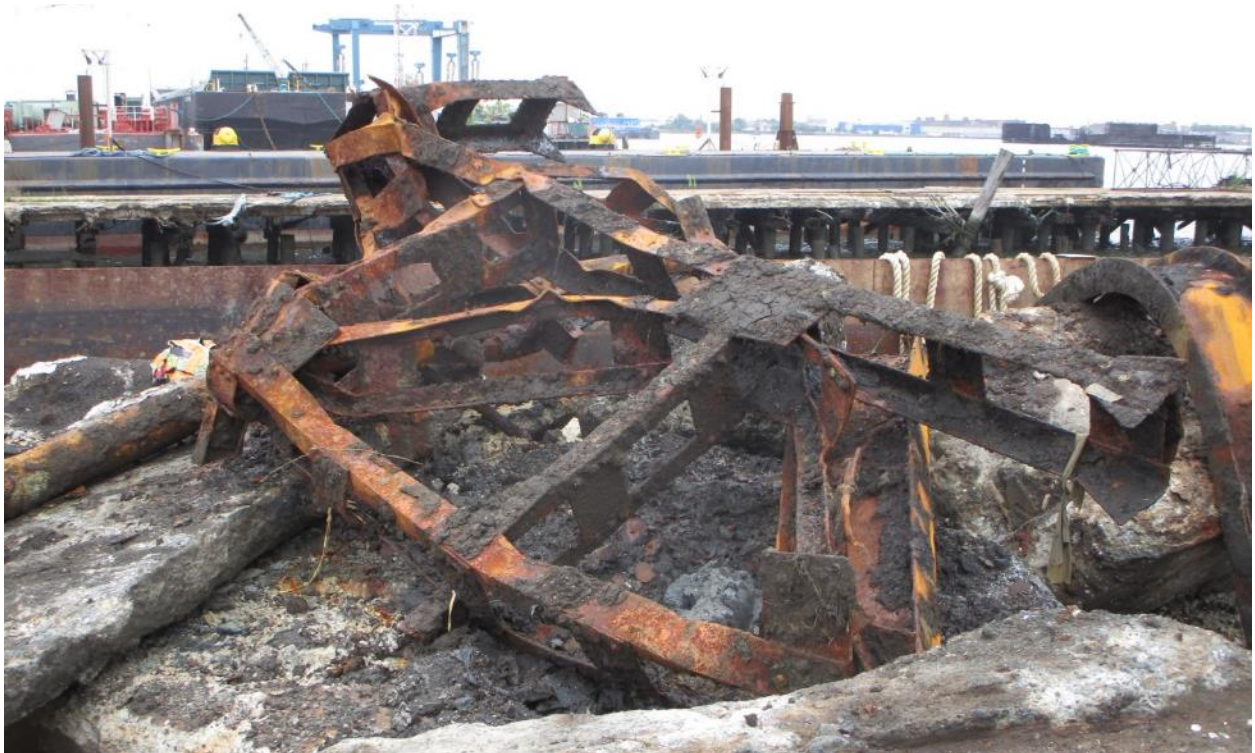
The truss is in a poor state of preservation, heavily twisted and corroded (Photograph 2 and 3). The truss appears to be four-foot tall and 18-inches wide, constructed using C-channels, I-beams, and iron/steel rivets. The truss segment is approximately 15-foot long. No markings or attached information plates were observed.

Photograph 2. Steel Truss: Recovered in vicinity of sonar target 31c (Chronicle Heritage, August 7, 2024).

Chronicle Heritage does not recommend retention of the steel truss discussed in this memo. The constructed truss section is in very poor condition with unknown previous function. In its current damaged condition, it cannot be definitively placed in time or usage, and, therefore, has little research value.

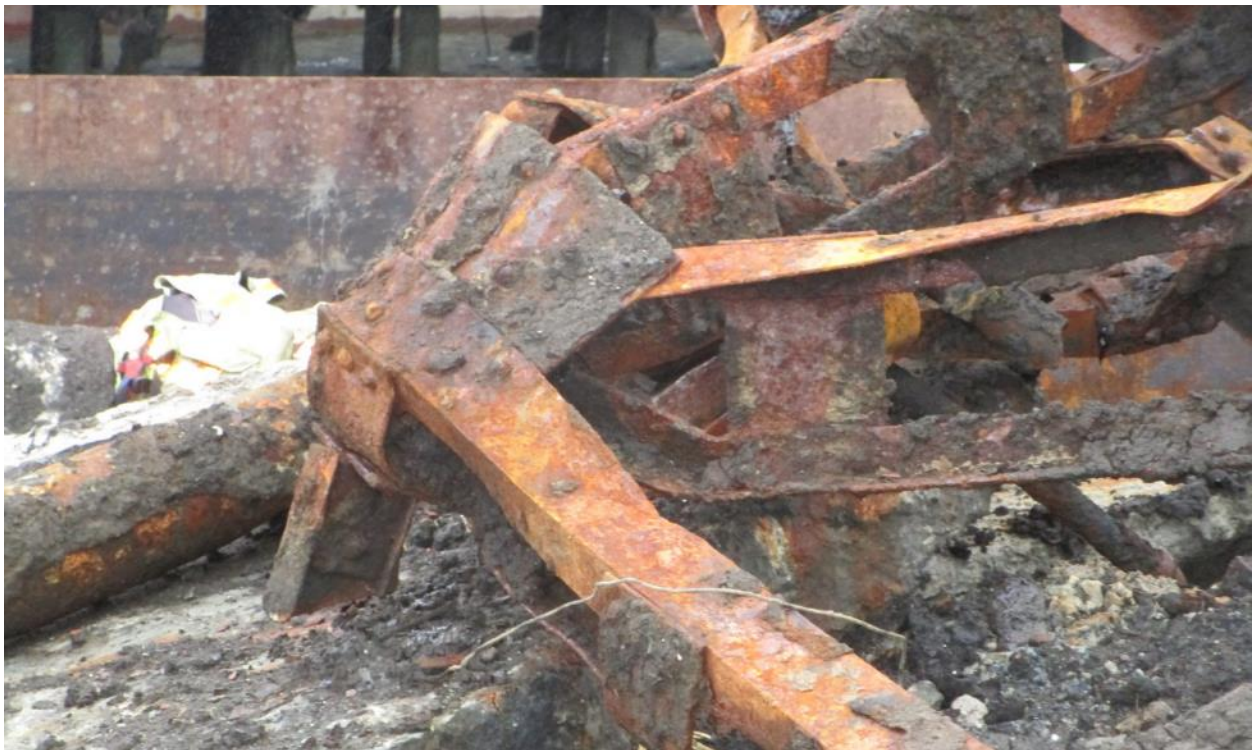
Photograph 3. Steel truss: Detail of angle iron and rivet construction (Chronicle Heritage, August 7, 2024).

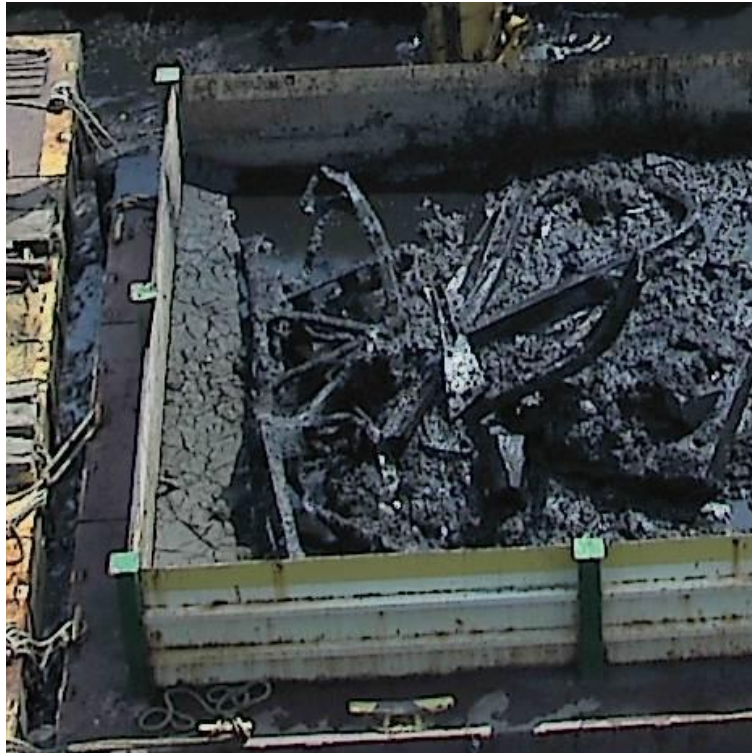
Upon further review of the item pulled from the Canal, it was determined that the truss is a k series steel joist (See Figure 4). These have been produced since the late 1920s into today for the purpose of holding static loads on structures like roofs. With that probable interpretation in mind, there is a strong possibility that this item is not related to either of the two bridges but rather came from one of the now razed buildings located on the upland parcels adjacent to the Canal. Figure 2 gives an idea of the types of buildings that were prevalent in the area during the 20th century that were constructed of steel structures like the one found in the Canal. K series joists are still popular construction materials for industrial buildings, temporary buildings, or partial structures like pole barns.

Photograph 4. Joist in Mini-Barge after dredging.

The condition of the joist and its location within the canal makes it difficult to definitively attribute it to any structure within the area, let alone the nearby bridges. The origin of the joist could be from a number of industries that lined the canal in that area. Previous occupants of this section of the canal includes lumbar and coal yards, a feed mill, and oil works. Many of these industries would have had steel construction buildings, most of which are not extant on the landscape today. Additionally due to its simple rivet construction, it is difficult to date its construction to the period of significance. Because of the nebulosness of the origins of the joist, it is recommended that it not be retained as an object of local interest.

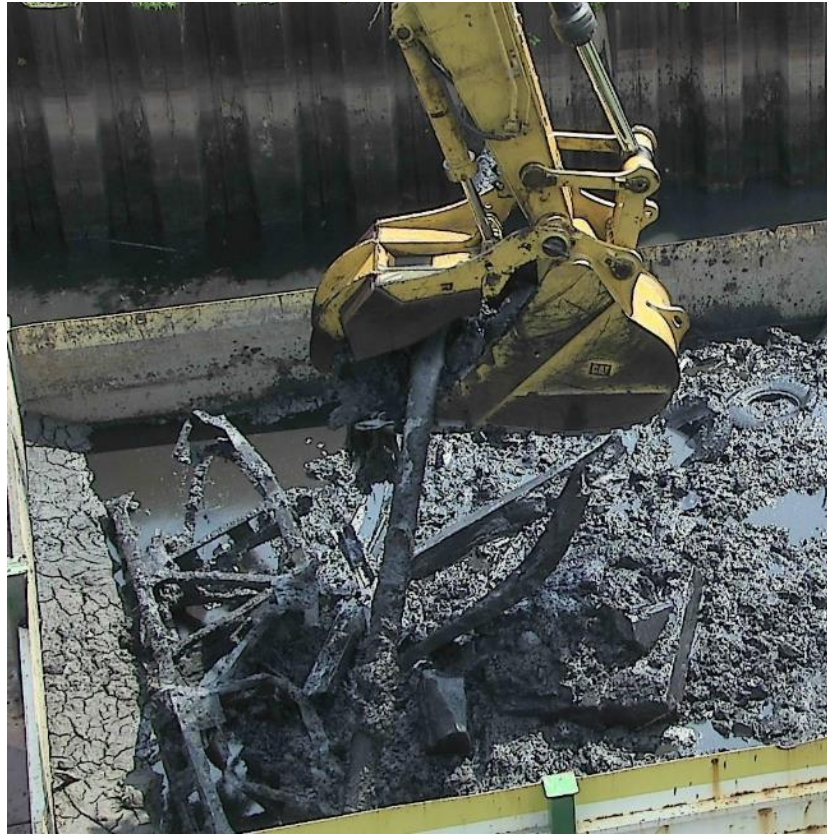
Photograph 5. Close up of joist after dredging.

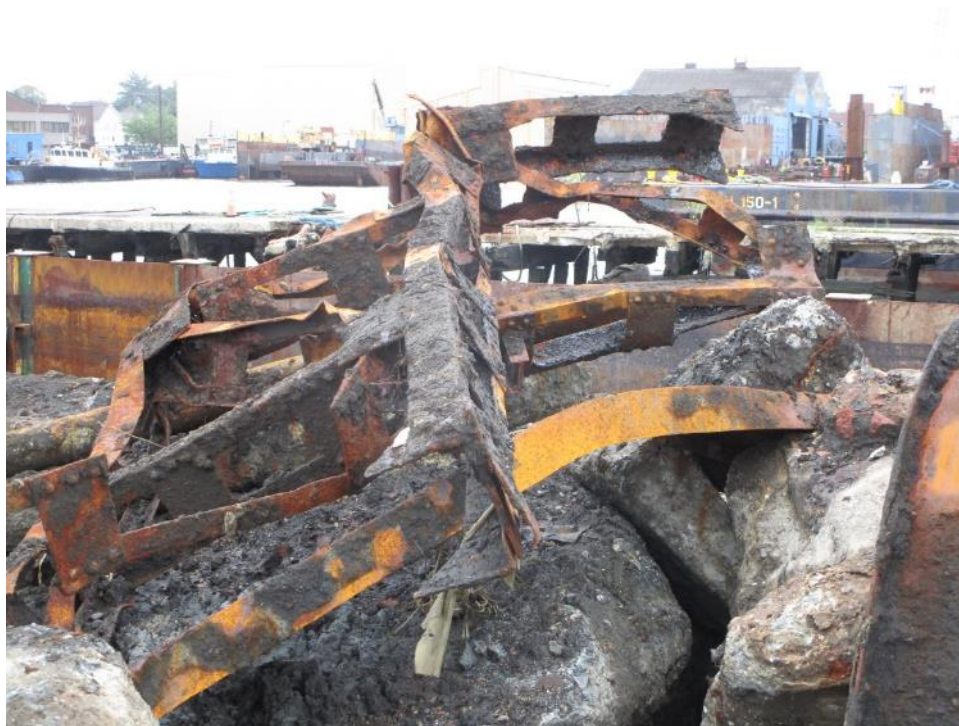
Photograph 6. Joist after cleaning.
