**GOWANUS CANAL SUPERFUND SITE  
RTA2 REMEDIAL CONSTRUCTION  
Water Quality Monitoring Weekly Data Summary**

**PERIOD: February 18, 2025 – February 21, 2025**

**Date of Report: February 25, 2025**

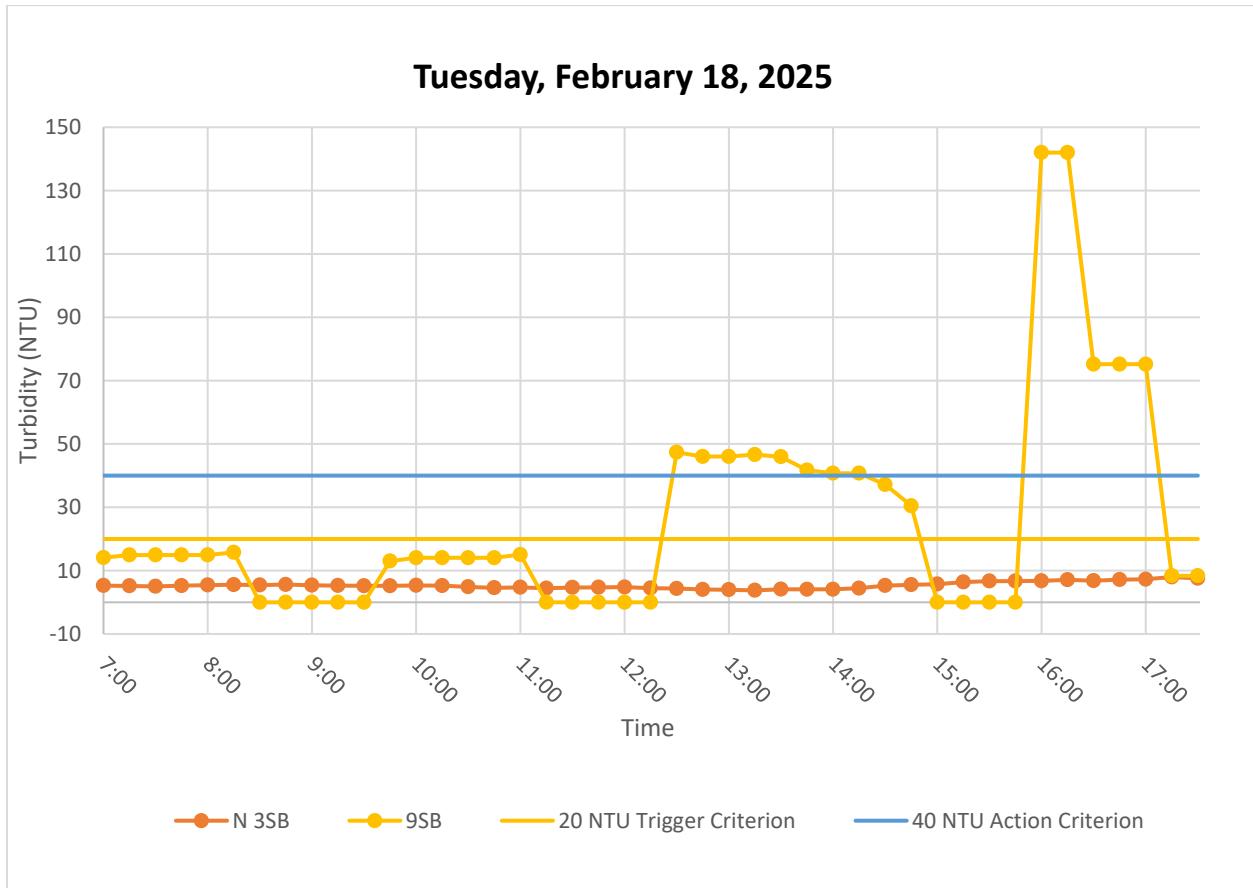
### 3.1 Tuesday, February 18, 2025

Throughout the reporting period, readings at the 3SB sonde remained relatively stable. No in-water construction related work was performed on Monday, February 17<sup>th</sup>, 2025, due to a holiday schedule. Therefore no data is being reported for that day. Elevated readings by the 9SB sonde were recorded between the times of 12:30 to 14:30 and 15:30 to 17:30 on Tuesday, February 18<sup>th</sup>, 2025, 08:00 to 10:30 on Wednesday, February 19<sup>th</sup>, 2025, and 16:30 to 17:30 February 20<sup>th</sup>, 2025. The elevated readings recorded on February 18<sup>th</sup> and February 19<sup>th</sup> occurred during low tide conditions, resulting in interference with the mudline, and periods of commercial vessel movement, resulting in increased prop wash and resuspension of sediment in the vicinity of the

9SB. The elevated readings recorded on February 20<sup>th</sup> occurred during a period of commercial vessel movement, resulting in increased prop wash and resuspension of sediment in the vicinity of the 9SB.

**Figure 3.** Hourly rolling average turbidity readings from 07:00 to 17:30. Elevated readings recorded by the 9SB sonde are related to commercial vessel traffic and low tide interference.

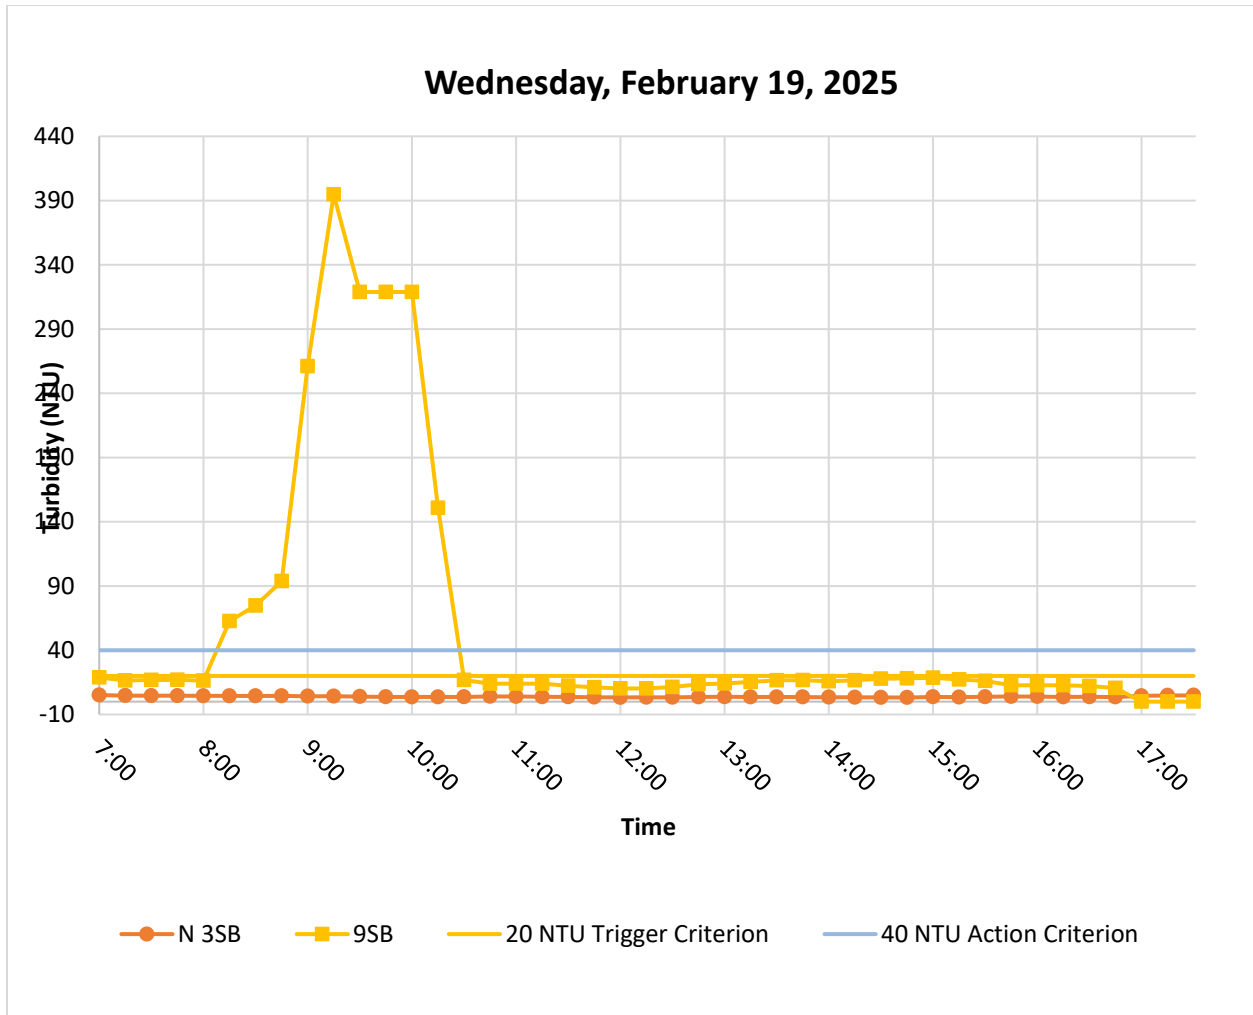
3.2 Wednesday, February 19, 2025

**Figure 4 .** Hourly rolling average turbidity readings from 07:00 to 17:30. Elevated reading recorded by the 9SB sonde are related to commercial vessel traffic and low tide interference.

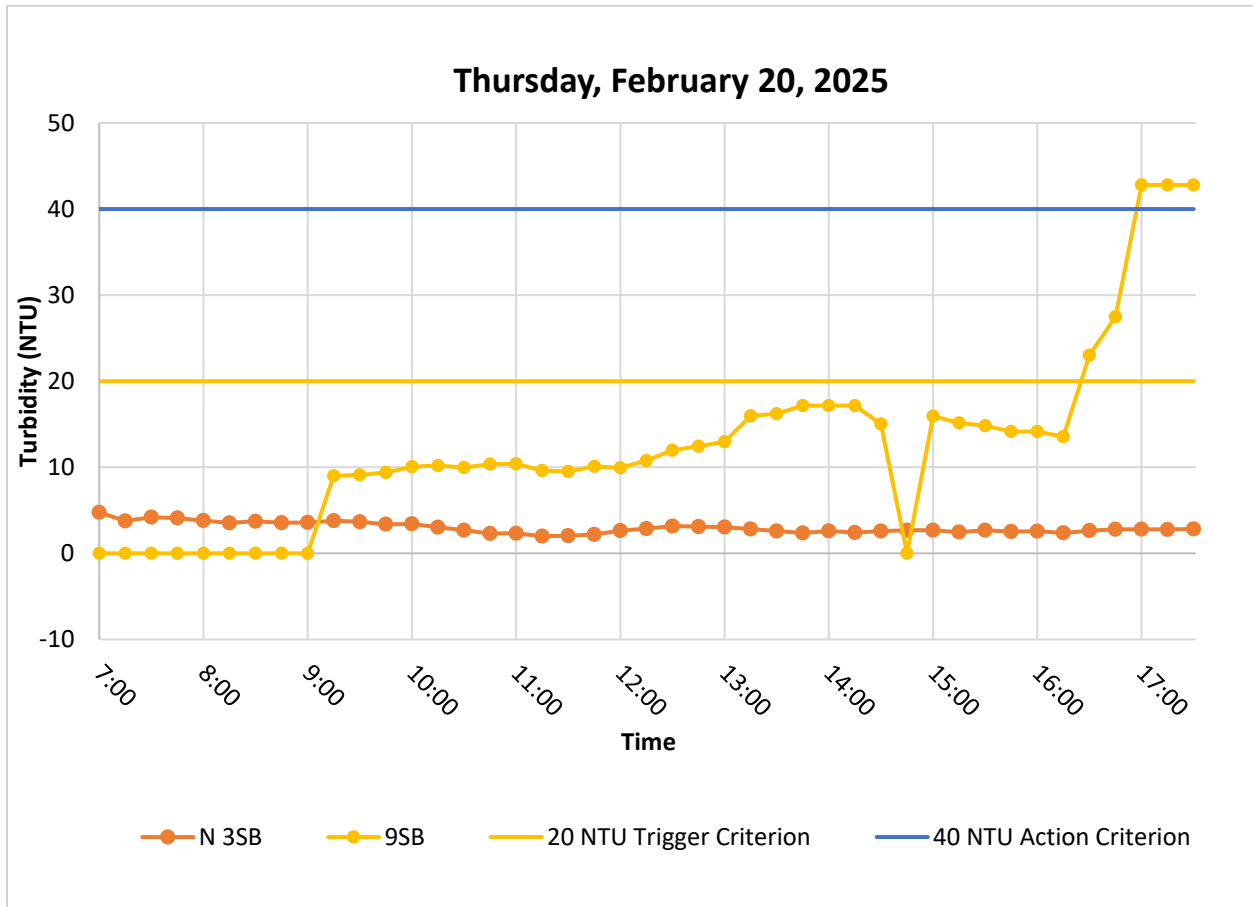
3.3 Thursday, February 20, 2025

**Figure 5.** Hourly rolling average turbidity readings from 07:00 to 17:30. Elevated reading recorded by the 9SB sonde are related to commercial vessel traffic.

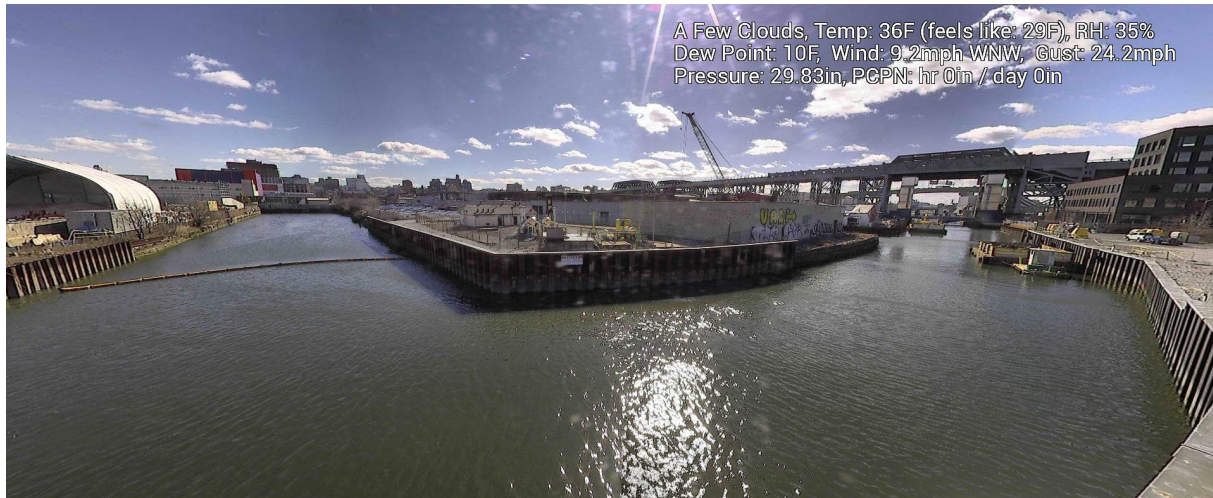
Throughout the majority of the reporting period, sheens in the RTA2 areas ranged from minimal to moderate.

**Figure 7 – February 17, 2025.** General Conditions in Canal north of 9<sup>th</sup> Street Bridge near TB6 during in-waterway construction activities.

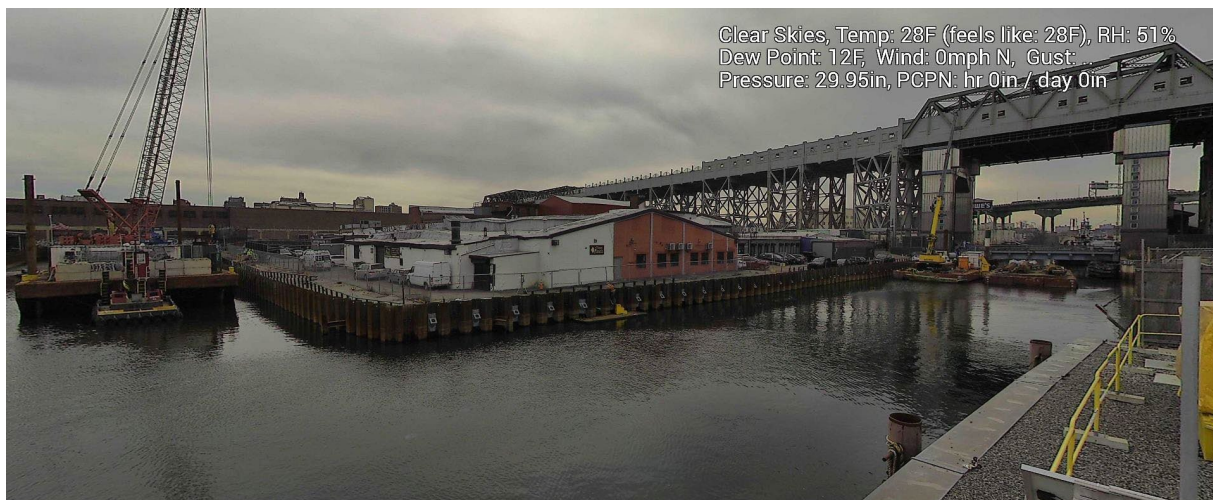
**Figure 8 – February 20, 2025.** General Conditions in Canal north of 9<sup>th</sup> Street Bridge near TB7 during in-waterway construction activities.

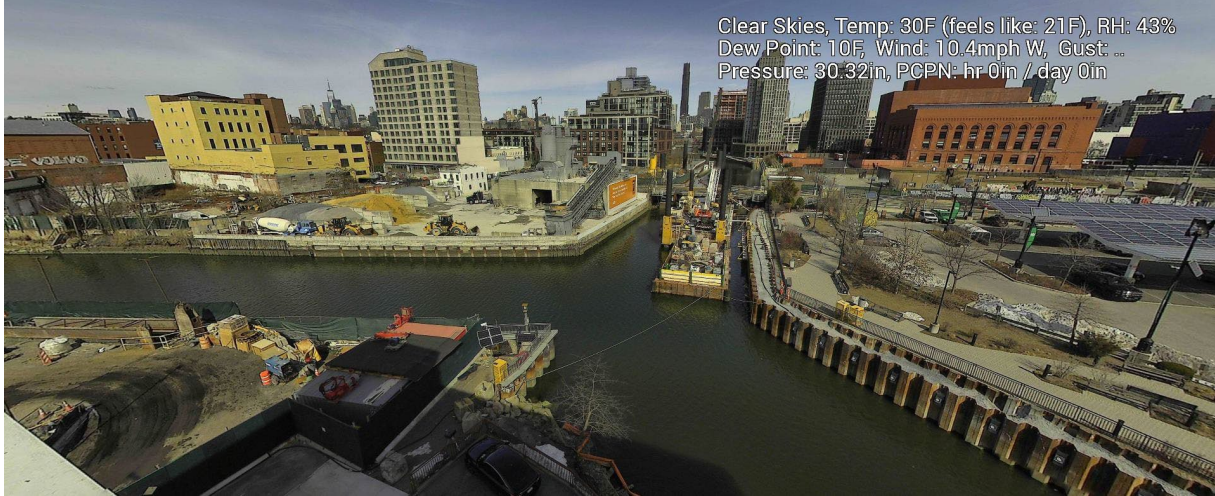
**Figure 9 – February 19, 2025.** General Conditions in Canal south of 3<sup>rd</sup> Street Bridge near TB4 during in-waterway construction activities.
