**GOWANUS CANAL SUPERFUND SITE  
RTA2 REMEDIAL CONSTRUCTION  
Water Quality Monitoring Weekly Data Summary**

**PERIOD: July 1, 2024 – July 5, 2024**

**Date of Report: July 9, 2024**

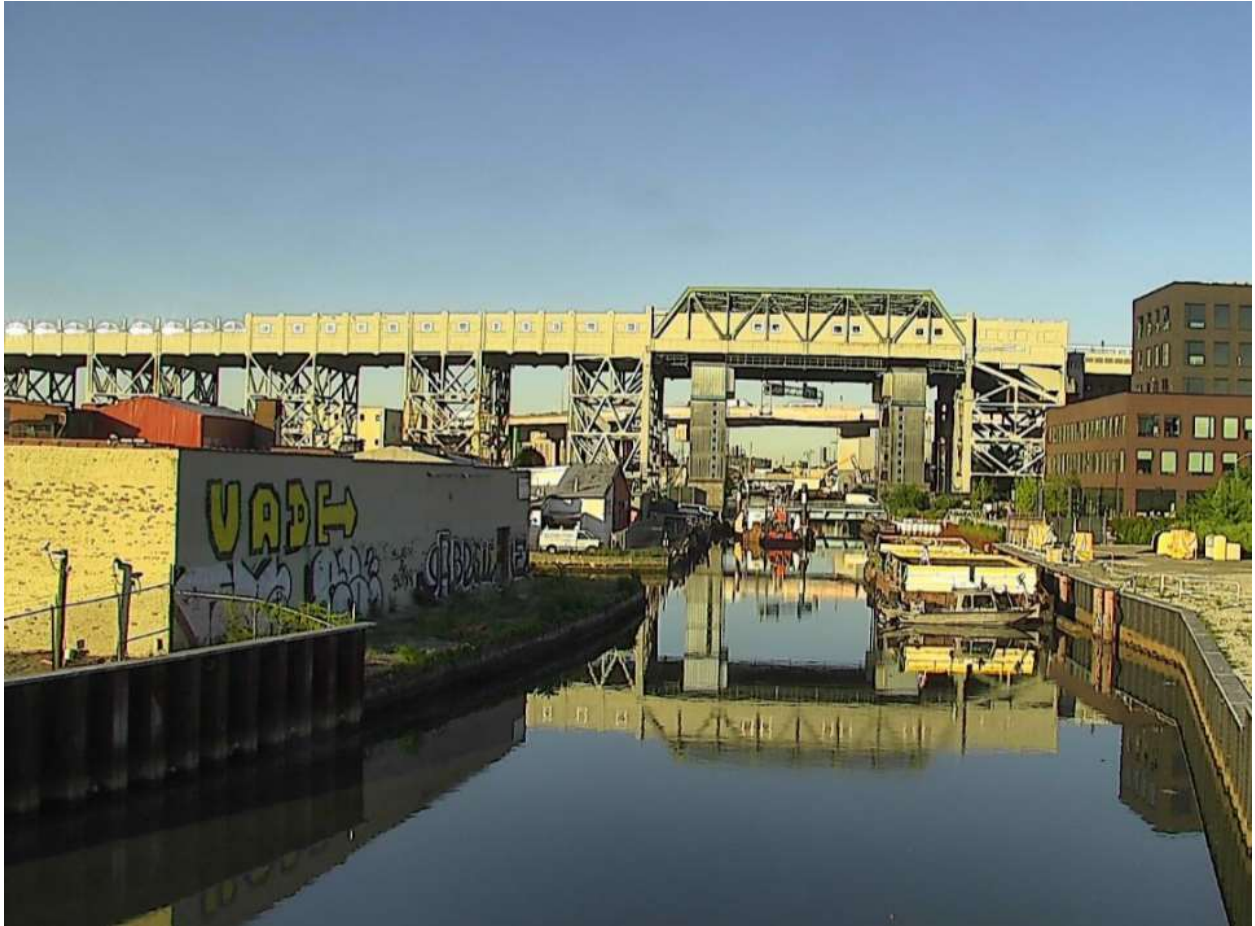
Visual indications of elevated turbidity unrelated to construction activities were observed throughout the reporting period. Sheens in areas of RTA2 were minimal. Turbid water was noted south of 3<sup>rd</sup> Street Bridge during and after work activities throughout the week.

**Figure 2 – July 2, 2024.** General Conditions in Canal north of 9<sup>rd</sup> Street Bridge prior to work activities at 6:52AM.

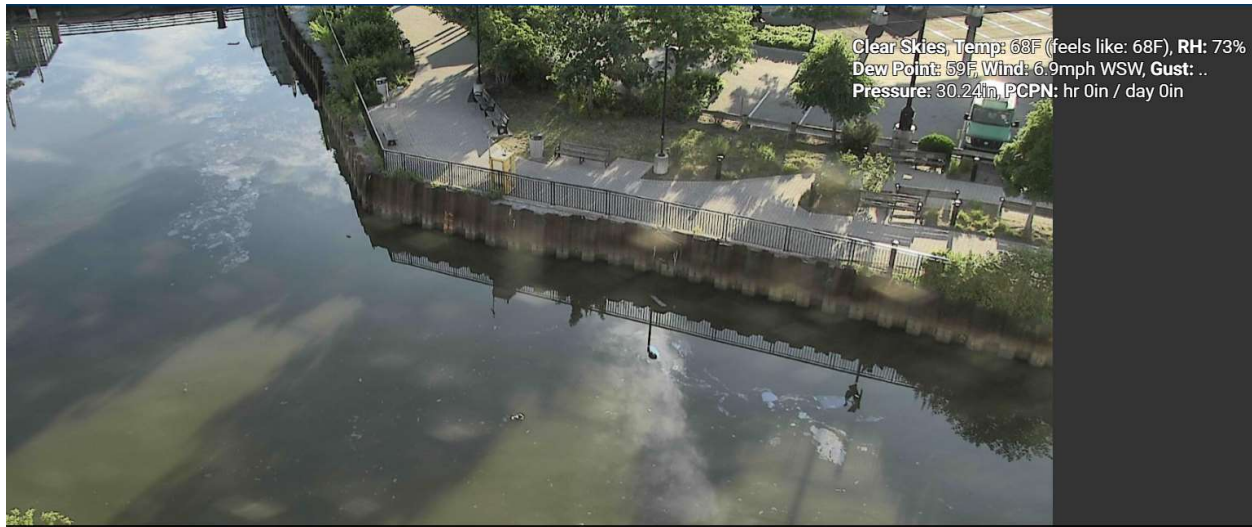
**Figure 3 – July 3, 2024.** General Conditions in Canal south of 3<sup>rd</sup> Street Bridge prior to work activities at 7:02AM.

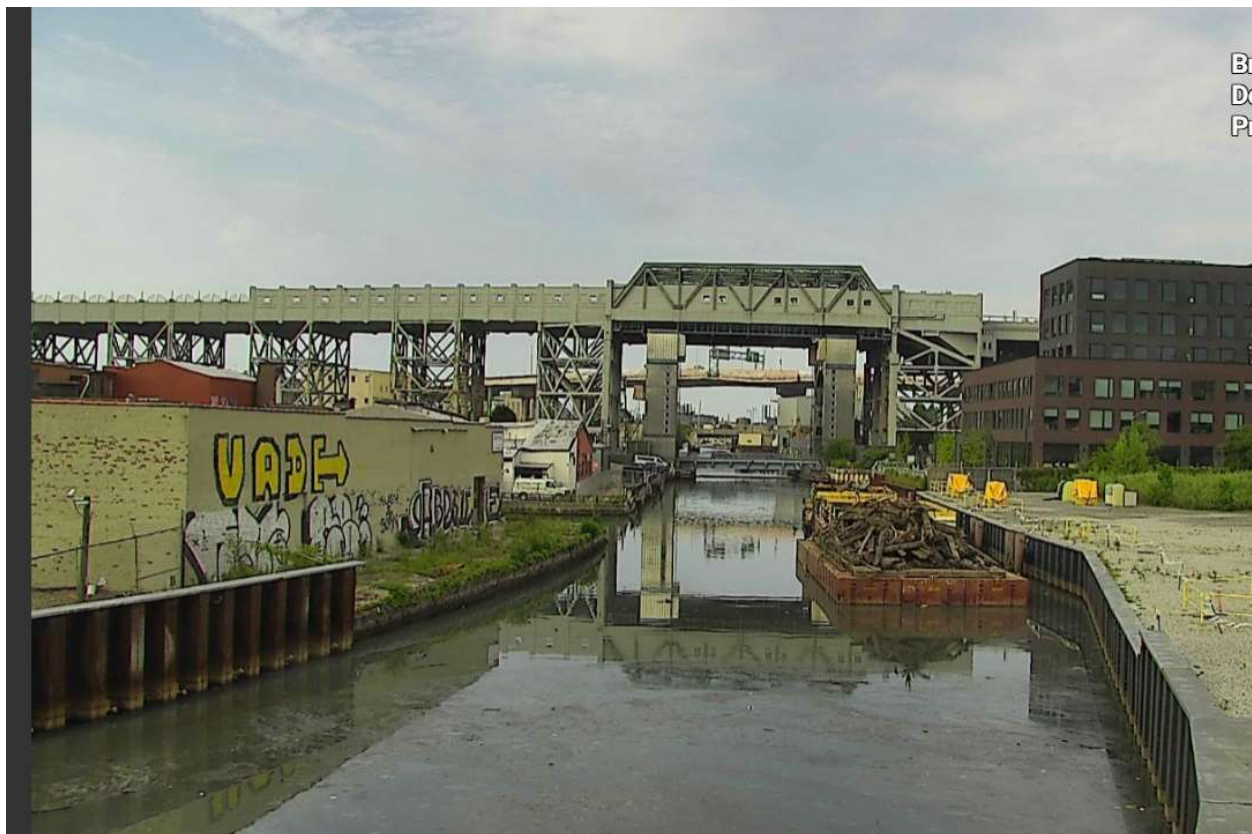
A rainfall event which triggered a CSO discharge occurred on Thursday, July 4 between 10:30PM and Friday, July 5 at 3:00AM. The weather conditions onsite were as follows:

**Figure 4- July 4, 2024.** General Conditions in Canal north of 9<sup>th</sup> Street Bridge. No work performed this day. Suspected CSO discharge noted at 8:37AM in this area.
