Gowanus Canal Superfund Site Brooklyn, NY

**U.S. Environmental Protection Agency
Region 2
April 2011**

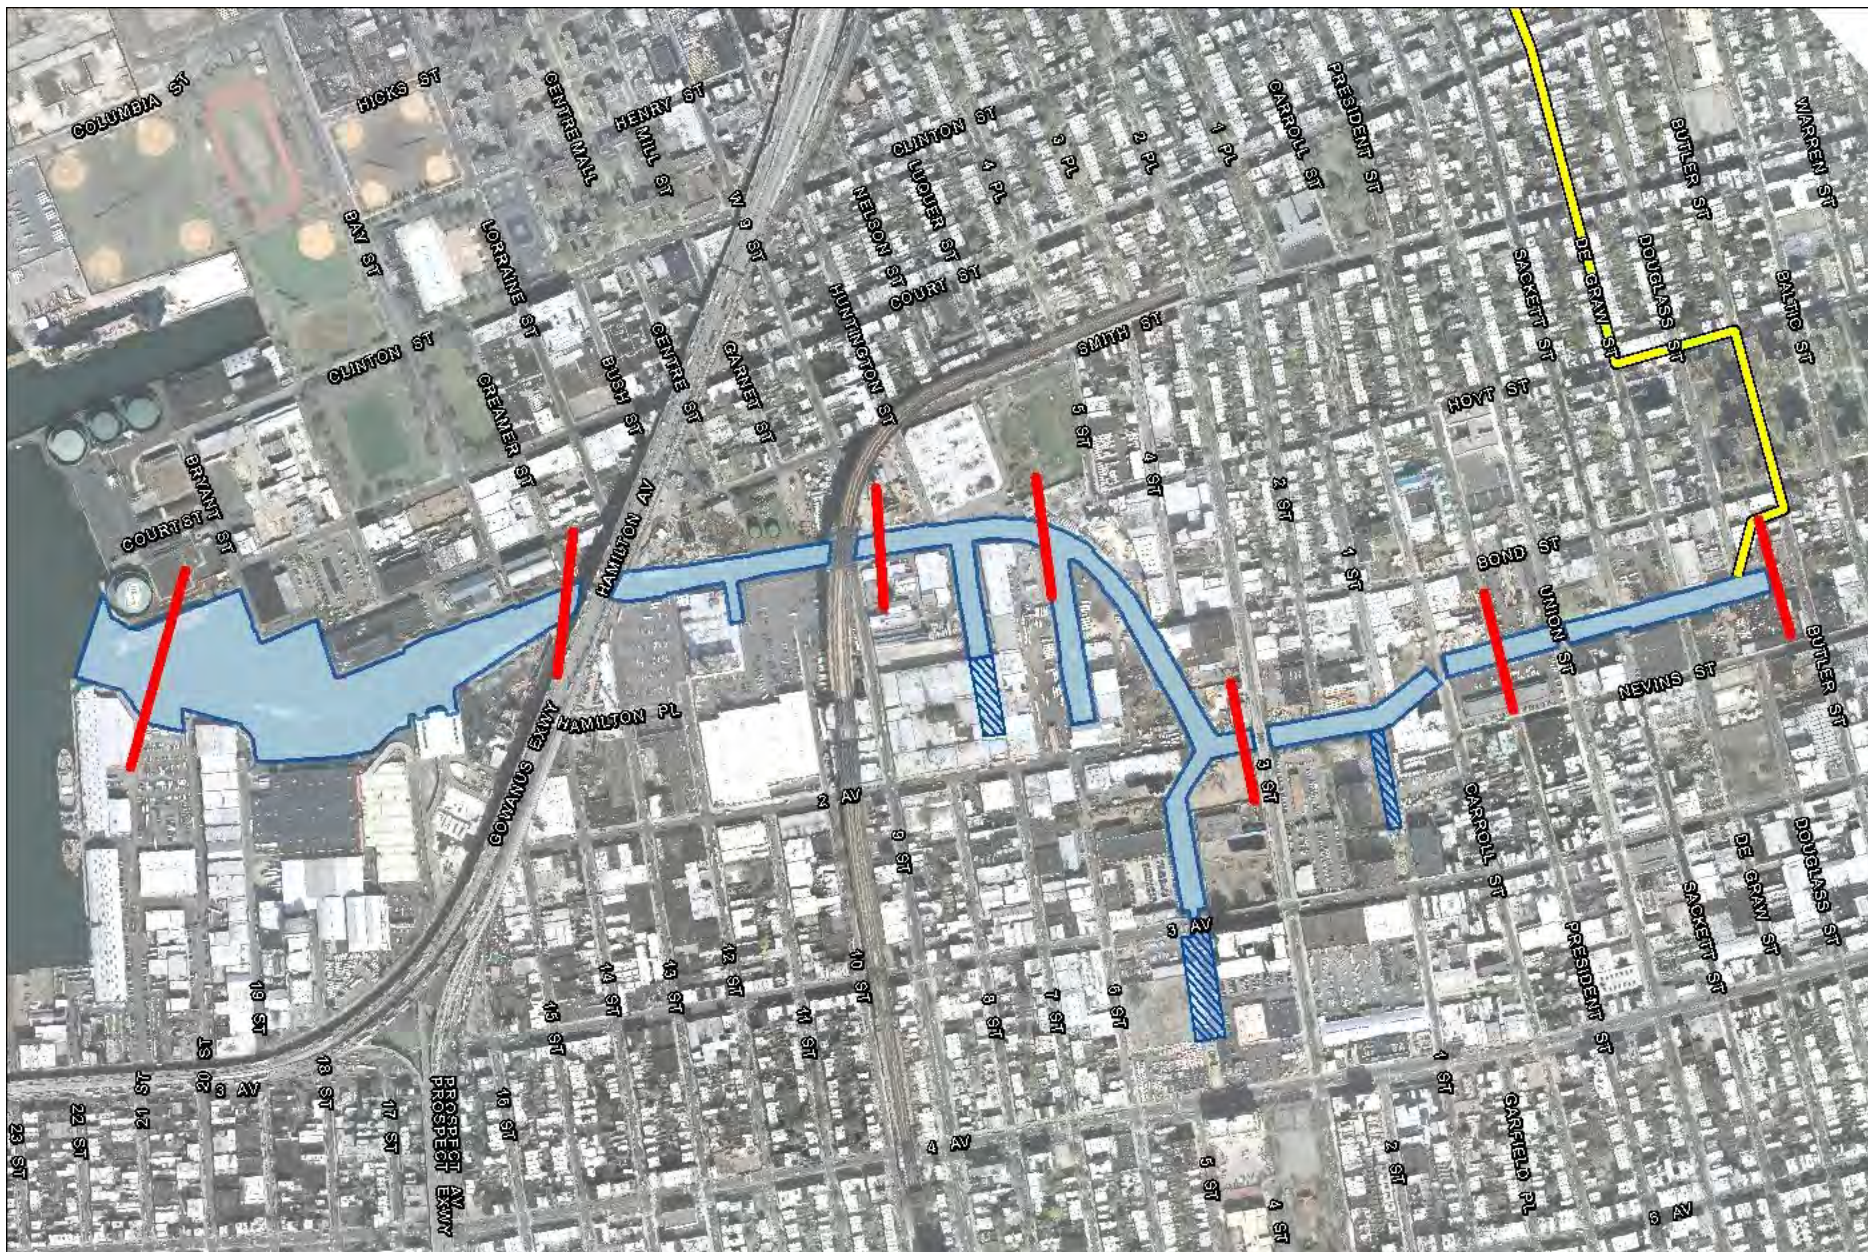
Fish and Crab Tissue Sampling Locations

Type	Species
Small prey fish	Atlantic Tomcod Hake Mummichog
Blue Crab	Blue Crab
Larger Fish	American Eel Striped Bass White Perch

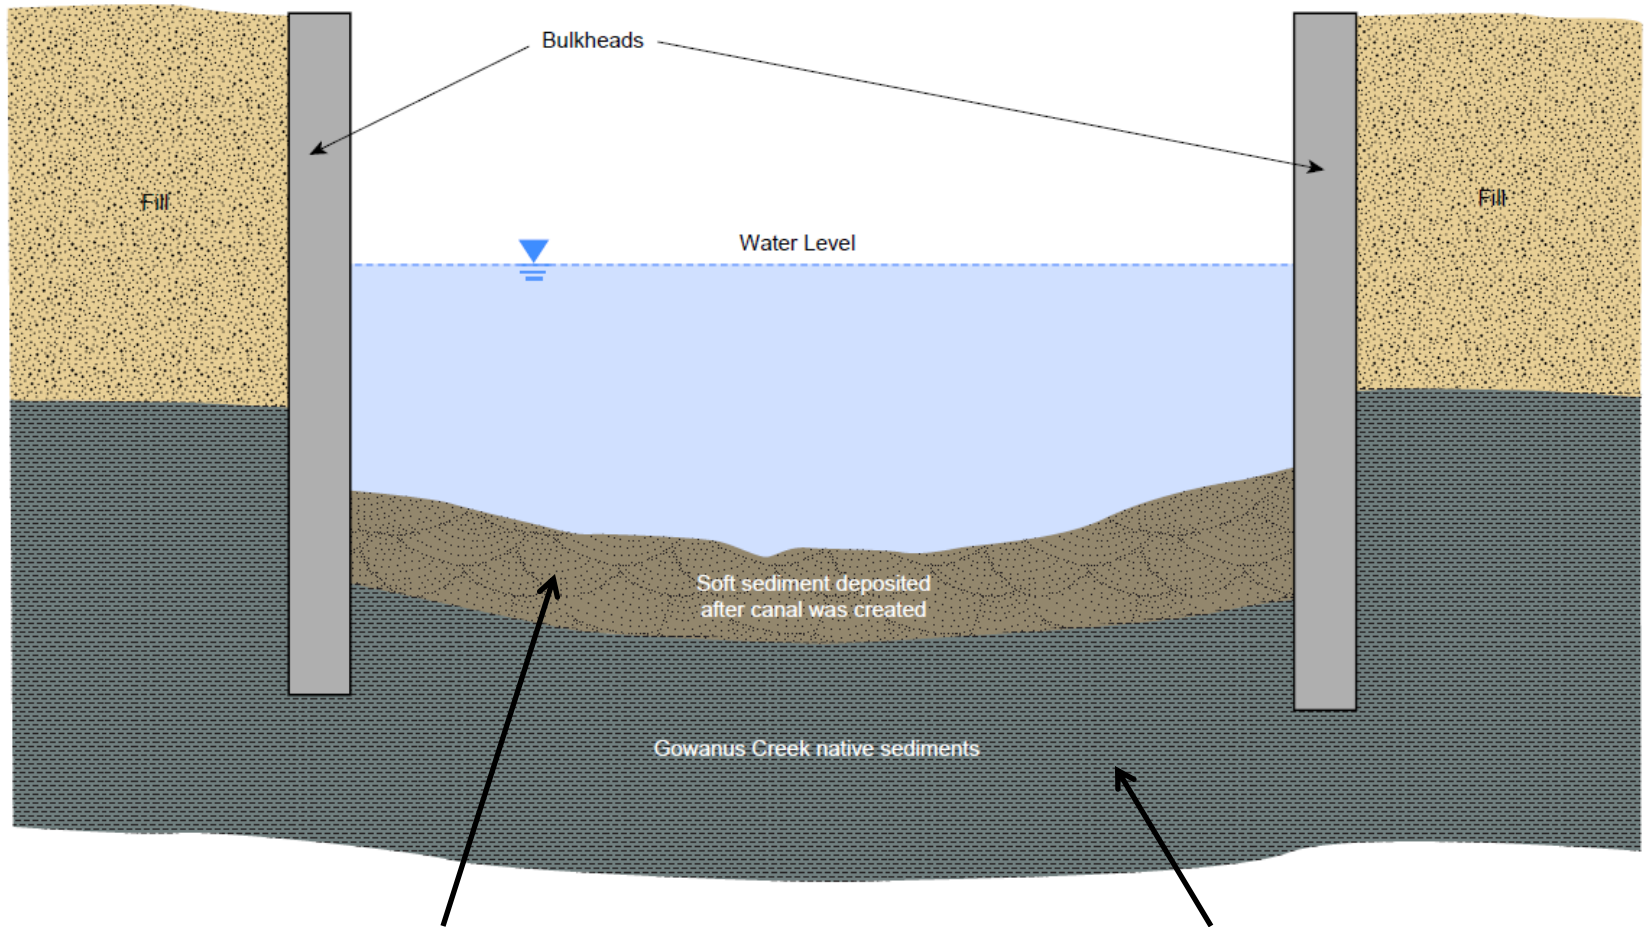
Gowanus Canal Sediment Layers

Soft Sediment

Native Sediment

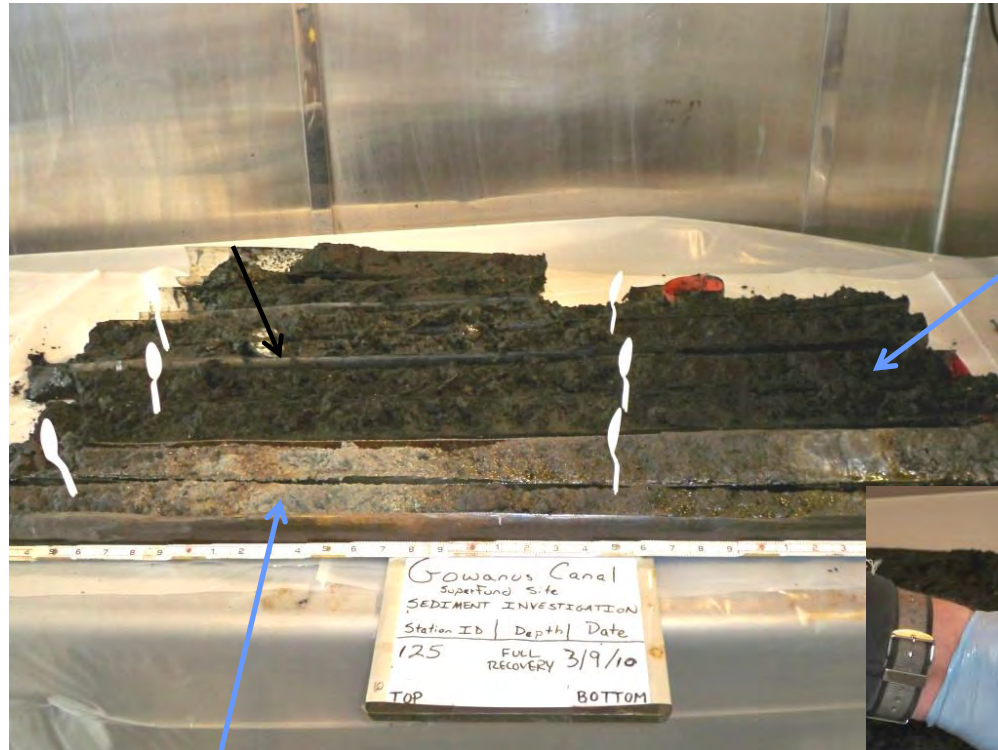
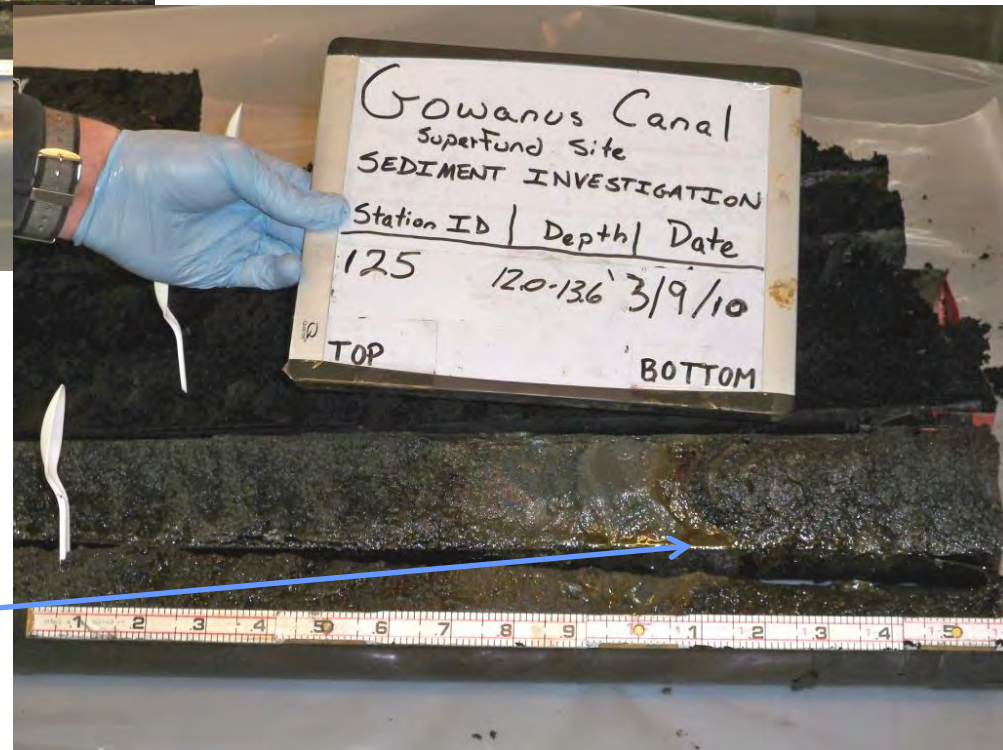
Deep Sediment Characterization

Soft Sediment

Native Sediment

NAPL

Sediment Layer	BTEX (mg/kg)	PAHs (mg/kg)	PCBs (mg/kg)	Lead (mg/kg)
Surface soft	0.36	527	0.43	533
Deeper soft	188	3,490	3.5	770
Native	233	2,920	0.026	14

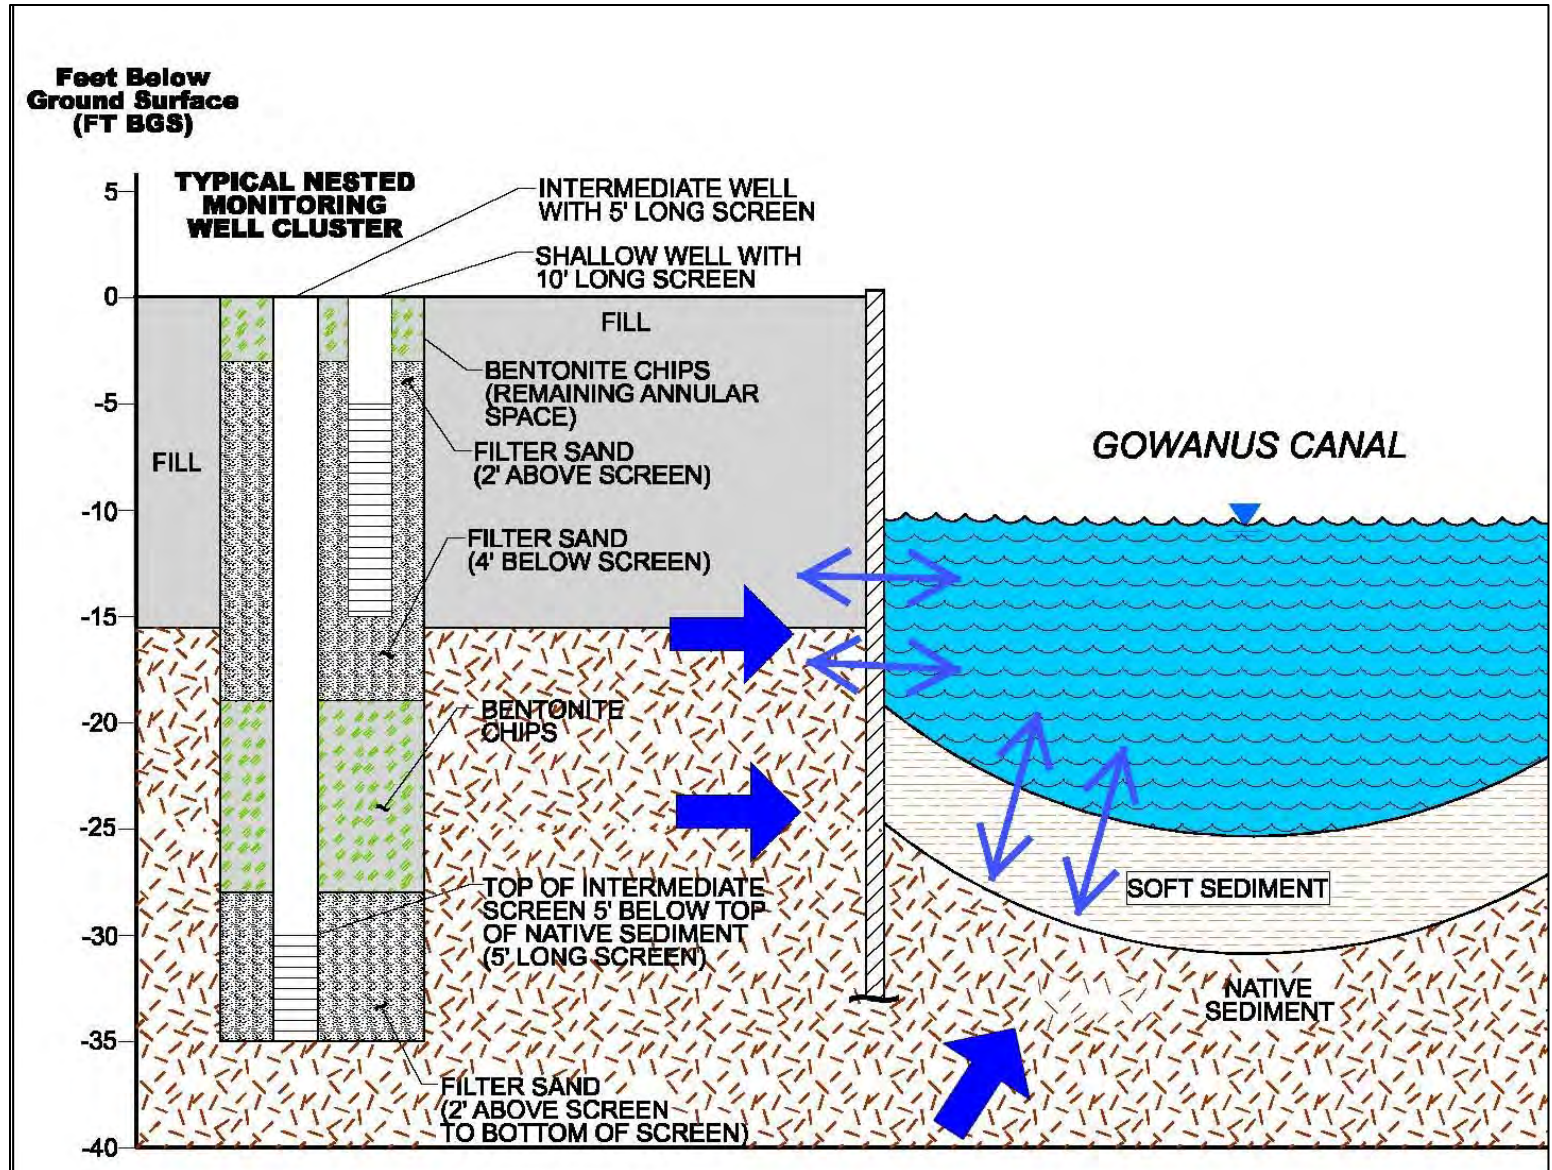
Well Depths and Groundwater Flow

- ◆ **Shallow & intermediate groundwater generally flows toward the canal**
- ◆ **High tides can reverse local flow directions so canal surface water enters adjacent soils**
- ◆ **Large volume tidal fluctuations in surface water; comparatively smaller contribution of groundwater to the canal**
