EPA Briefing March 2012

Enforcement Briefing

Gowanus Canal Superfund Site
Brooklyn, NY

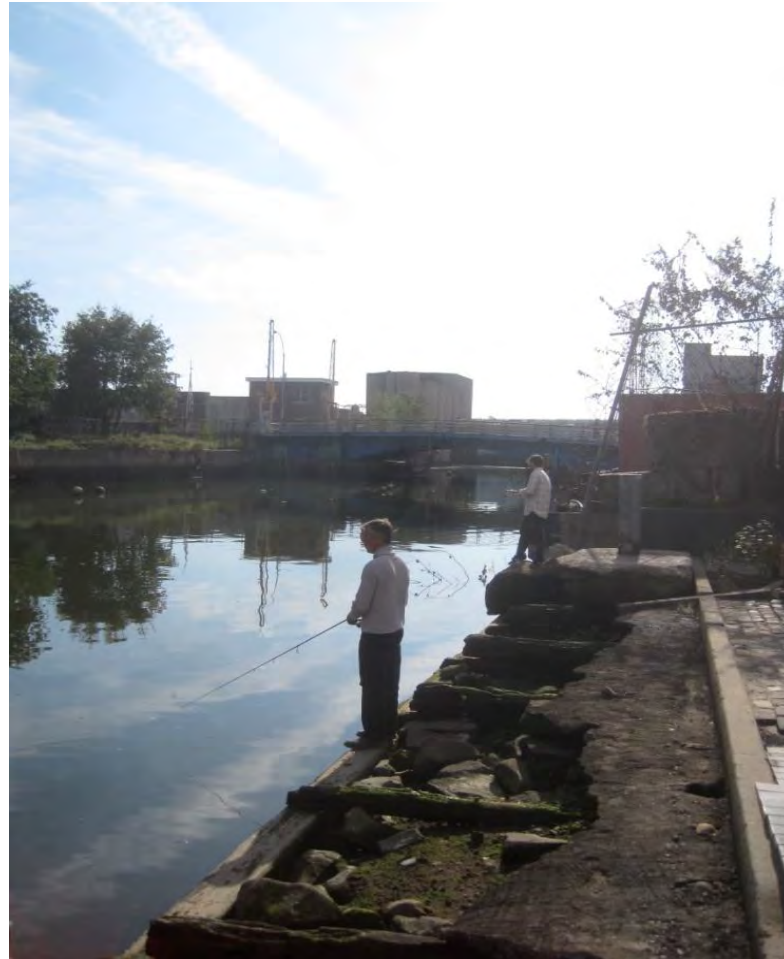
A section of exposed timber crib bulkhead. Upland disposal and groundwater discharges can migrate through and beneath bulkheads to the Canal.

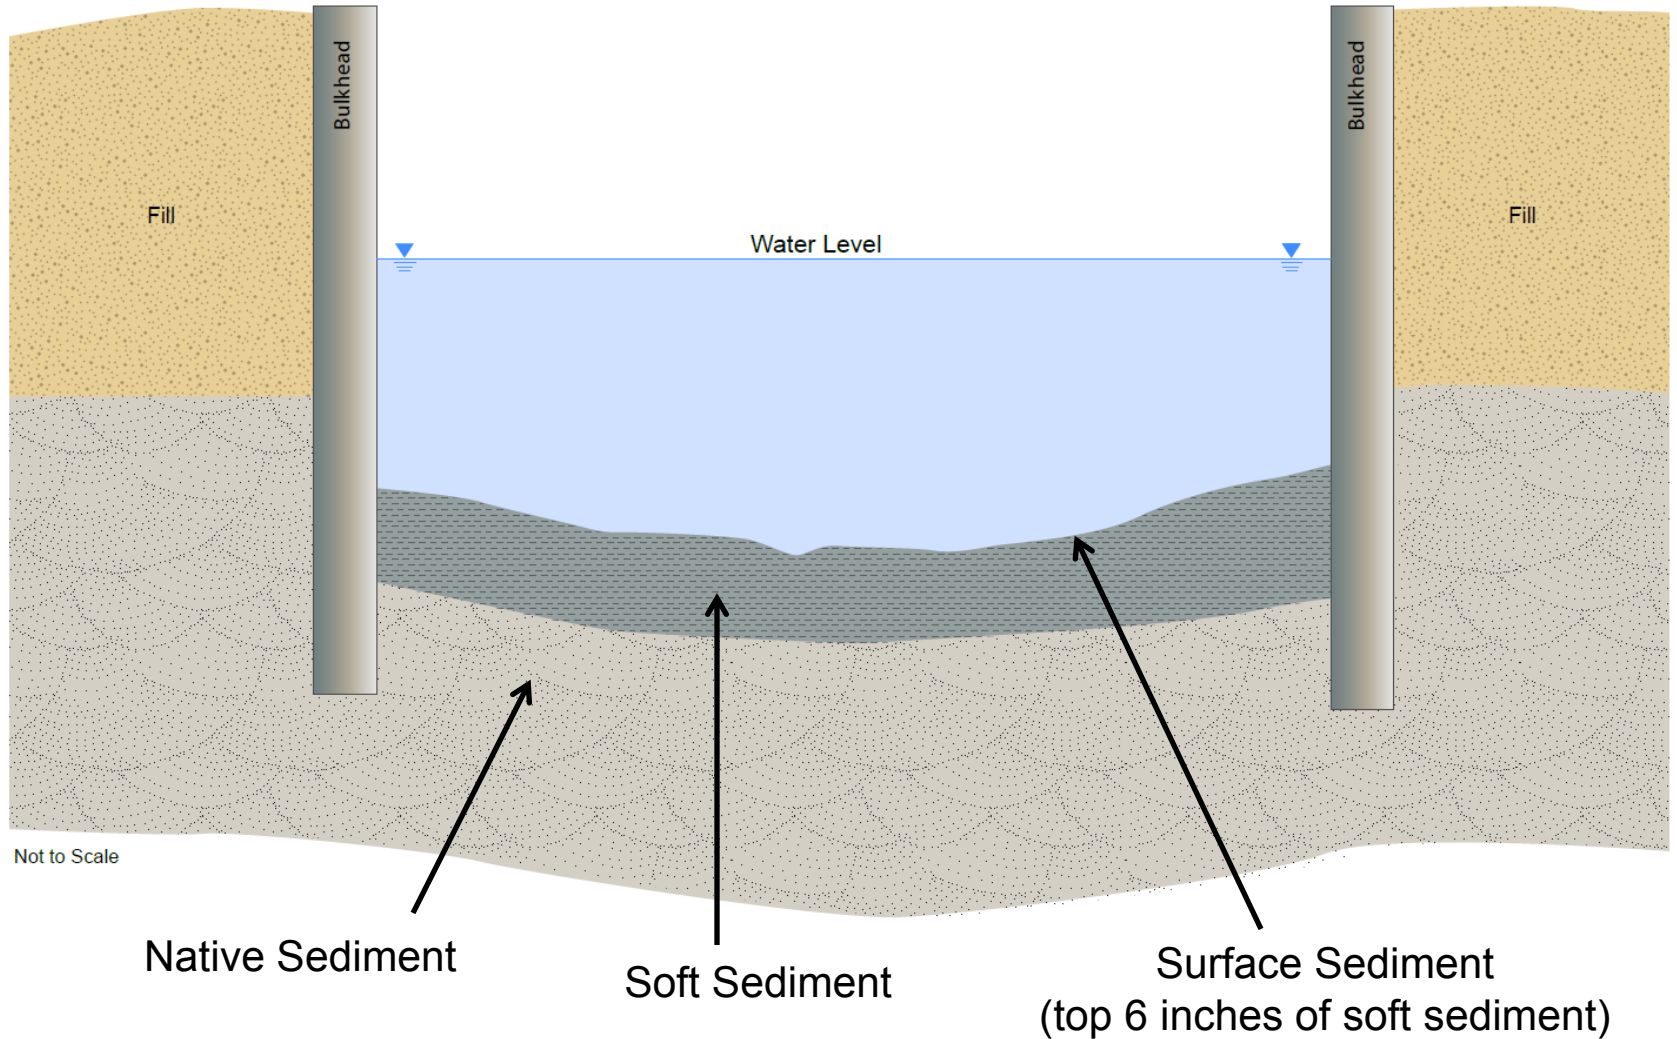
Gowanus Canal Sediment Layers

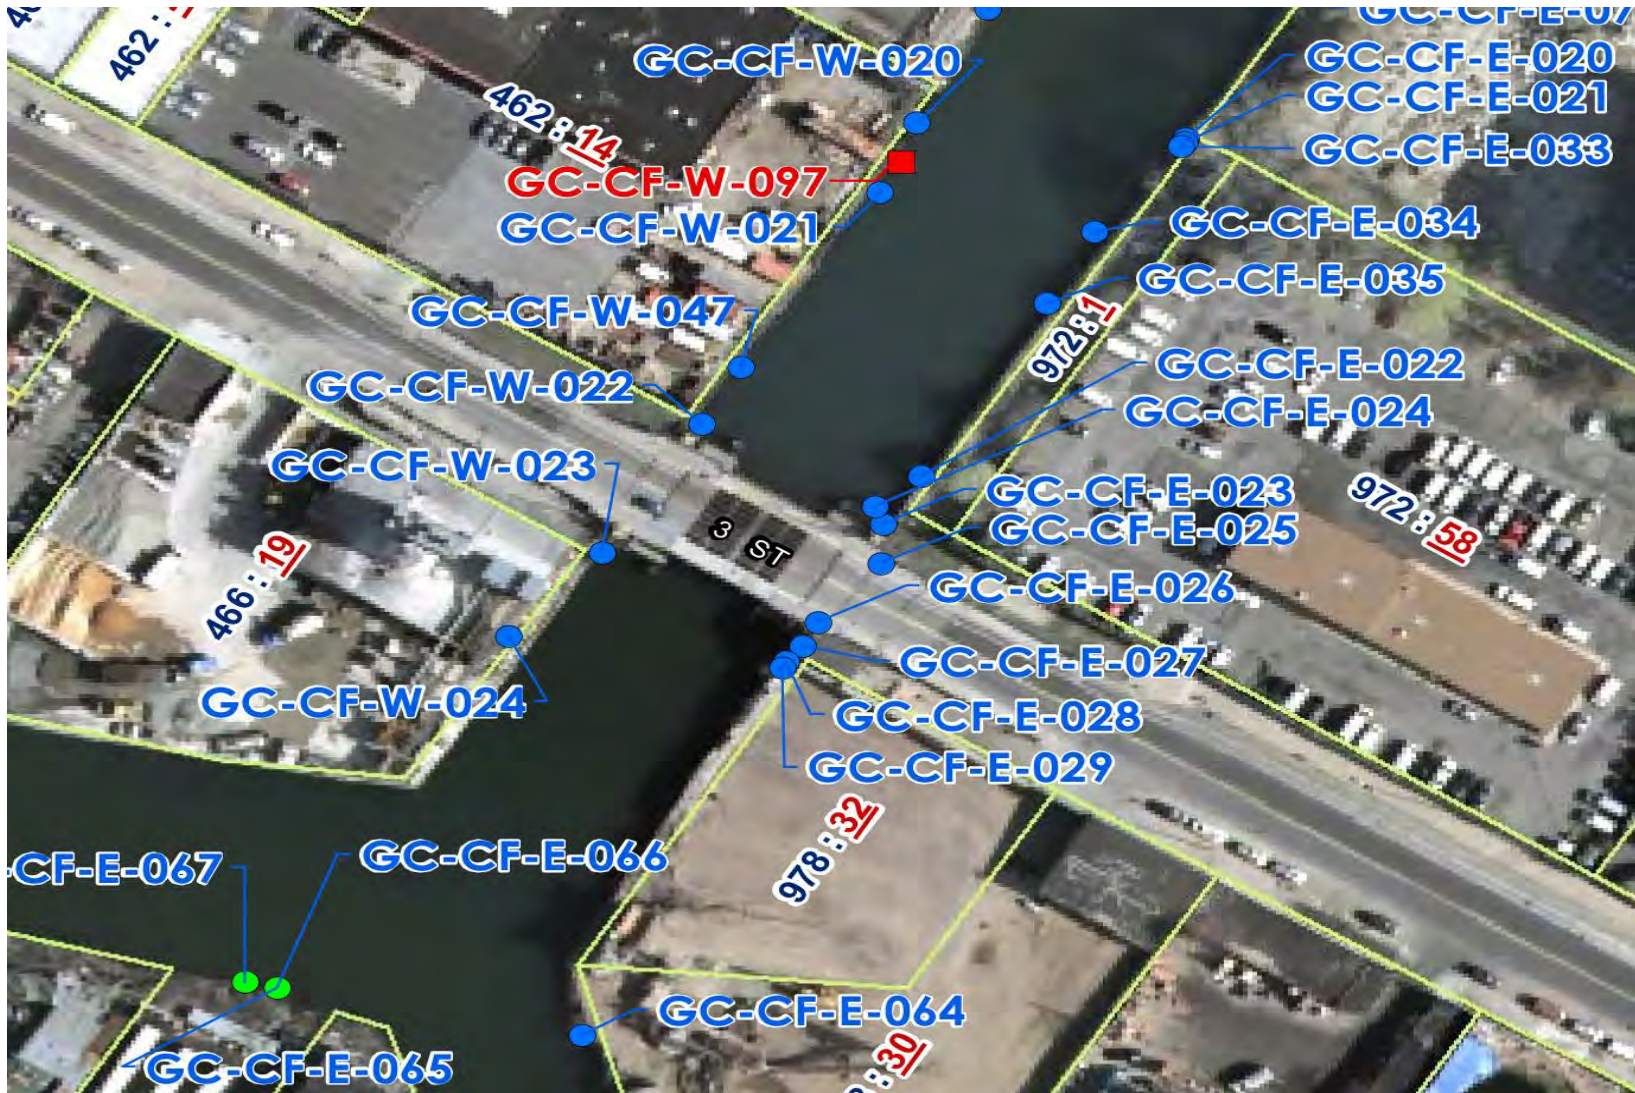
EPA's 2010 RI found 231 non-CSO outfalls,

EPA found few discharges from non-CSO outfalls. Most date from era of uncontrolled direct discharge.

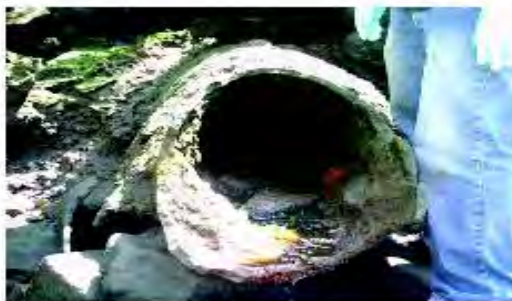
GC-CF-E-55

Gowanus Canal - Remedial Investigation
Appendix D-12A - Survey of Outfall Pipes

East Bank of Canal

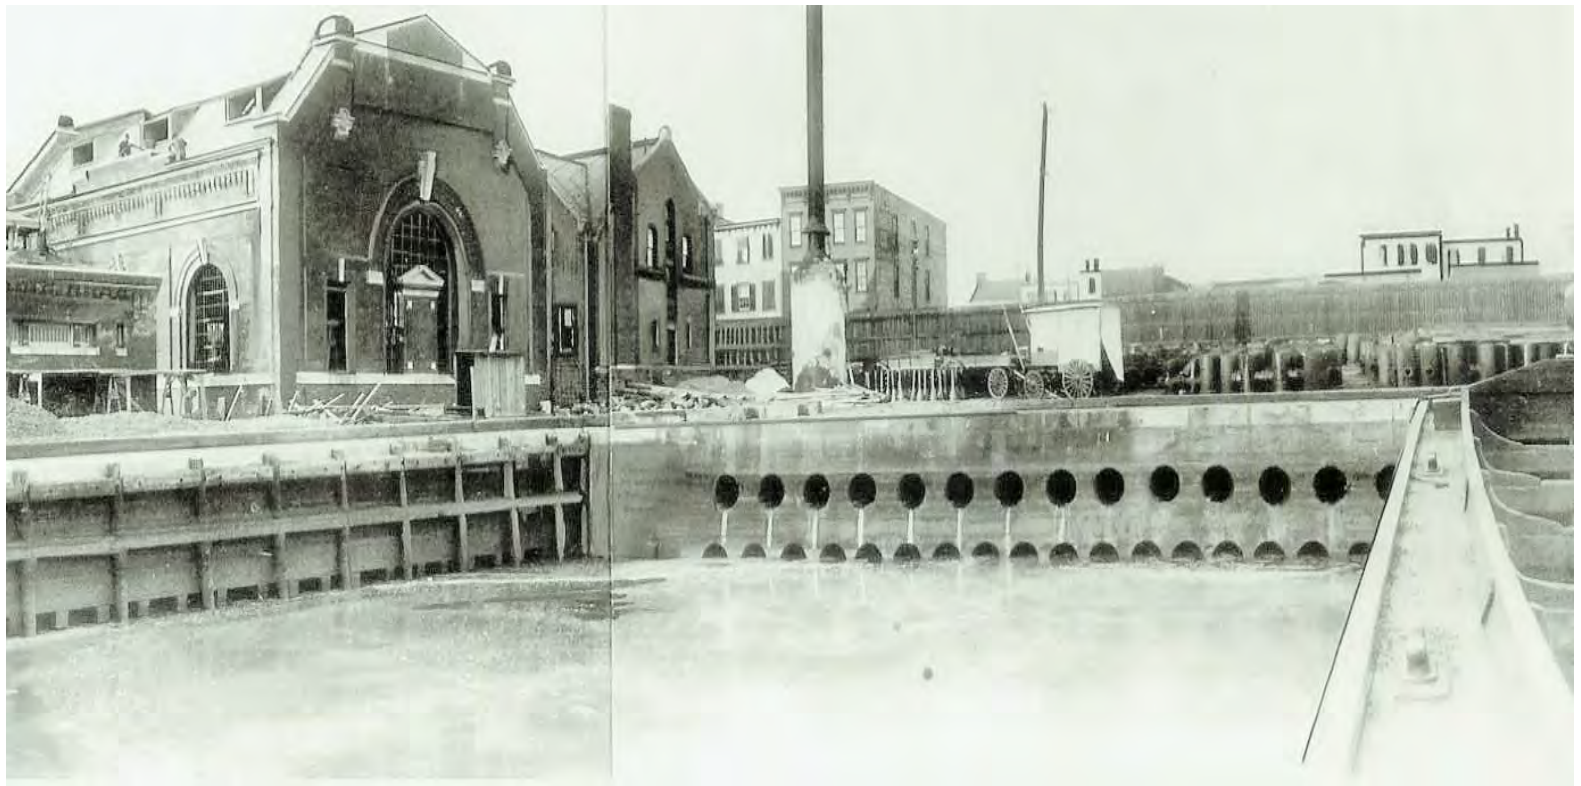
1911 - Flushing Tunnel and Pump Station completed, originally pumping water from head of Canal to the harbor.

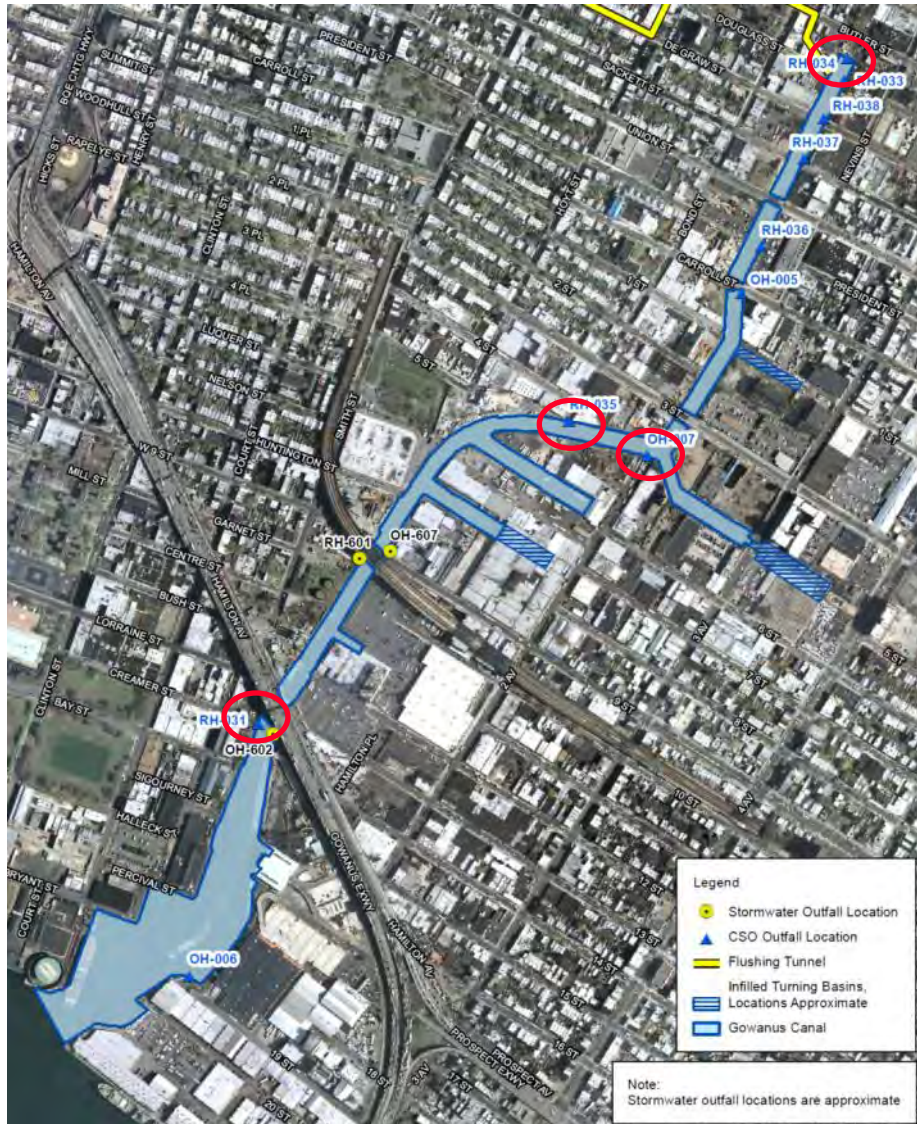
CSO and Stormwater Outfalls

- ◆ 92% of the watershed is served by combined sewers, 2% by storm sewers, and 6% is uncaptured flow
- ◆ Four outfalls account for 95% of the annual CSO discharges

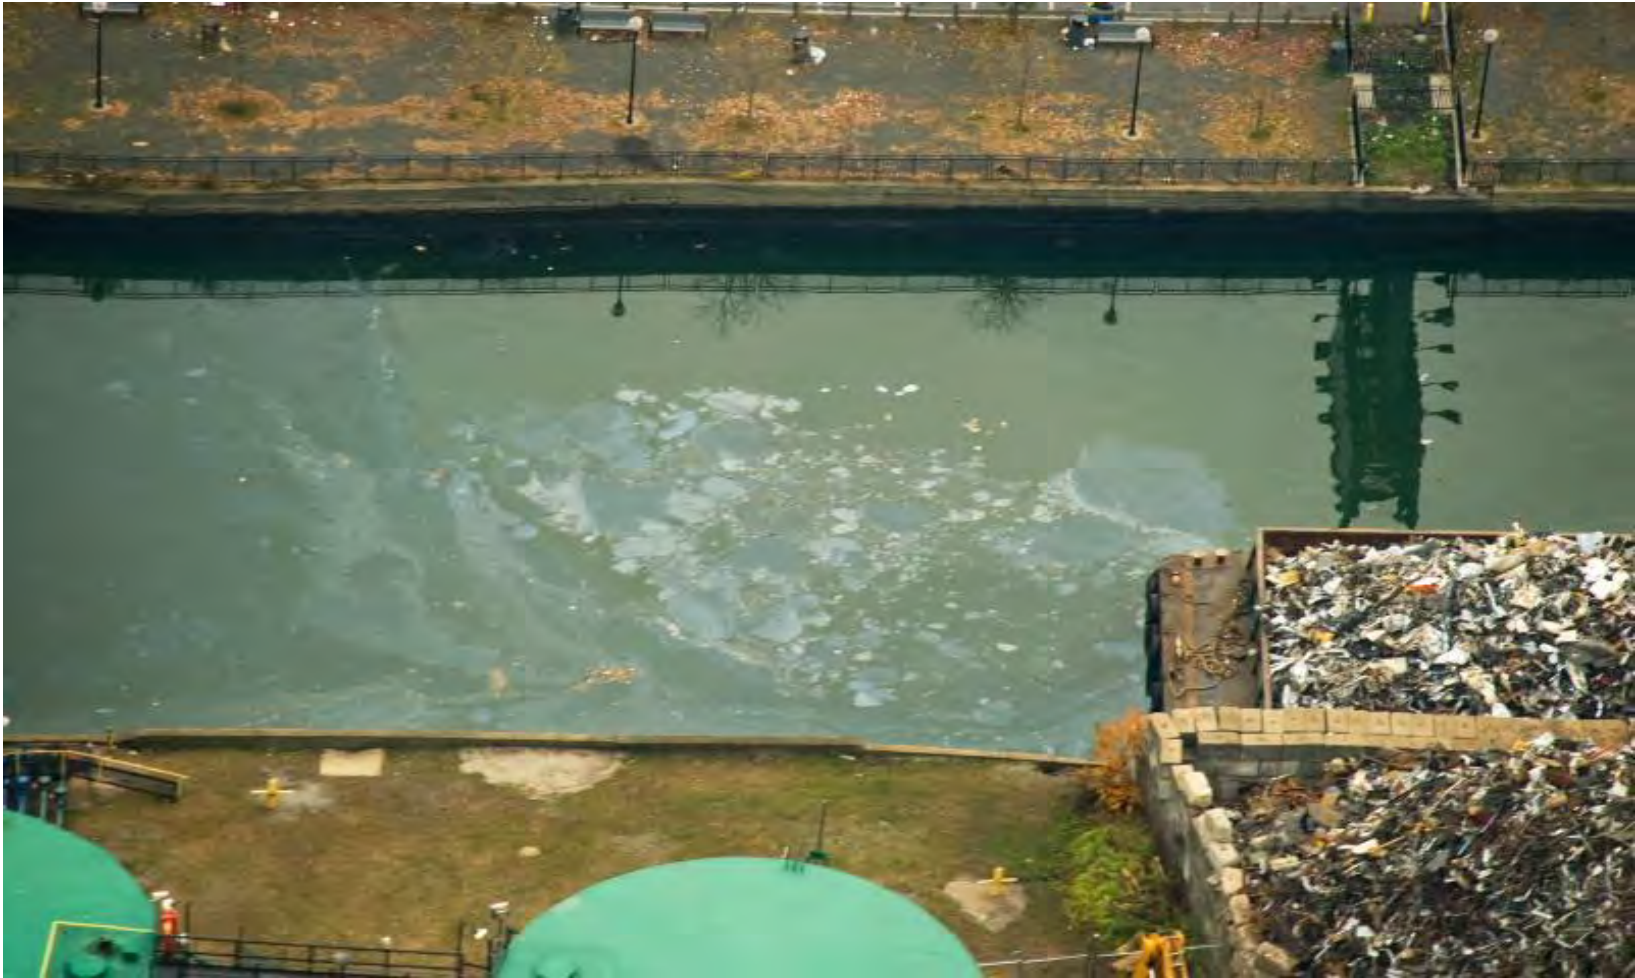
Coal tar upwelling often creates visible sheens

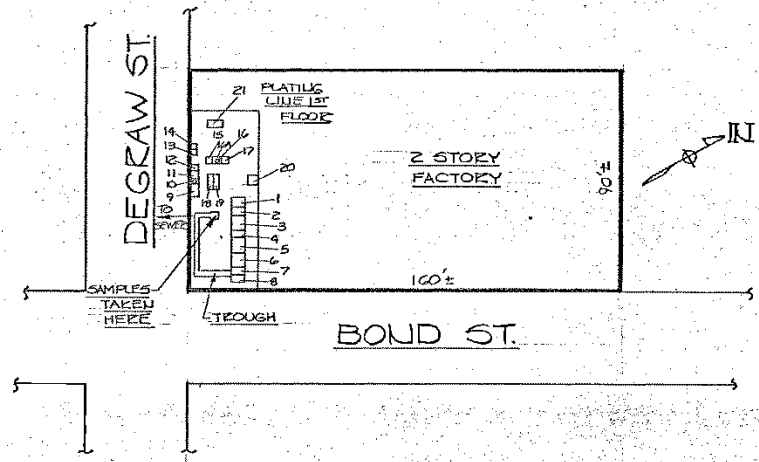
• PLOT PLAN • 1"=40'0"

BY J.S. DATE 4-17-85 SUBJECT BASELINE MONITORING REPORT SHEET NO. 1 OF 1
 CHKD. DATE O.Z. GEDNEY CO. JOB NO. 85-56
 262 BOND ST. BROOKLYN, N.Y.

TANK #	CONTENTS	CAPACITY/ GALS.	TANK #	CONTENTS	CAPACITY/ GALS.
1	SOAP	250	12	RINSE	100
2	SOAP	225	13	RINSE	50
3	RINSE	400	14	RINSE	50
4	ACID	175	15	RINSE	50
5	ZINC	450	16	CHROMATE	18
6	RINSE	400	16A	RINSE	100
7	RINSE	175	17	ZINC	150
8	CHROMATE	225	18	ZINC	150
9	SOAP	275	19	ZINC	160
10	ACID	16	20	ZINC	300
11	RINSE	125	21	VAPOUR DEGREASER	100

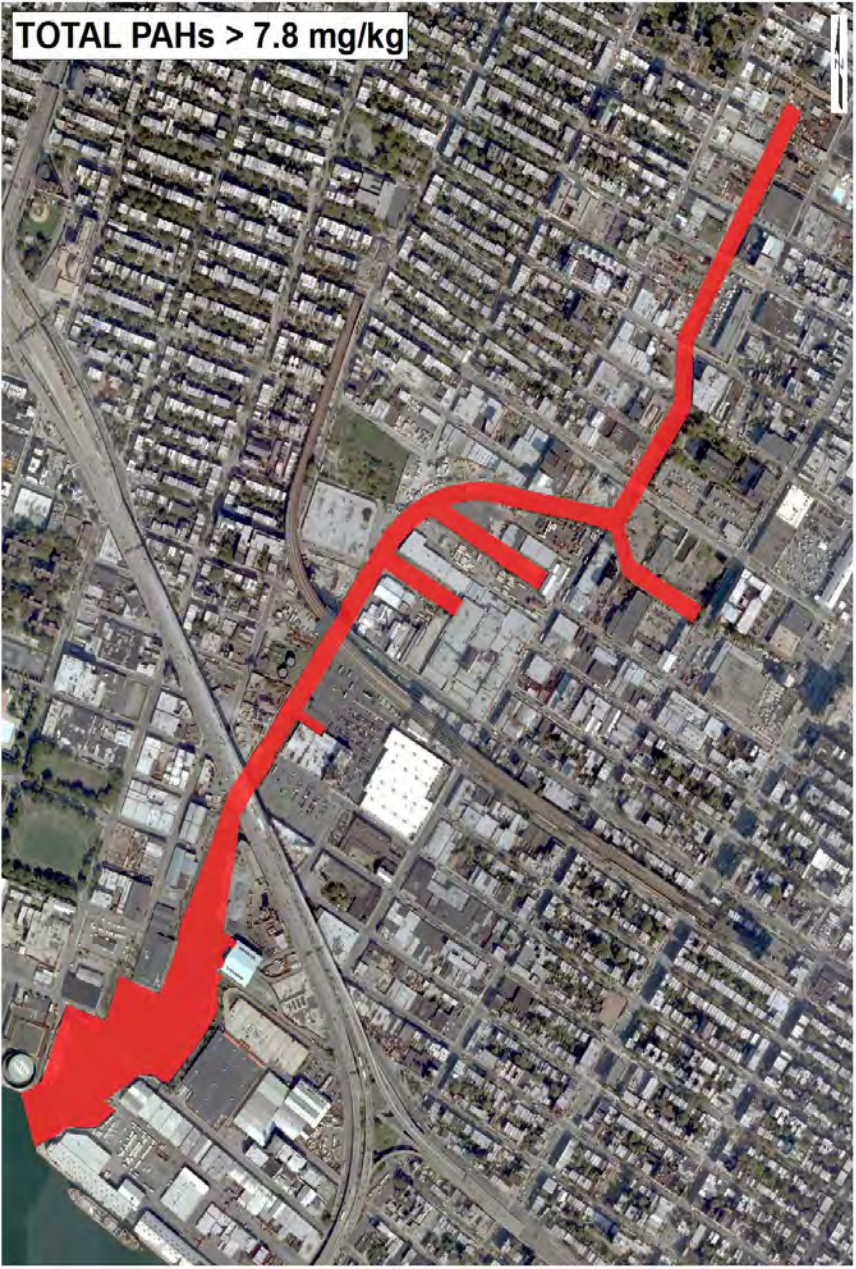
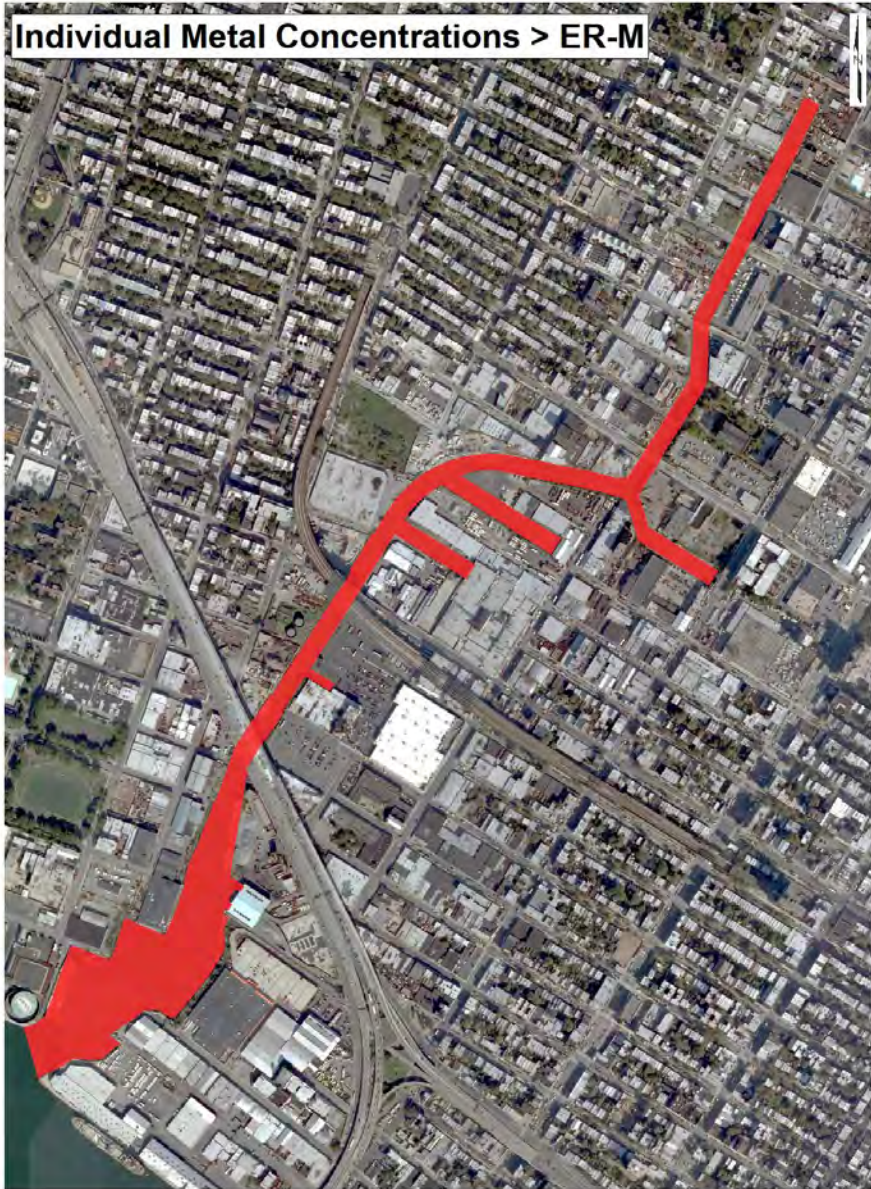
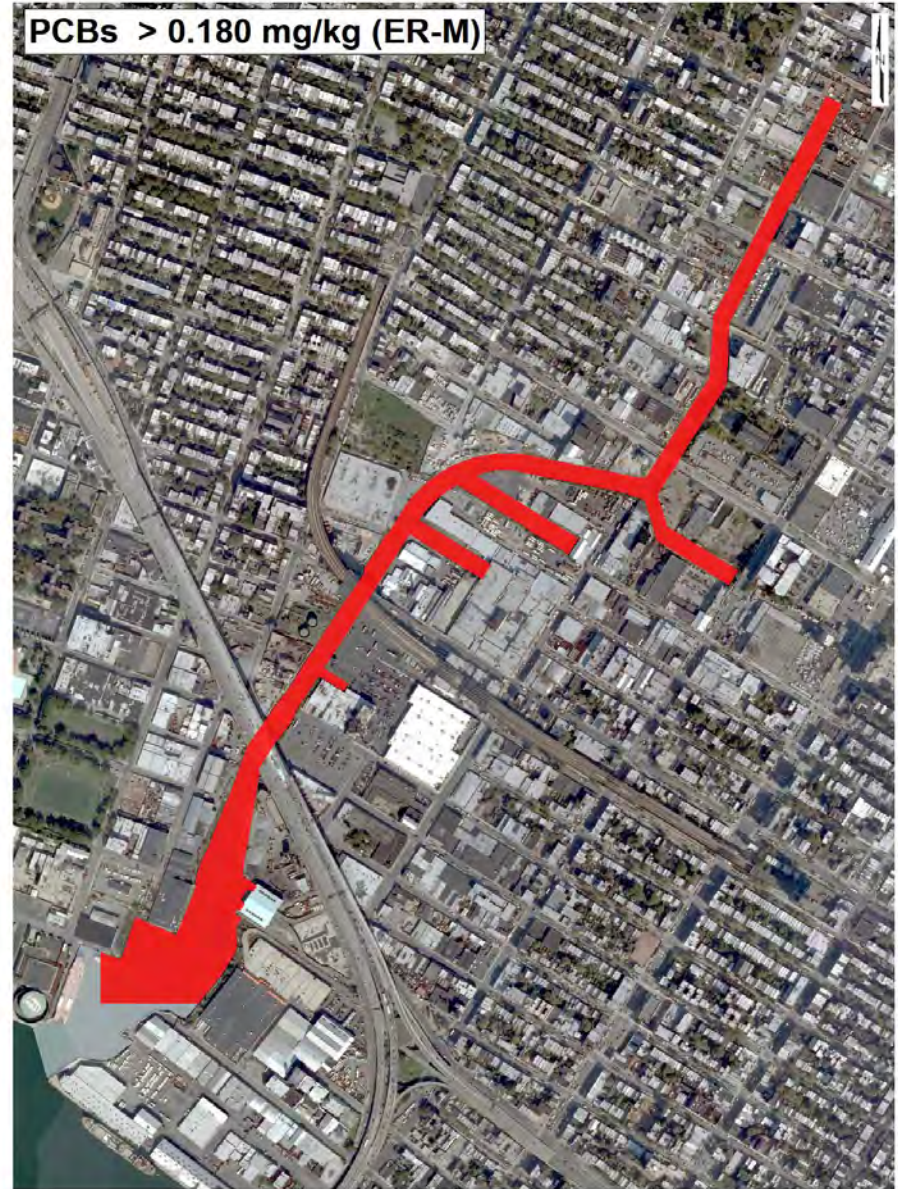
Canal sediments contain hazardous substances, many at elevated levels, linked to PRP disposal

- Accumulated sediments are contaminated with a broad spectrum of co-mingled CERCLA hazardous substances, including **PAHs**, **PCBs** and **metals**.
- All of these contaminants will be addressed by the sediment remedy.
- PAHs and metals exceed Preliminary Remediation Goals (PRGs) in samples throughout the Canal.
- PCB levels in sediments throughout the Canal are above the anticipated PRG and Effects Range Median (ER-M).

TOTAL PAHs > 7.8 mg/kg
