Memorandum

RE: Memo # 14 – End of Fieldwork Results of Level 1 Cultural Resource Review
Debris Staging at Clean Earth – Claremont
RTA-1A Dredging, Level 1 Monitoring
Gowanus Canal Remediation Project
Brooklyn, Kings County, NY

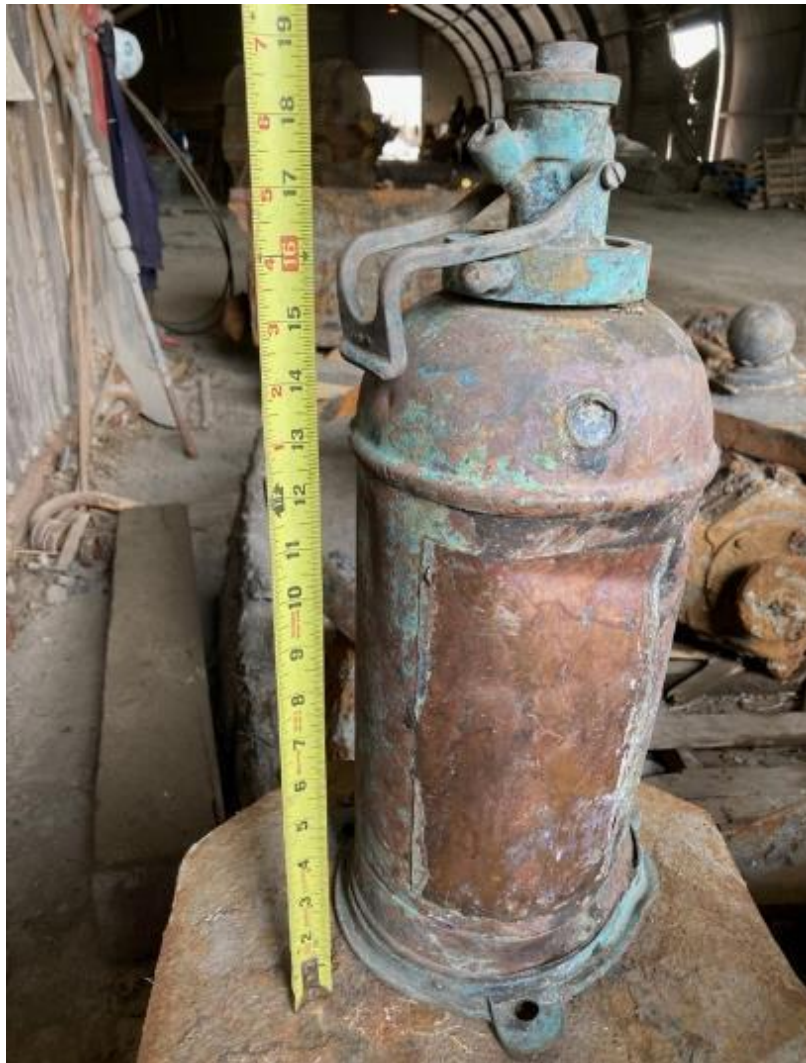
This item appears to be a copper fire extinguisher (Photograph 1). The eye-holes at the base of the item suggest that it would have been bolted to a fire truck, or perhaps a fire boat. Although the item has no manufacturing date or information on it, a 1923 advertisement for a Stutz fire truck (Figure 1) illustrates three types of mounted extinguishers on the side and rear of the truck is an example of this type of apparatus. Fire departments in the area would have used this type of extinguisher.

Measurements: Height 19" Width 6"

Photograph 1 – Copper fire extinguisher.

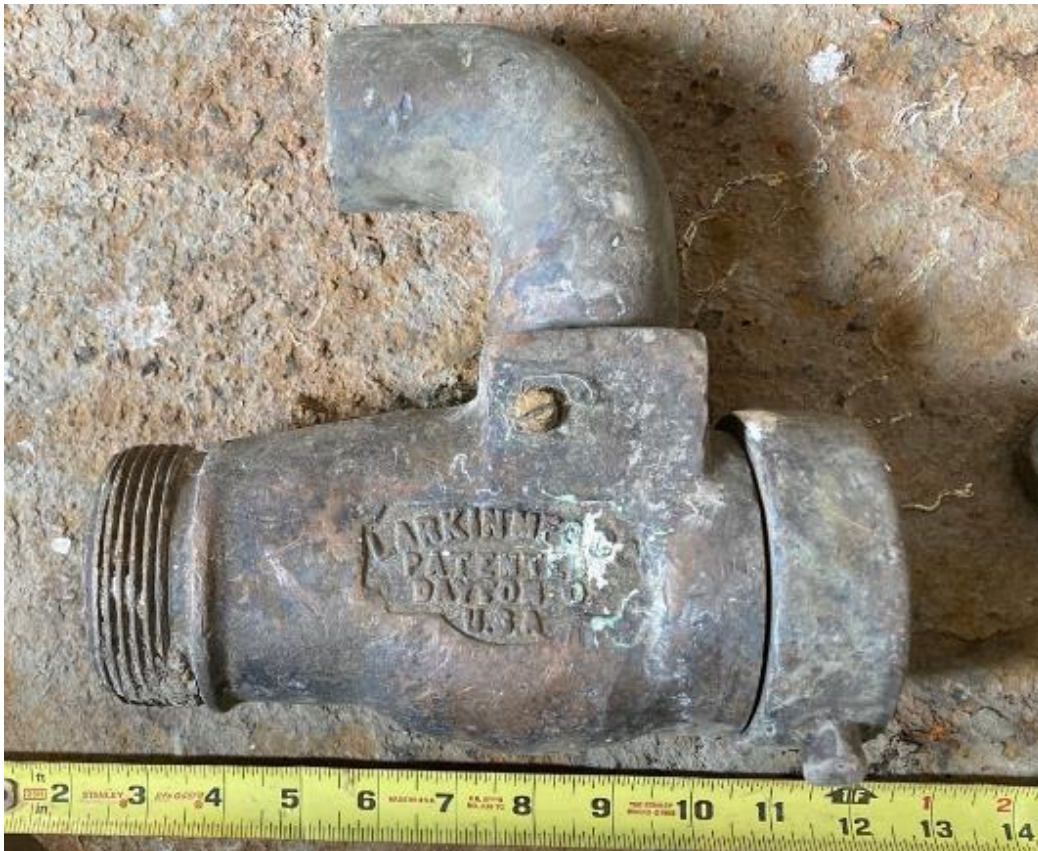
This brass item was manufactured by the Larkin Manufacturing Company of Dayton, Ohio (Photograph 2). The Larkin Mfg. Co., originally the M.D. Larkin Supply Company, specialized in fire suppression equipment and was incorporated in 1907.¹ A 1915 article from in Fire and Water Engineering Magazine lists the types of equipment the company manufactured and distributed (Figure 2). Fire departments in the area would have used this type of equipment as safety technology improved.

Measurements: Length 10" Height 9" Width 3"

Photograph 2 – Brass component of a fire suppressant apparatus manufactured by the Larkin

Manufacturing Company of Dayton, Ohio.

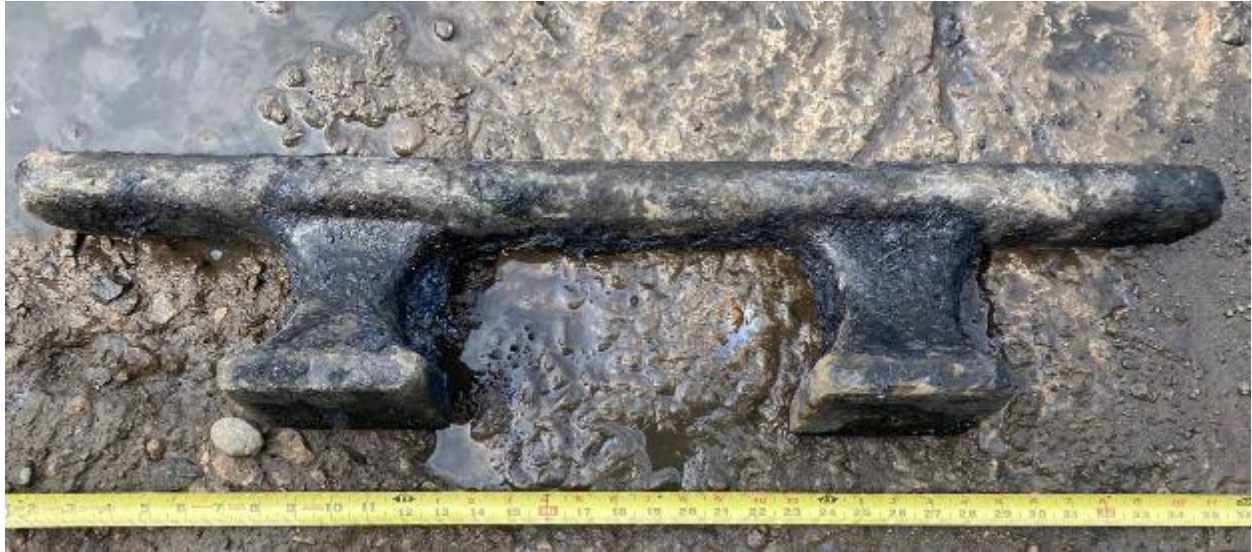
This iron mooring cleat (Photograph 3) is hardware typically used to secure a rope tied to a boat while docked, or vis-versa. These types of cleats would have been used throughout the canal to tie off barges and other water craft. Although no date can be assigned, it represents activities related to the canal's past.

Measurements: Length 36" Height 6" Width 4"

Photograph 3 – Iron mooring cleat.

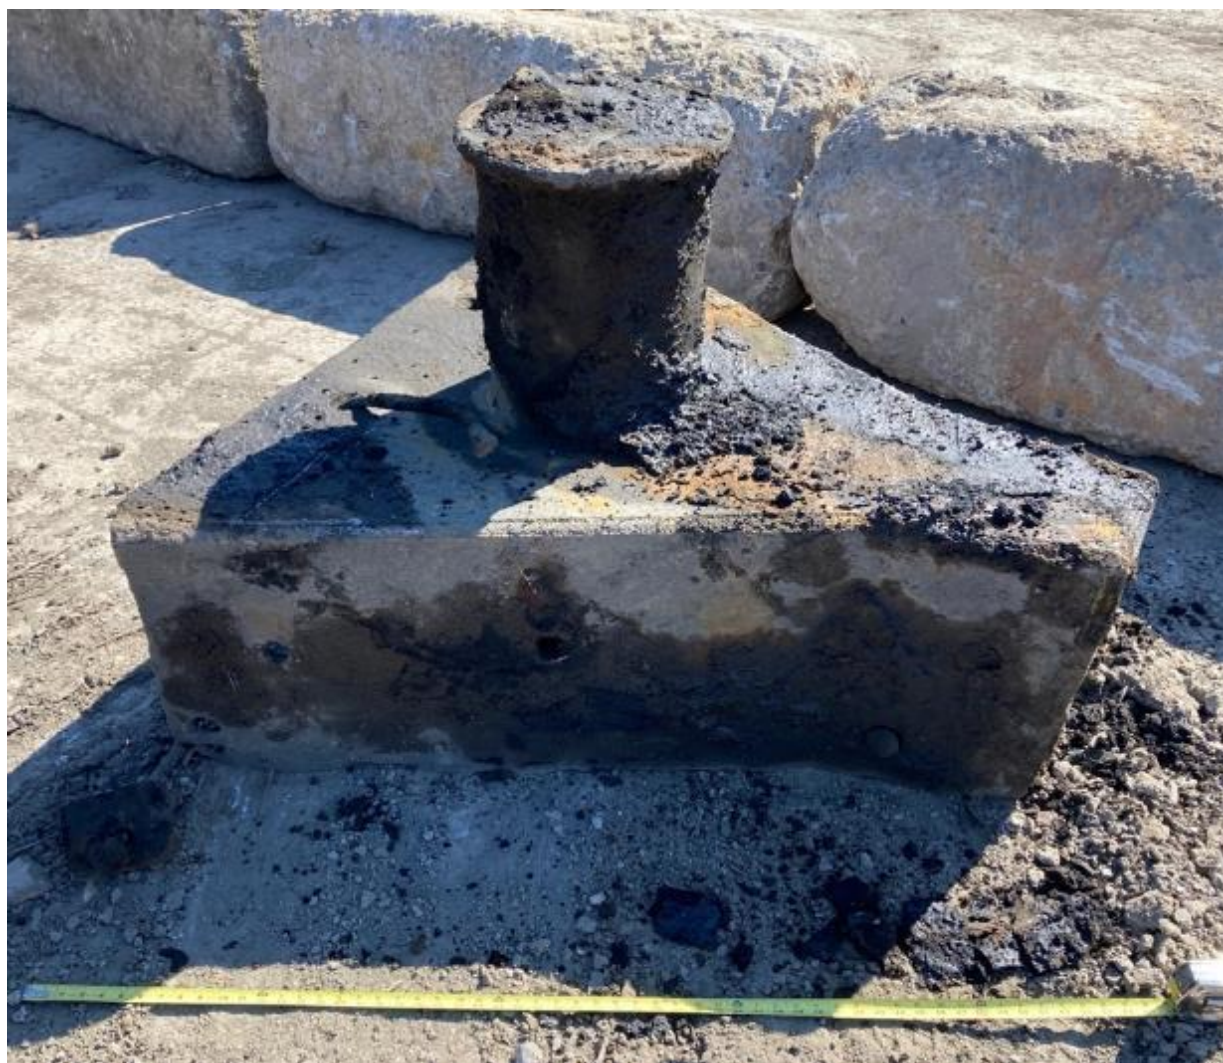
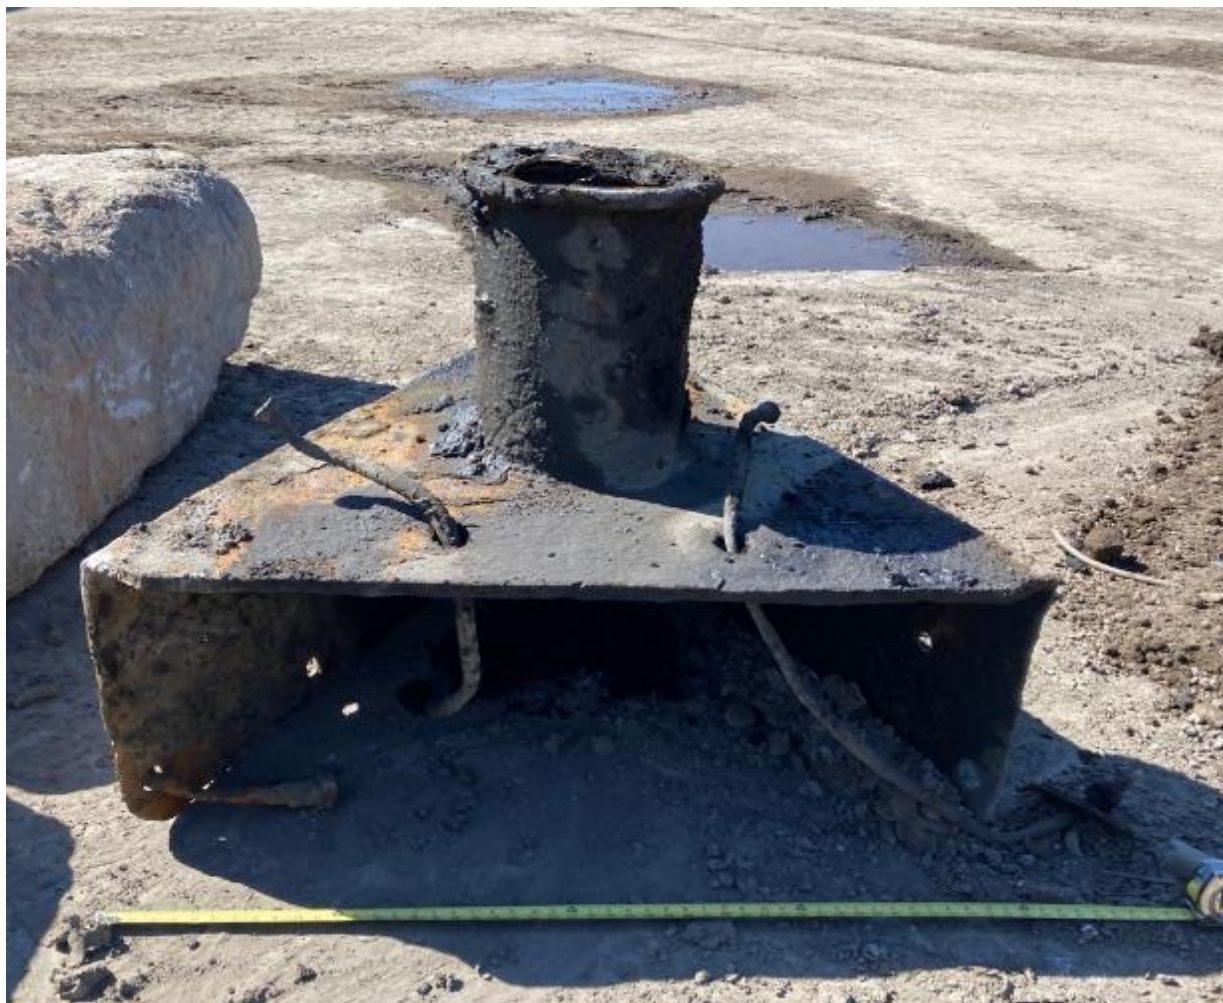
This undated mooring bollard was used to secure water craft to a dock or pier. The large size and integrated triangular foundation suggest that it was used at the point of a tapered pier and its use was related to larger boats and barges (Photograph 4). The long iron bolts were used to secure it to the bulkhead (Photograph 5). The welded construction dates this bollard to the 20th century. These bollards can be associated with the later part of the canal's commercial, industrial and transportation activities.

Measurements: Length 58" Height 19" Width 42" (Bollard 13" in diameter)

Photograph 4 – View of bollard item, front view.

Photograph 5 – View of bollard item, rear view.

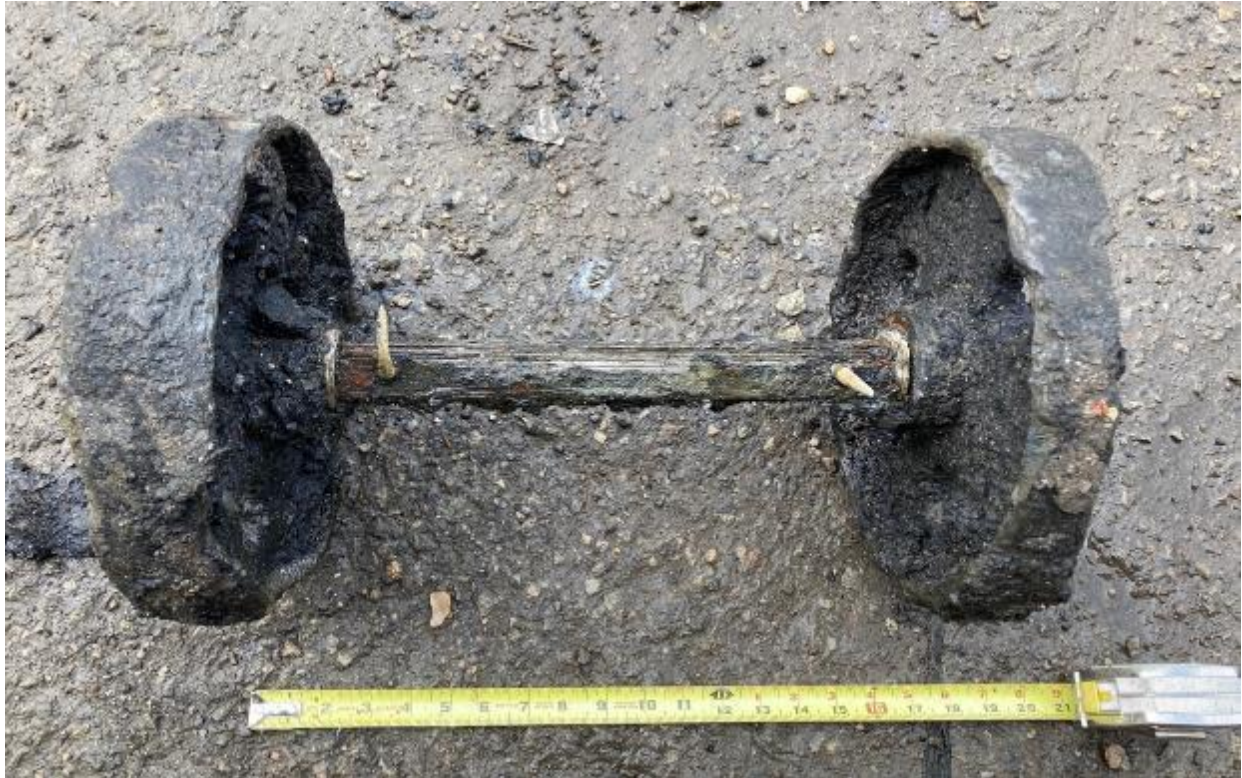
This item appears to be a set of metal wheels from a narrow industrial cart (Photograph 6). Although undated, this item represents the industrial, shipping and storing character of the area and is most likely associated with the Gowanus Canal's commercial, industrial and transportation activities.

Measurements: Length 21" Height 14"

Photograph 6 – Set of metal wheels with a wooden axle.

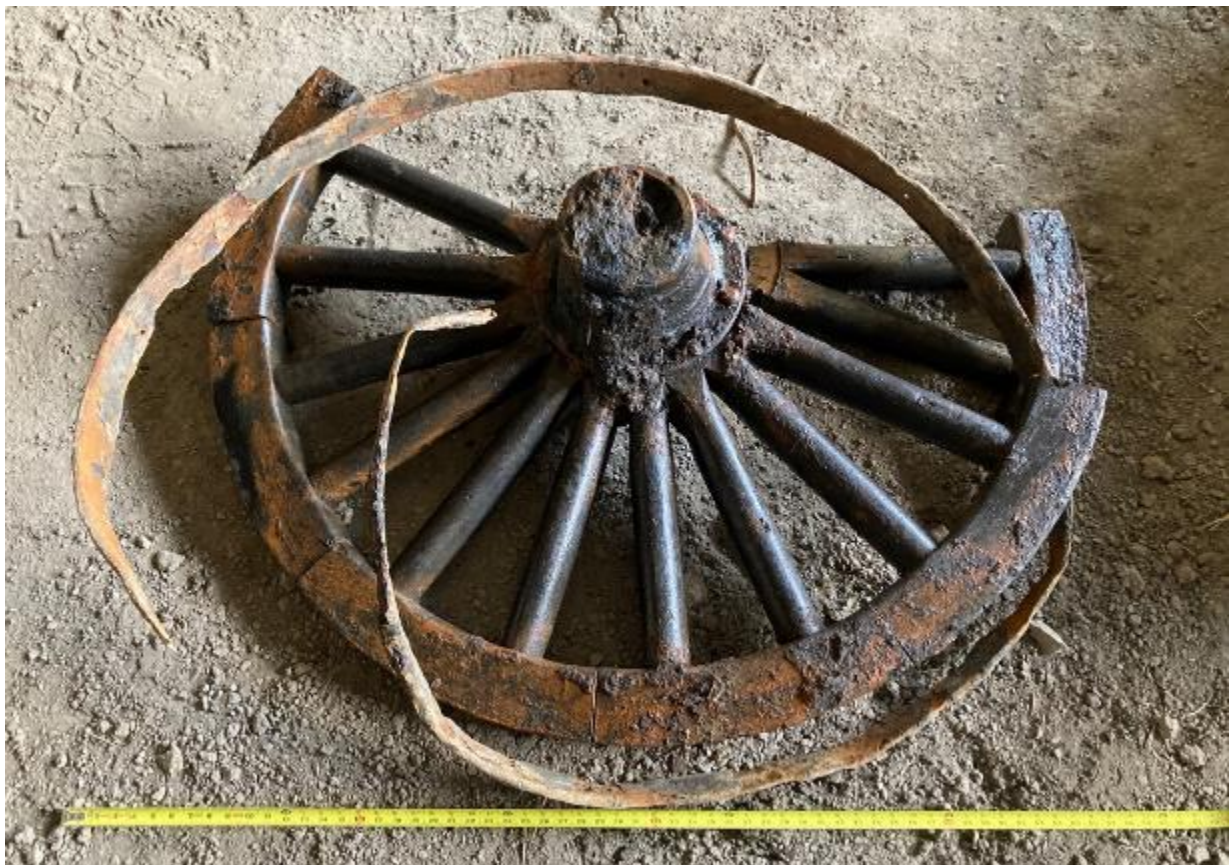
This undated item was typical of the 19th and early 20th centuries. The wheel has an iron hub and tread with wooden spokes and rim. It was constructed in two-spoke sections with attached rim section. Several sections are missing (Photograph 7). This item represents the industrial, shipping and storing character of the area and is most likely associated with the Gowanus Canal's commercial, industrial and transportation activities. The wood portion is porous and is most likely difficult or impossible to decontaminate and should therefore be discarded. However, the metal portions of the wheel, the hub and metal tread, could be decontaminated and be retained as an object of local interest

Measurements: Diameter 56" Depth, Hub 18" Depth, Rim 3.25"

Photograph 7 – Partial wagon wheel and metal rim overview.

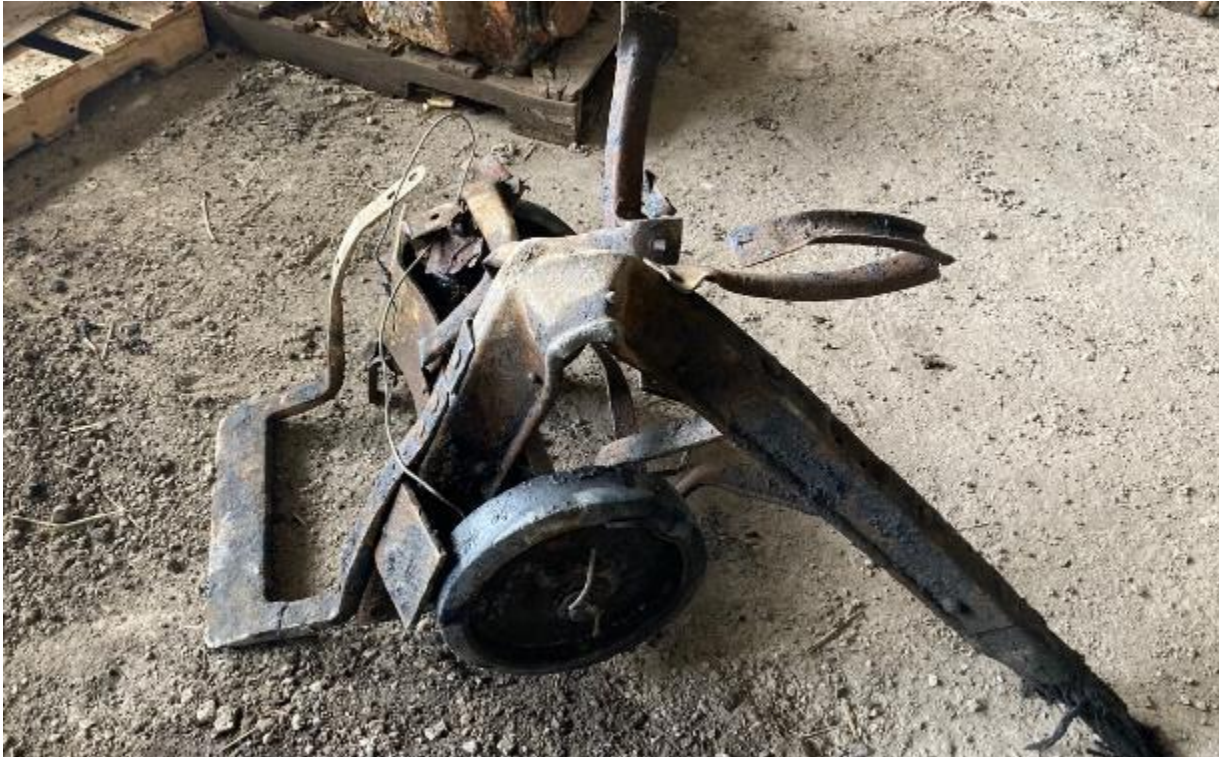
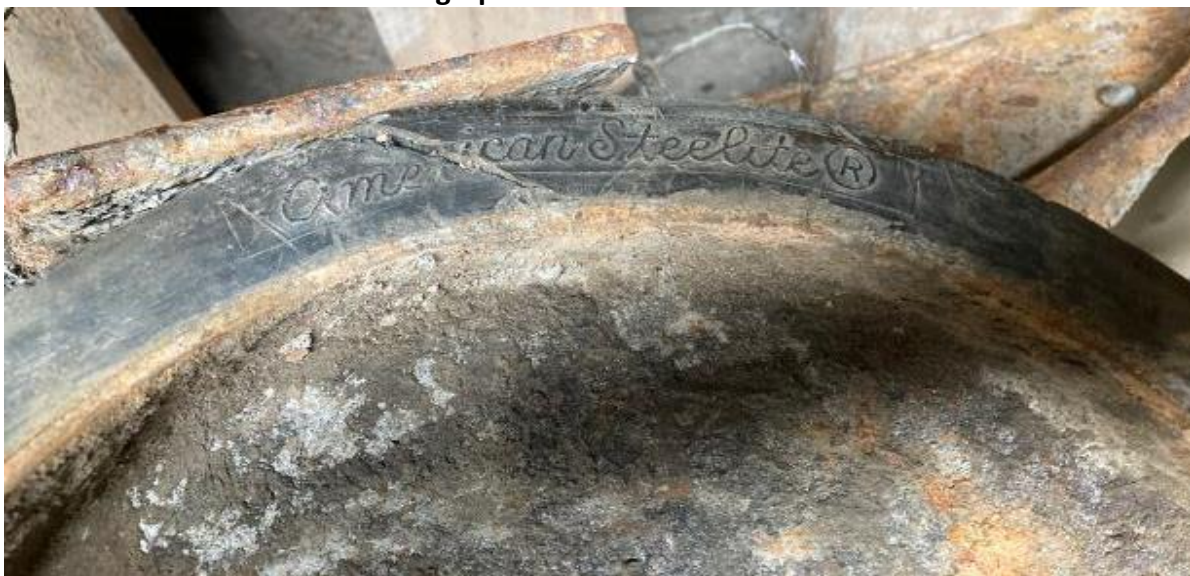
This item is a typical industrial hand truck (Photograph 8). The wheel is embossed with the name Steelite® (Photograph 9). The ® symbol was not used before 1948 suggesting that the hand truck was used during the mid-20th century at the earliest. This item represents the industrial, shipping and storing character of the area and is most likely associated with the later part of Gowanus Canal's commercial, industrial and transportation activities.

Measurements: Height 38" Width 21" Depth 27"

Photograph 8 – Industrial hand truck.

Photograph 9 – Embossed manufacture registered trade mark on wheel.

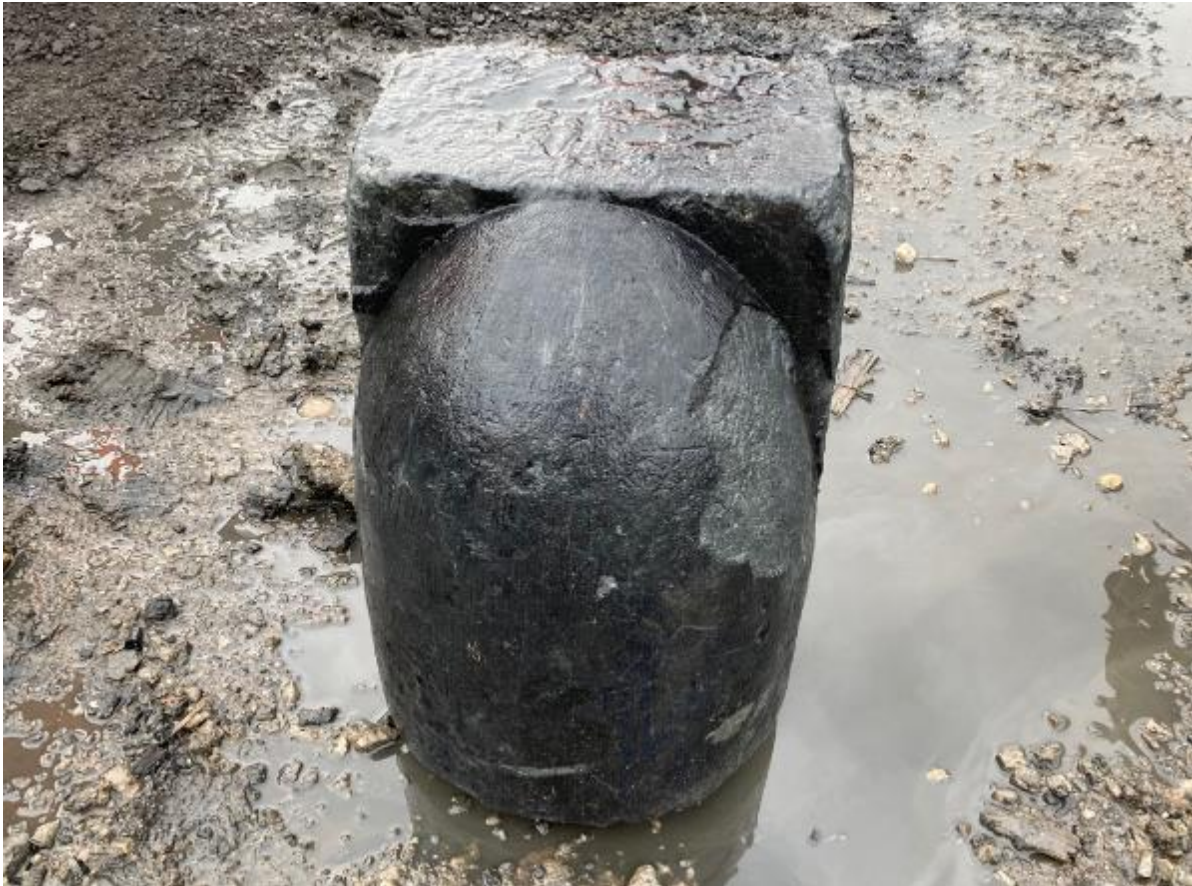
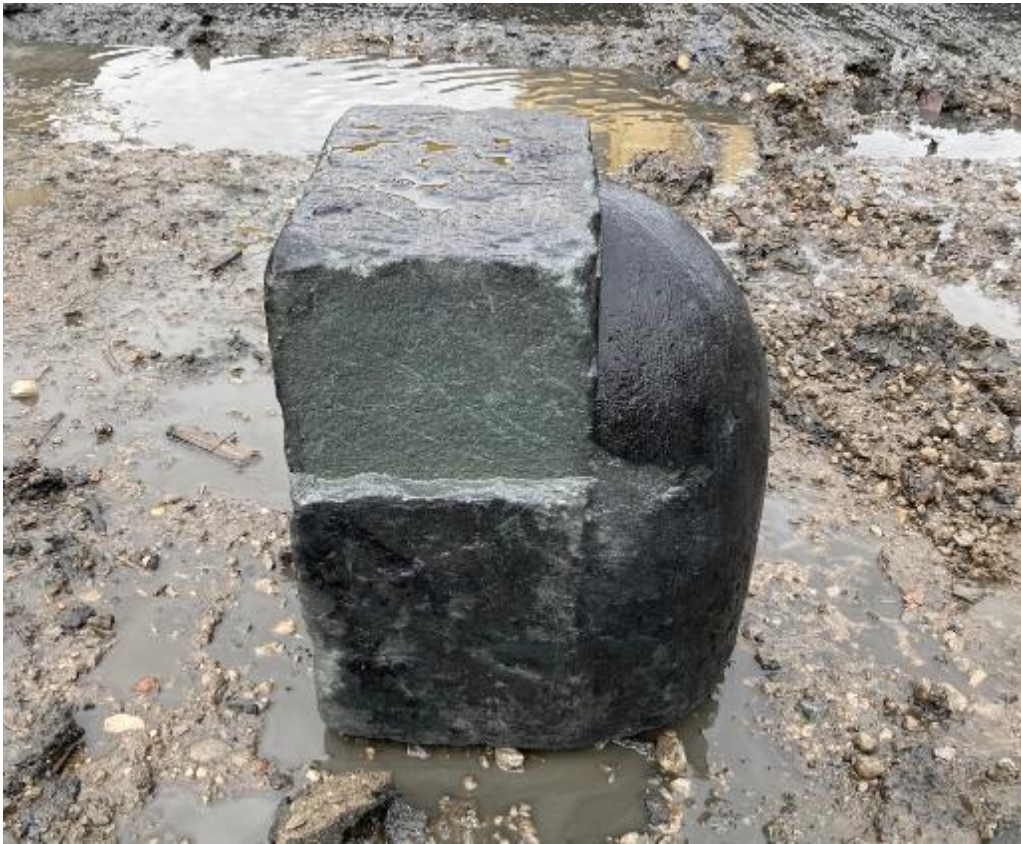
This large carved stone block with egg-shaped design on one side remains undated. Its size suggests it was part of a significant structure (Photographs 10 and 11). Its rough surface on the top, lower sides and back suggest it was inset into a wall. Research was unable to verify if the item is directly associated with the canal as an artifact or an item of interest.

Measurements: Height 21” Width 15” Depth 17”

Photograph 10 – Large stone block. Front view.

Photograph 11 – Large stone block. Side view.

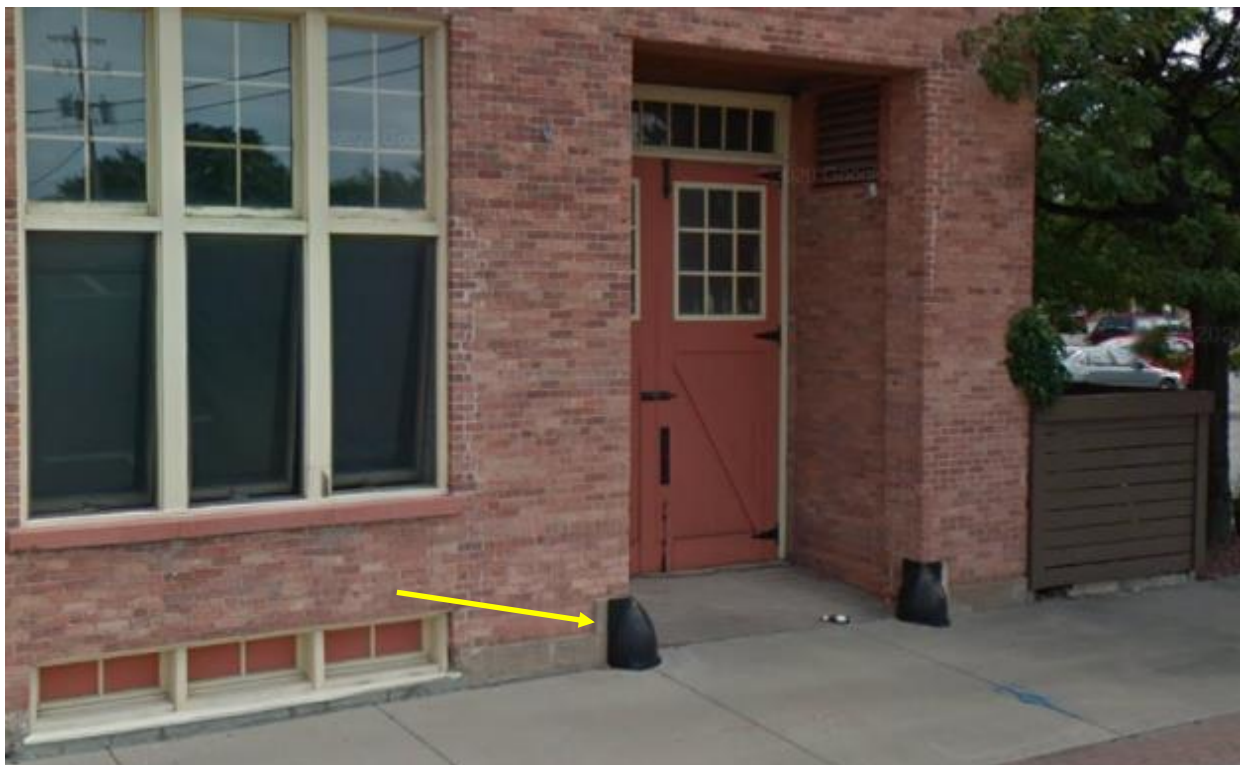
This is most likely a “guard stone”, an exterior architectural element (Photograph 12) located at the corner or gates, entries, and walls to prevent damage from vehicle wheels. Historically, the wheels, and particularly the hubs, of horse-drawn vehicles protrude beyond the vehicle’s body, and were prone to striking the corner of a building or gate. These stones, when struck by a wheel, would push the vehicle away from the wall and allow the hub to pass without causing damage to the building or gate.

Photograph 12 – Guard stones (yellow arrow) at the corners of a building's vehicular entrance.

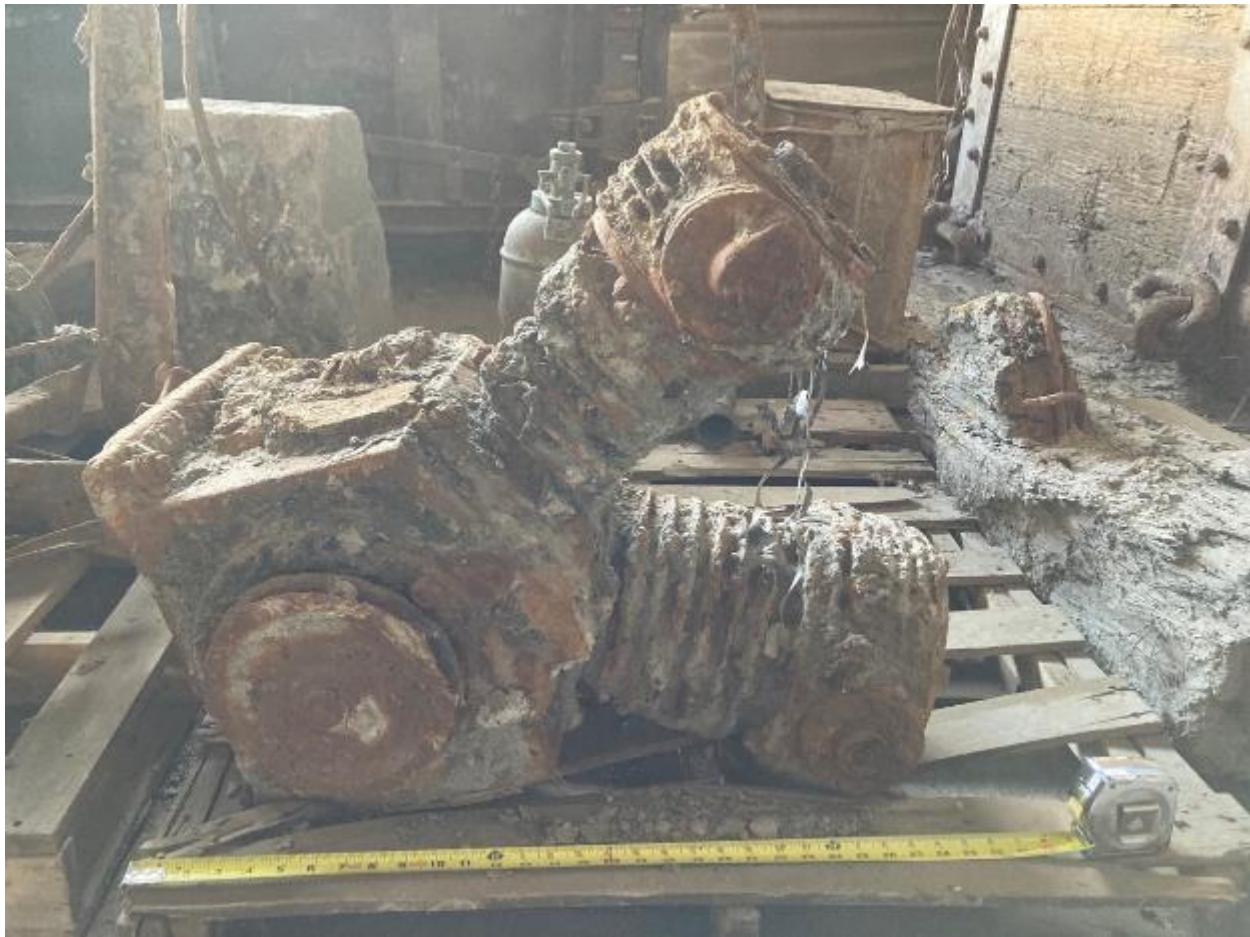
This is a V style, two-cylinder air compressor (Photograph 13 or, less likely, an engine. It is a design that has been common through the second half of the twentieth century to the present time (Figures 3 & 4). This equipment generates compressed air for tools and machinery frequently used for dockside work and services.

Measurements: Length 28" Height 24" Depth 12"

Photograph 13 – Machine component.

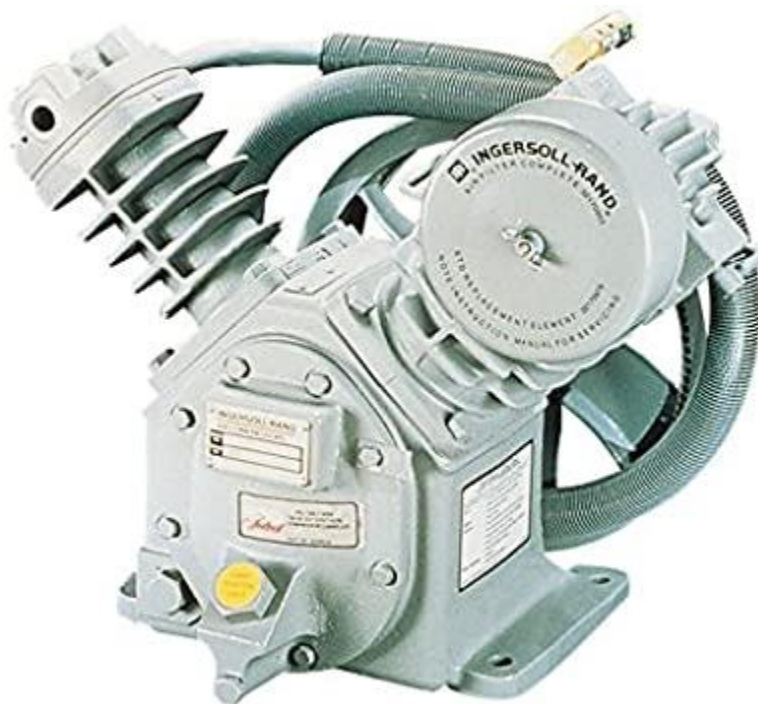
Figure 3 - Ingersoll Rand Two-Stage Type 30 Air Compressor Pump - 5 HP.

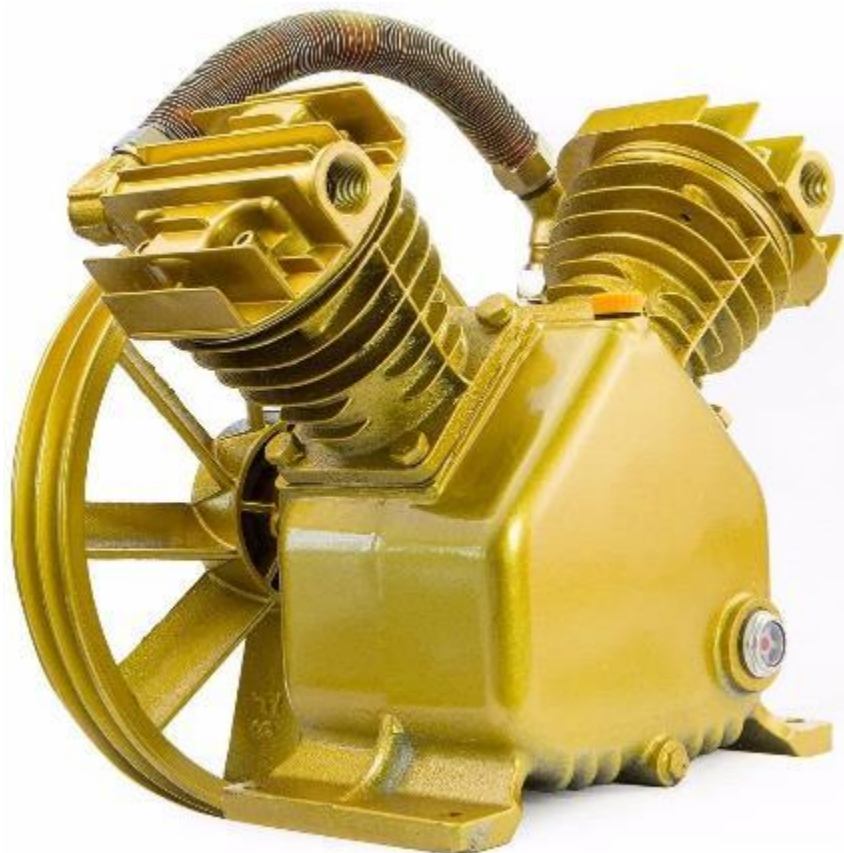
Figure 4 - Stark 5-5.5HP Dual Piston V Style Twin Cylinder Air Compressor.

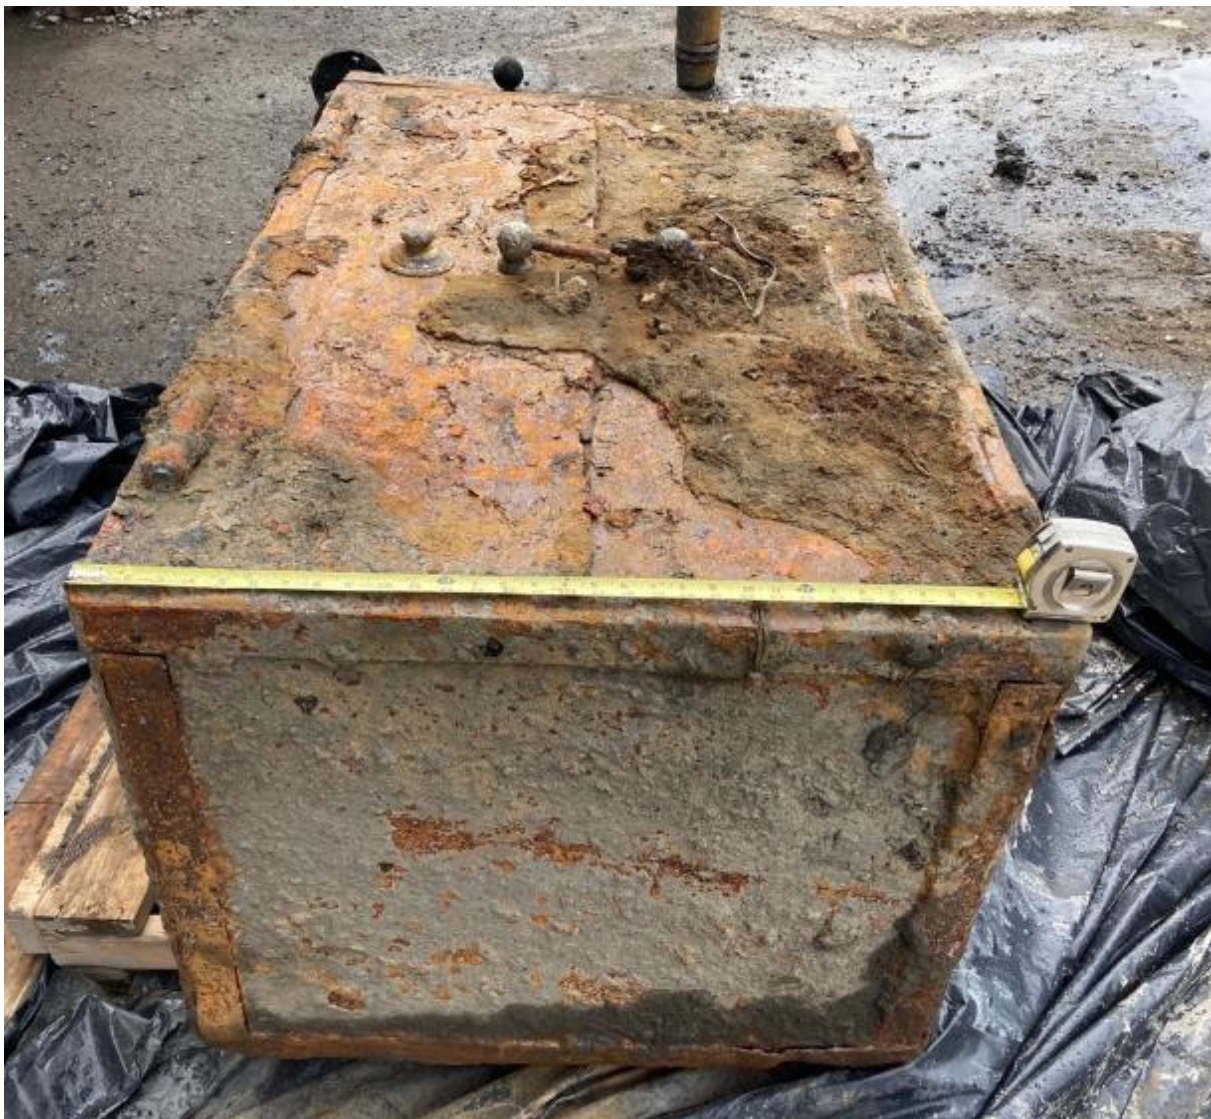
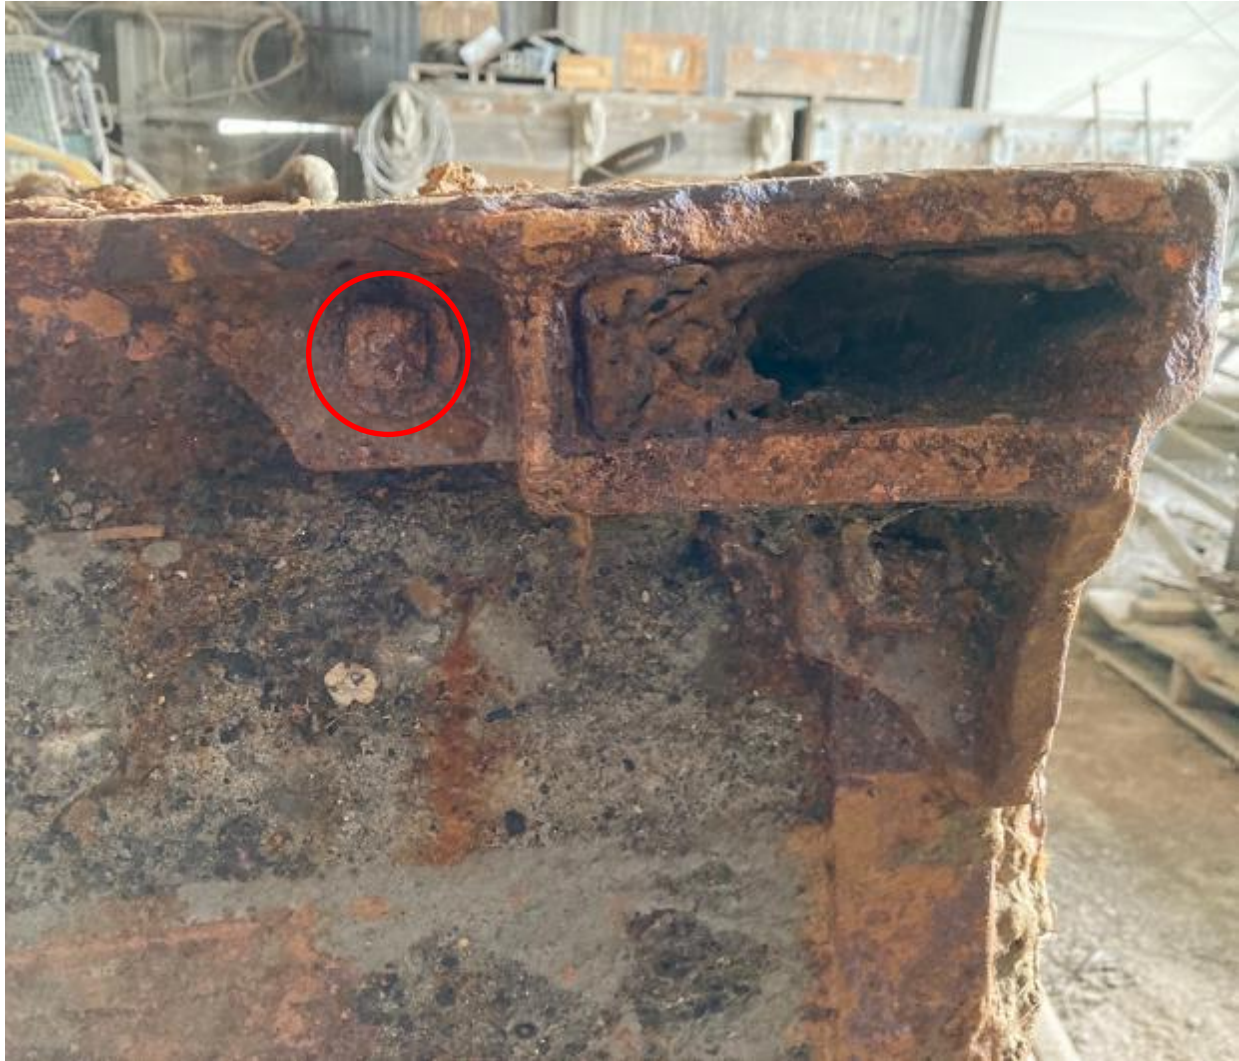
This item contained no manufacturing information to use for dating purposes (Photograph 14). Based on its size and the square bolts that attach the one remaining foot it likely dates to the 19th century (Photograph 15). It would have originally had four wheels attached to the bottom. The safe's association with the canal is unconfirmed. This item could have come from any number of buildings along the canal or could also be dumped trash from another location. The safe door has not been opened however, a small hole was cut open with a torch in the field when first recovered. AHRs was not onsite during this investigation and the safe could not be opened at Clean Earth due to rusting.

Measurements: Height 52" Width 33" Depth 27"

Photograph 14 – View of the top and front of the safe.

Photograph 15 – View of the square bolt attaching the foot of the safe (circle).

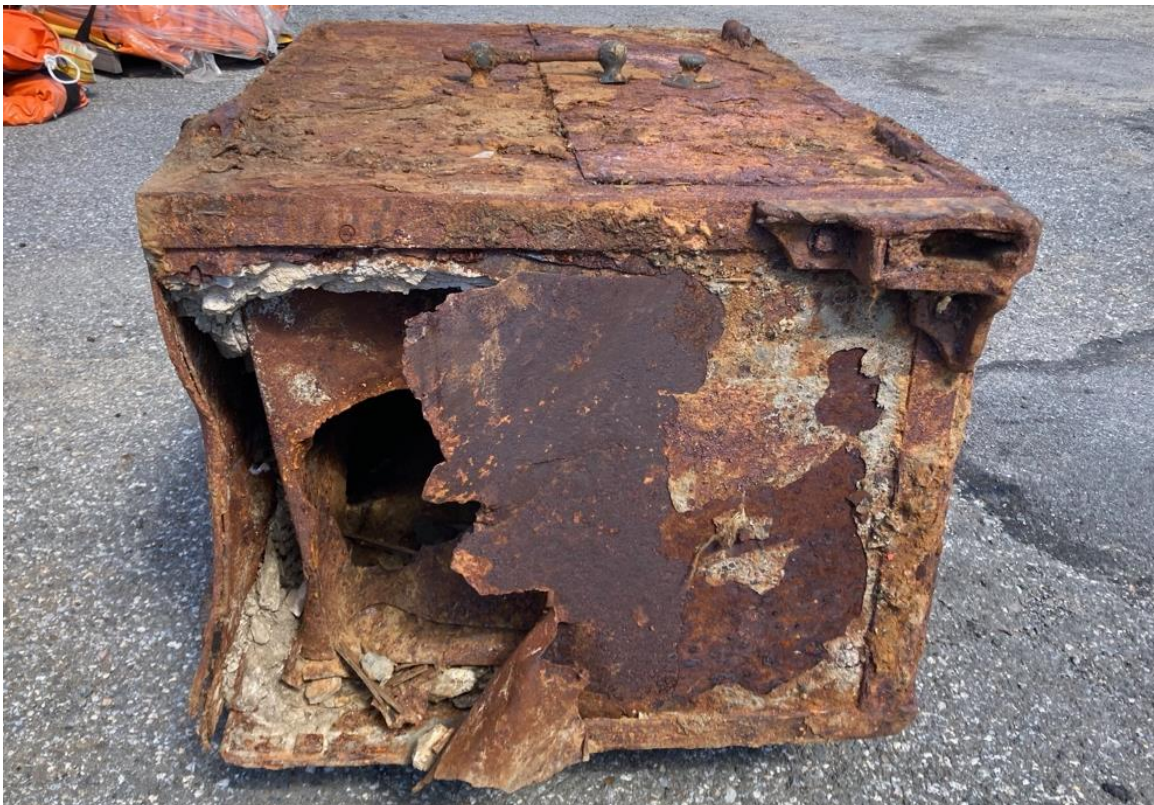
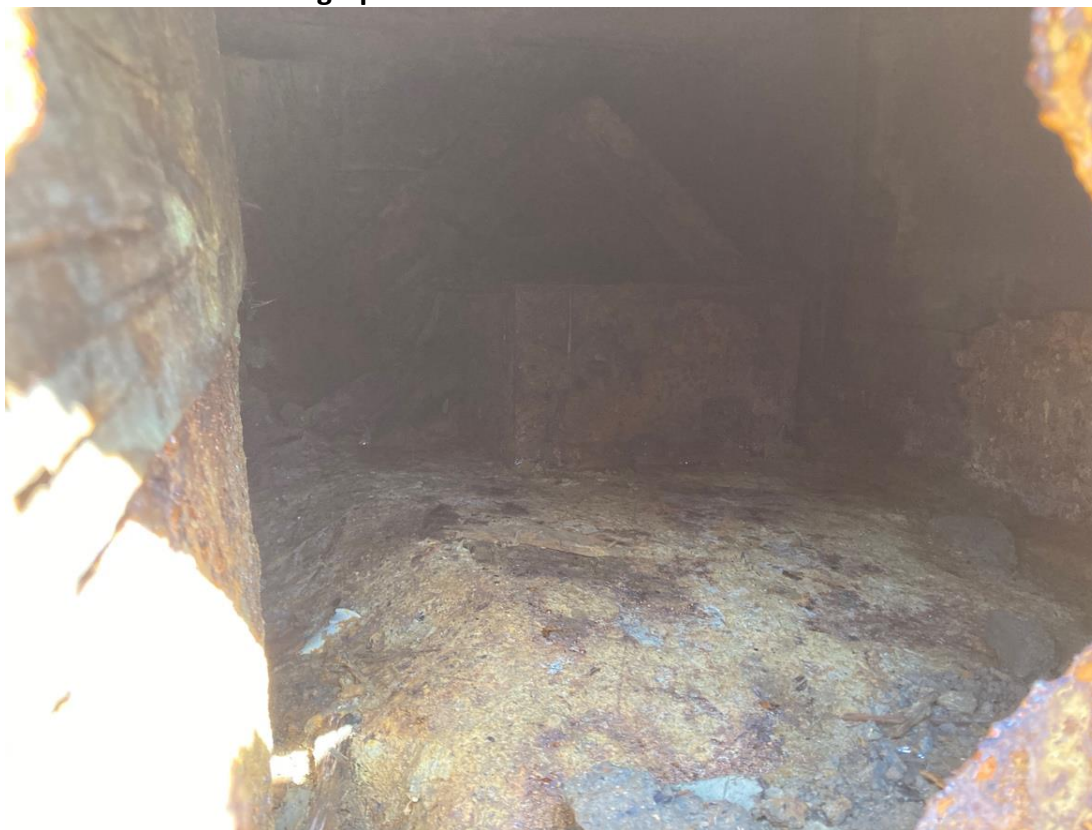
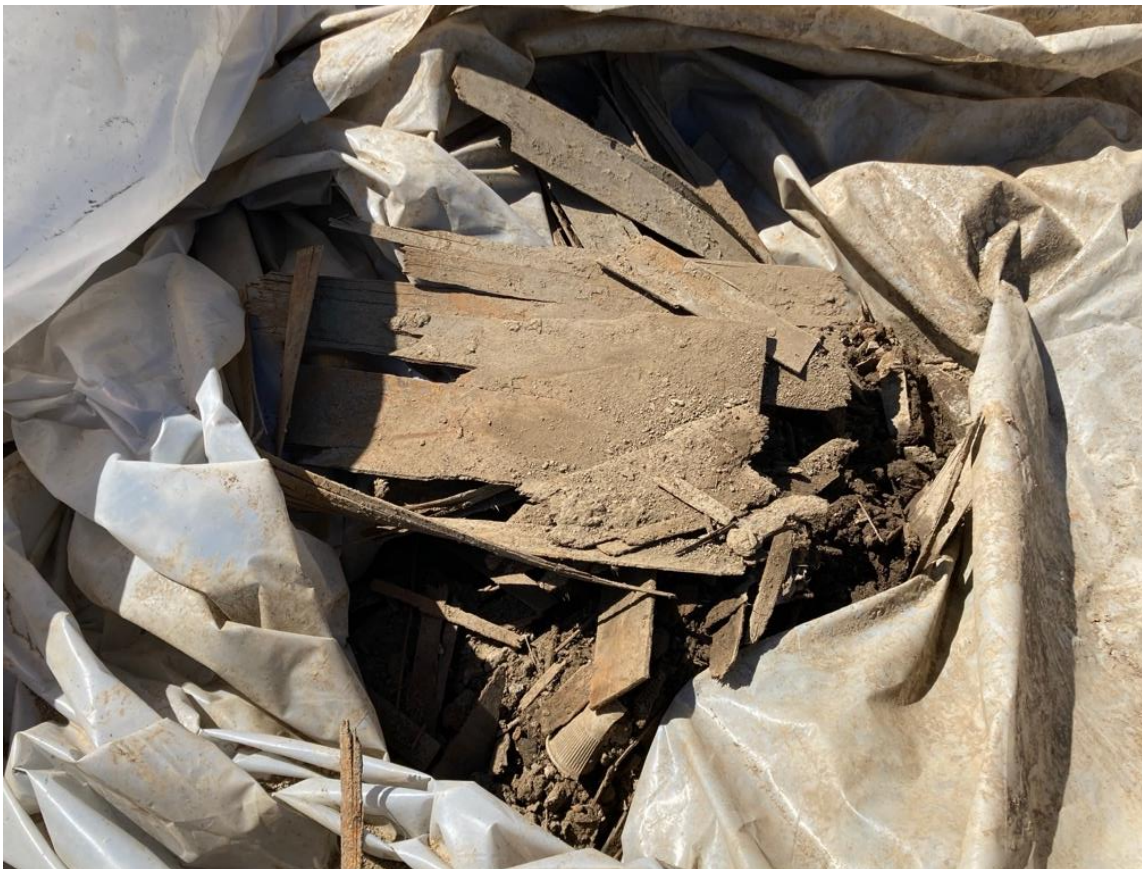
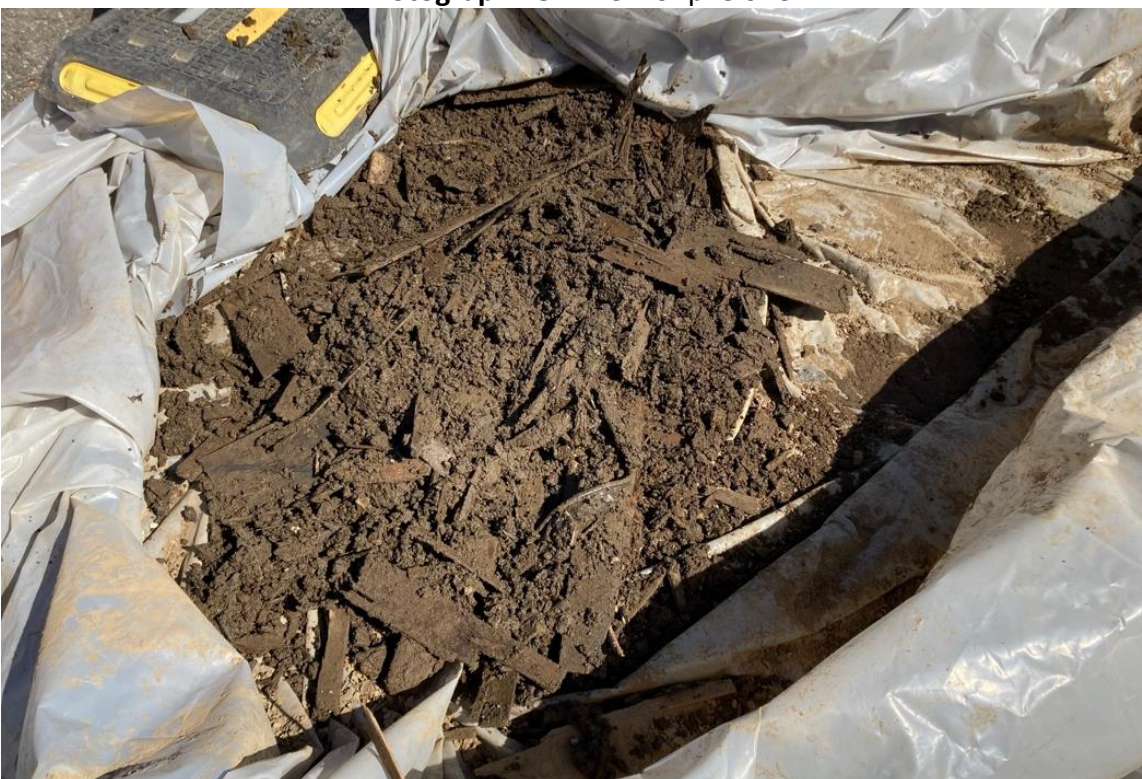
On 9/21/21 an AHRS archaeologist went to the Citizen Site to review the interior and contents of a previously recovered floor safe. The interior of the safe was inspected and two piles of removed material were searched by hand. The safe had been cleaned out through a hole in the bottom (Photograph 16) and showed no sign of residual material inside (Photograph 17). The contents of pile one (Photograph 18) consisted of brown soil with fragmented thin wood laminate, likely the interior of the safe and some small fragments of plastic. The pieces could also be parts of former shelves. The contents of pile two (Photograph 19) consisted mostly of the same soil and types of plastic with fewer wood fragments. No items of historic/archaeological significance were observed in either pile or the safe's interior.

Photograph 16 – View of the bottom of the safe.

Photograph 17 – View of inside the safe.

Photograph 18 – View of pile one.

Photograph 19 – View of pile two.
