Memorandum

RE: Memo # 14 – End of Fieldwork Results of Level 1 Cultural Resource Review
Debris Staging at Clean Earth – Claremont
RTA-1A Dredging, Level 1 Monitoring
Gowanus Canal Remediation Project
Brooklyn, Kings County, NY

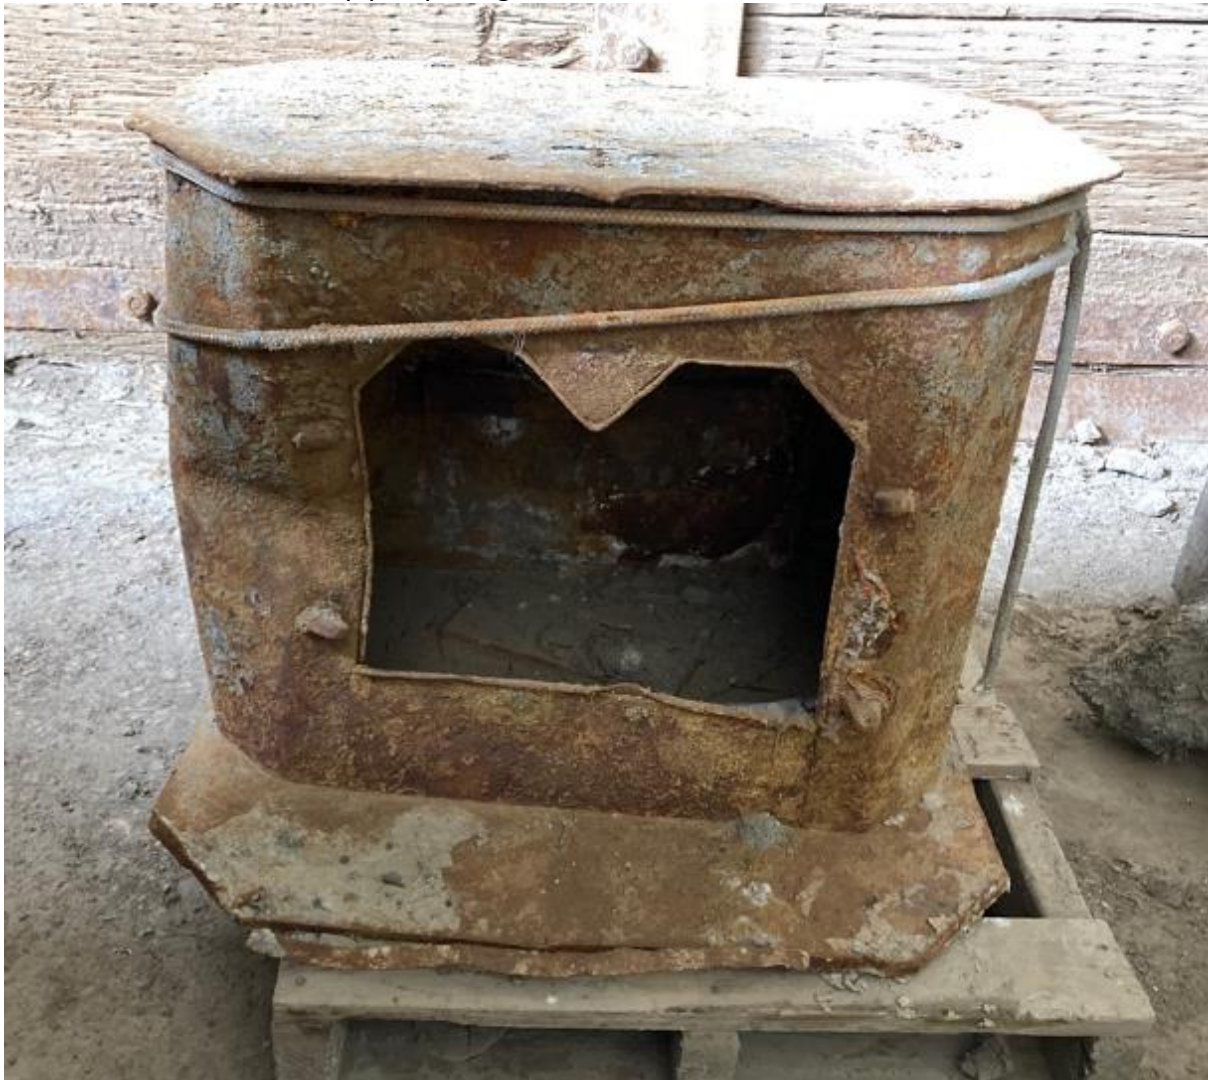
This iron stove is undated and contains no manufacturer's information. It is however, typical of the late 19th and early 20th centuries Franklin stove type. Tied to the stove was a modern rope, suggesting that the stove was used as an anchor and that its addition to the canal it was fairly recent (Photograph 20). This type of item could be associated with a business or home in the area but it is impossible to associate it with one based on the stove itself. Furthermore, this stove was used as an anchor as suggested, it was being used for a different function than intended, the modern rope indicates that it was a more recent addition to the canal and the stove could have come from anywhere.

Measurements: Length 26" Depth 15" Height 21" Fire aperture 14"x11"
Draft pipe opening 6"

Photograph 20 – iron stove with modern rope. Front view

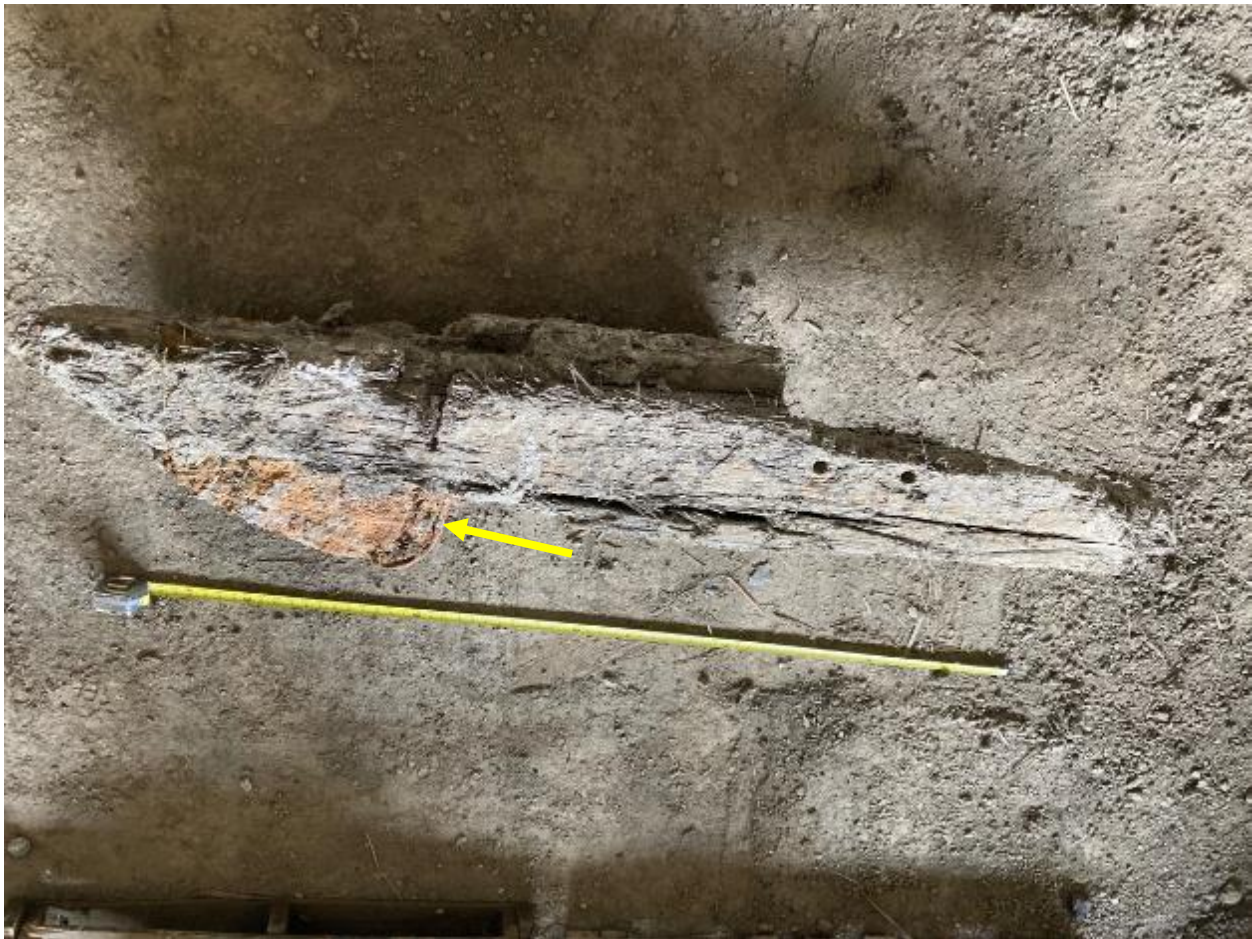
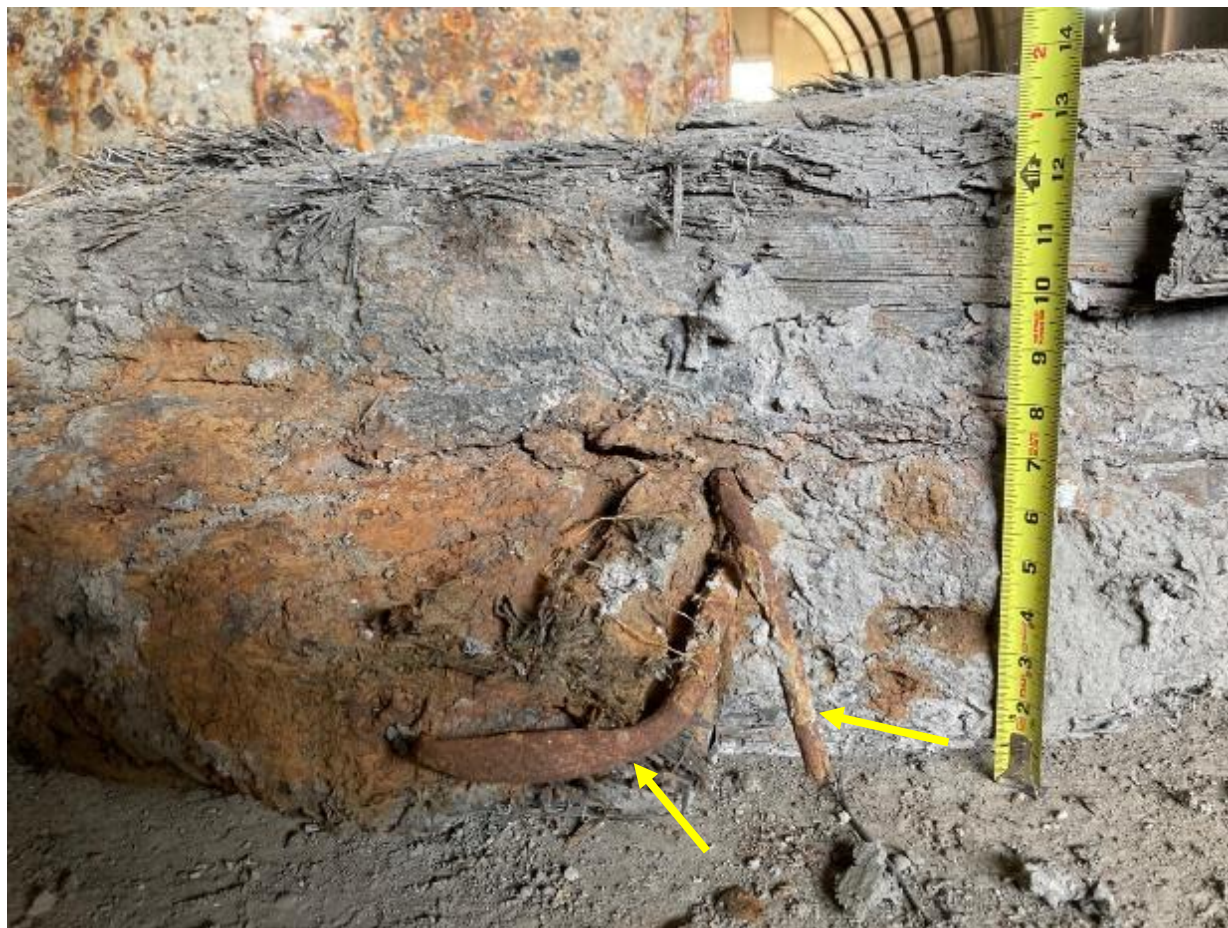
A fragment of a notched timber (Photographs 21) was retained as examples of the type of wooden material observed. The presence of two 10-inch metal spikes suggests that that it was part of the canal bulkhead or pier (Photograph 22). The timber fragment is possibly associated with the canal bulkhead or dock but could also have floated to the canal from a different location such as Manhattan or Queens. Regardless wood is a porous material and the timber is most likely contaminated from its time in the Gowanus Canal.

Measurements: Length 75" Width 15" Depth 13"

Photograph 21– Wooden timber with metal spikes (arrow).

Photograph 22 – Close up of metal spikes (arrows).

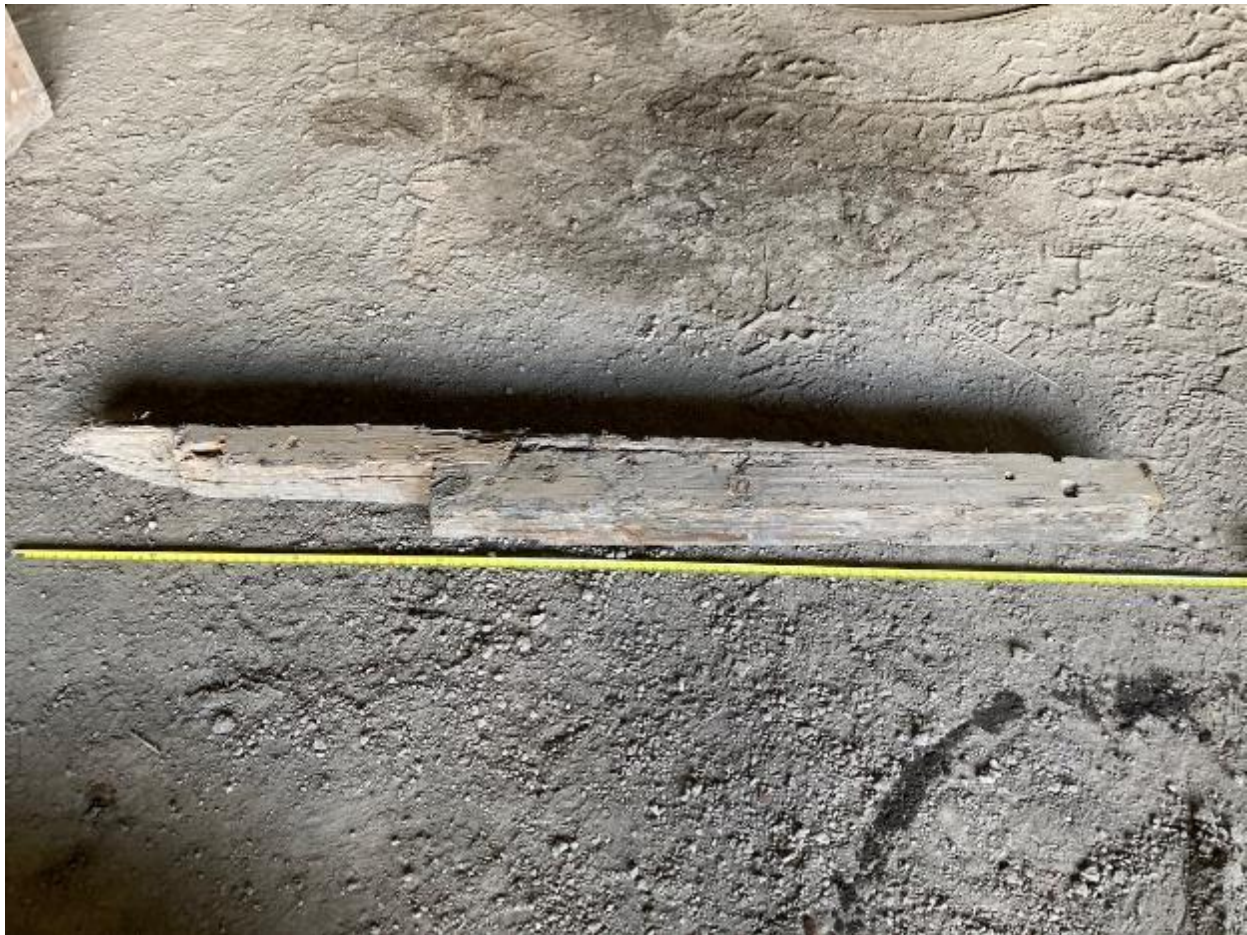
A fragment of a notched timber (Photograph 23). This item was retained as examples of the type of wooden material observed. The timber fragment is possibly associated with the canal bulkhead or dock but could also be part of a building or structure or even a wagon or cart. It is also possible that the timber floated to the canal from a different location such as Manhattan or Queens. Regardless wood is a porous material and is therefore the timber is most likely contaminated from its time in the Gowanus Canal.

Measurements: Length 72" Depth 10" Width 13"

Photograph 23 – View of notched timber.

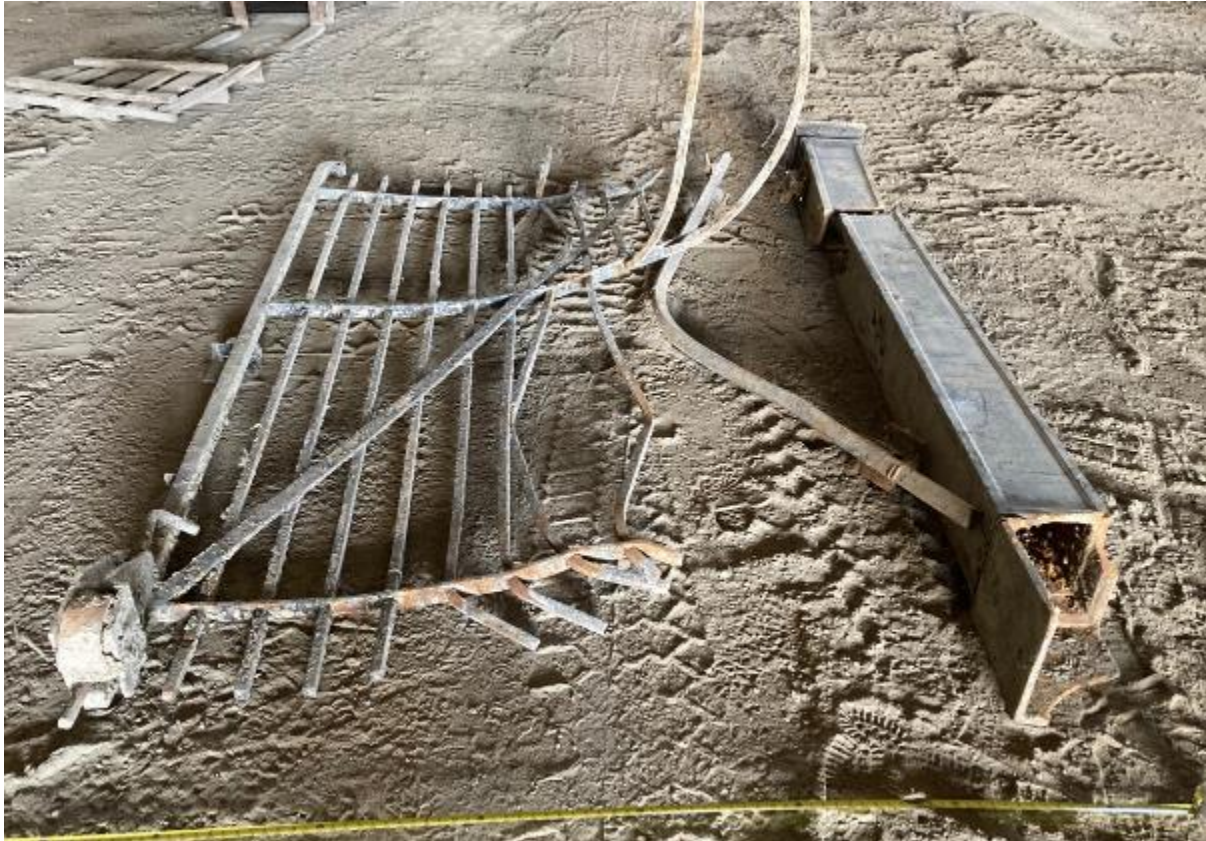
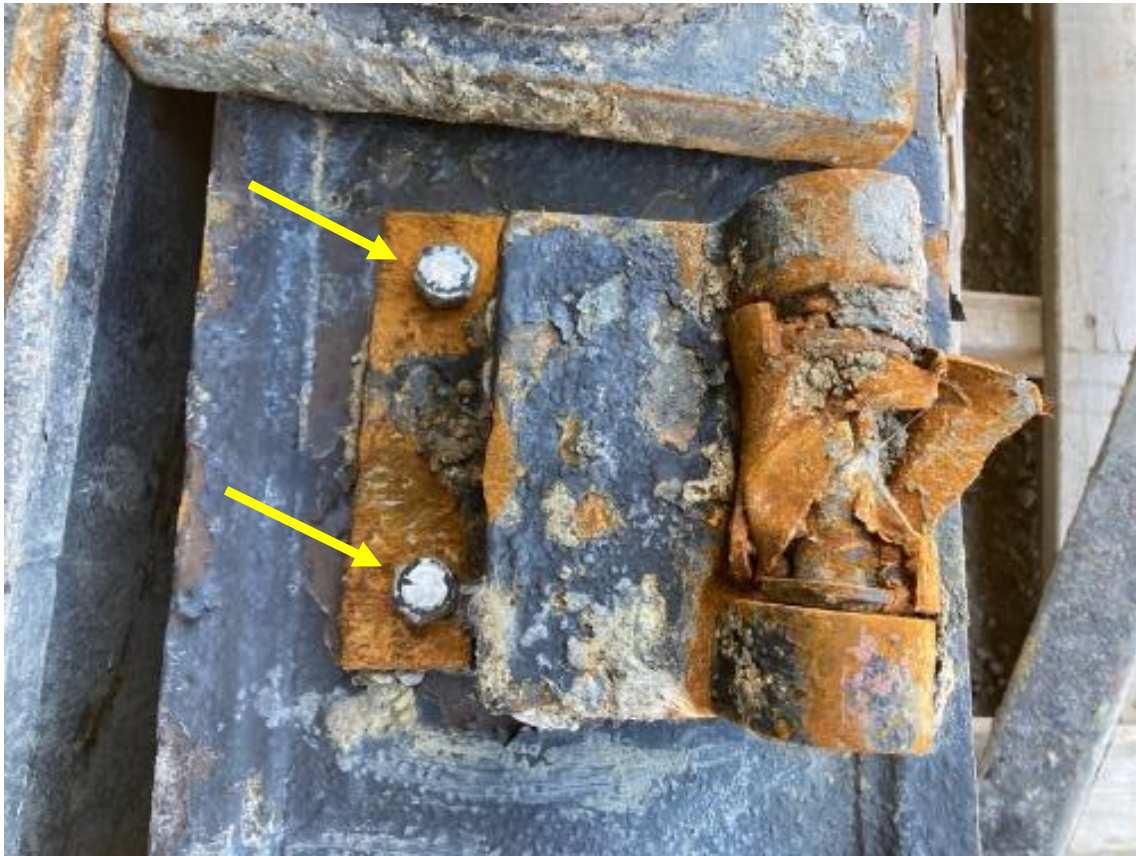
These items consist of a fragmented multi-component iron security gate and post. The items contain no manufacturing information to use for dating purposes (Photograph 24). This style of gate and post is still in production and the modern bolts and hinges suggest that it is modern (Photograph 25).

Measurements: Post - Height 141" Width 84" Depth 12"

Photograph 24 – Overview of iron gate and post.

Photograph 25 – Modern bolts and gate hinge (arrows).

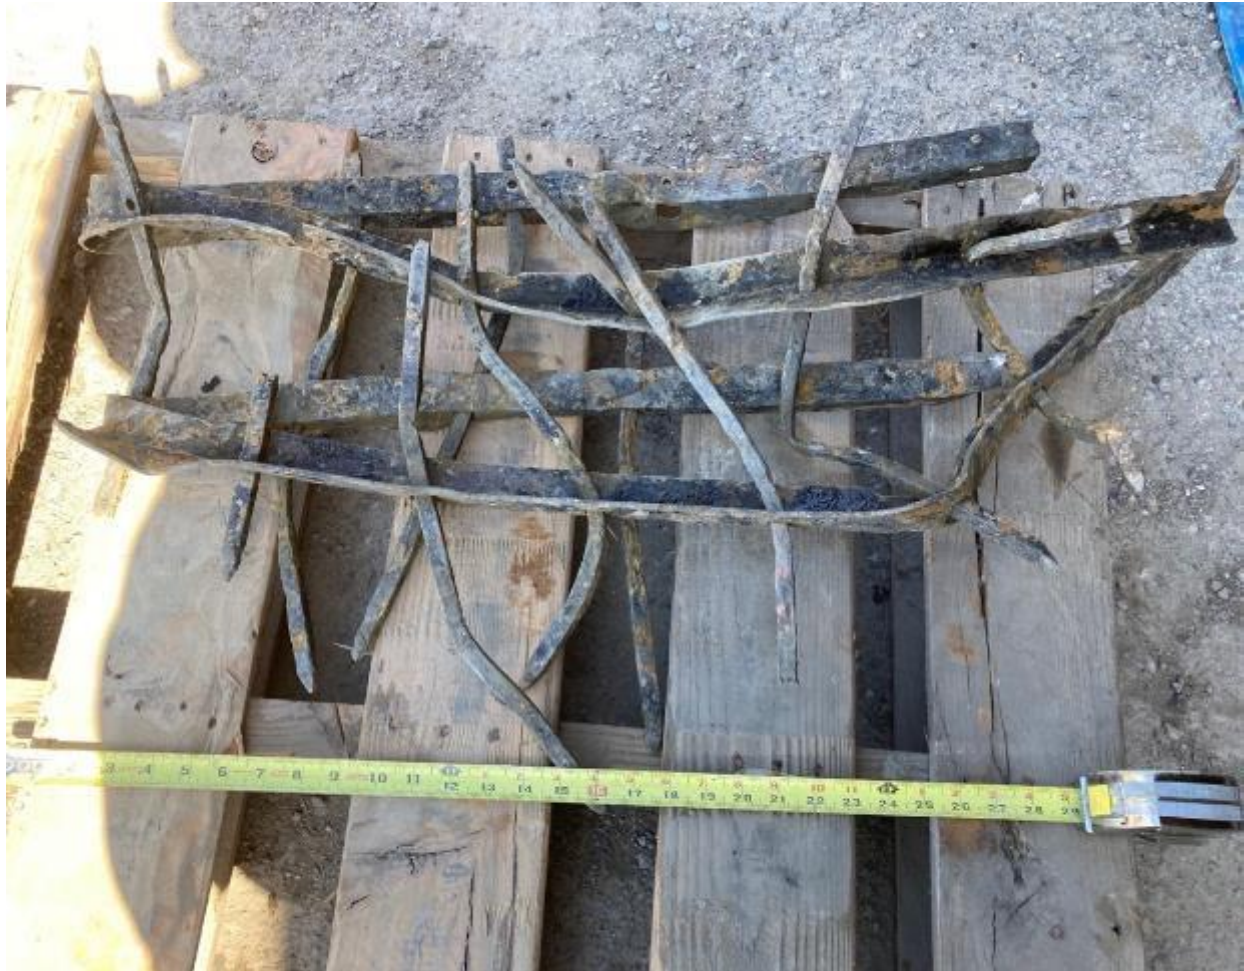
This undated iron fence section was likely set in the top of a masonry wall (Photograph 26). This style of fence has been used well into the 20th century.

Measurements: Length approximately 5'. Bent in half. Height 20"

Photograph 26 – Iron fence section

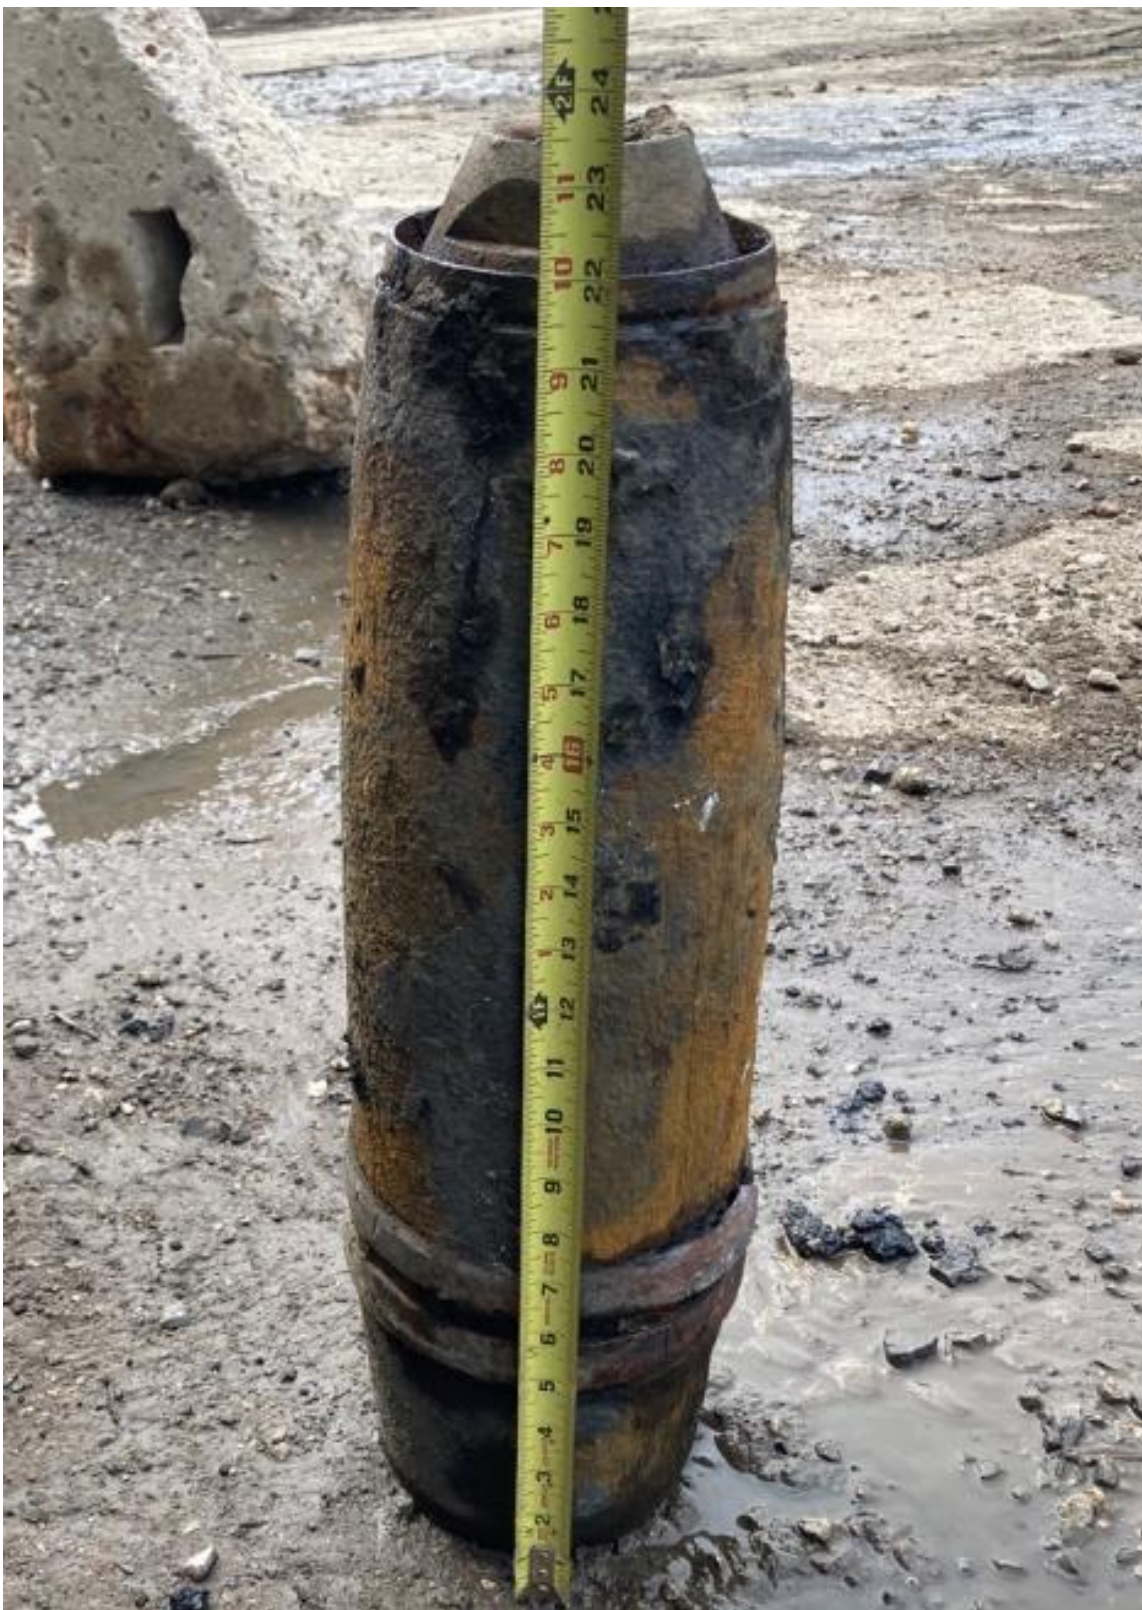
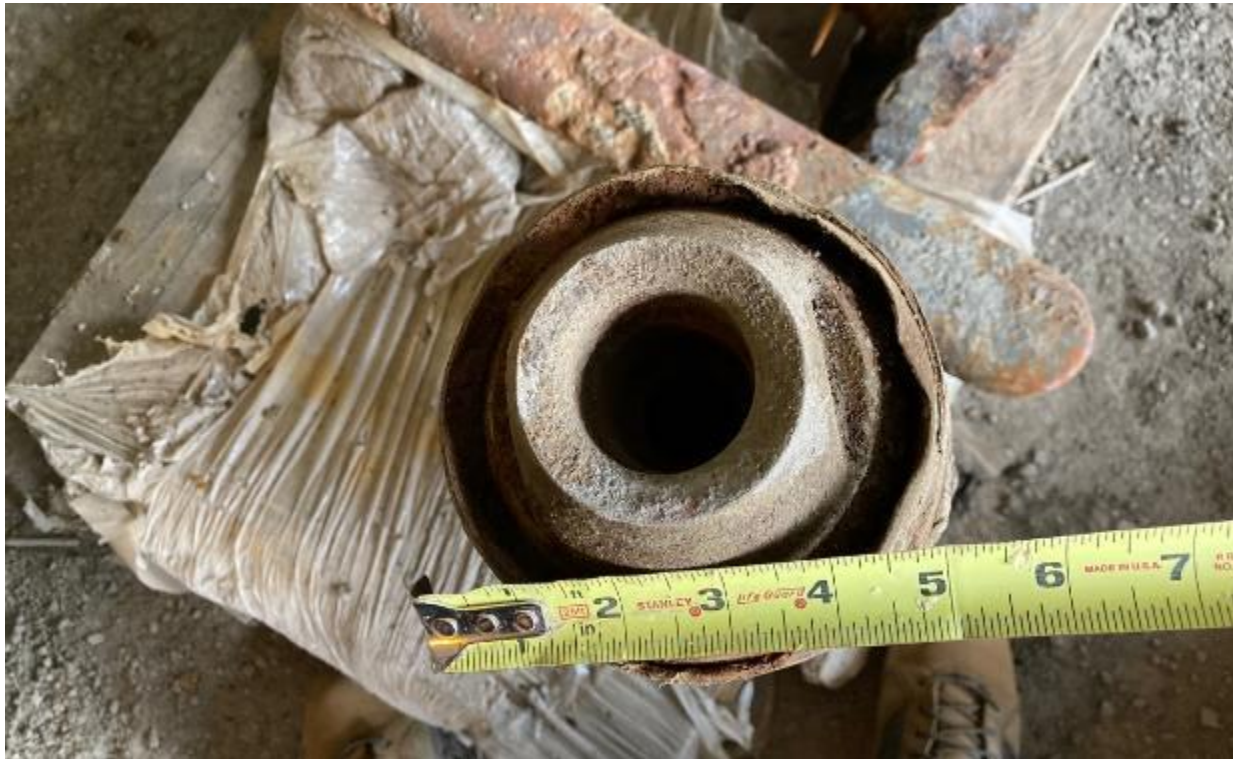
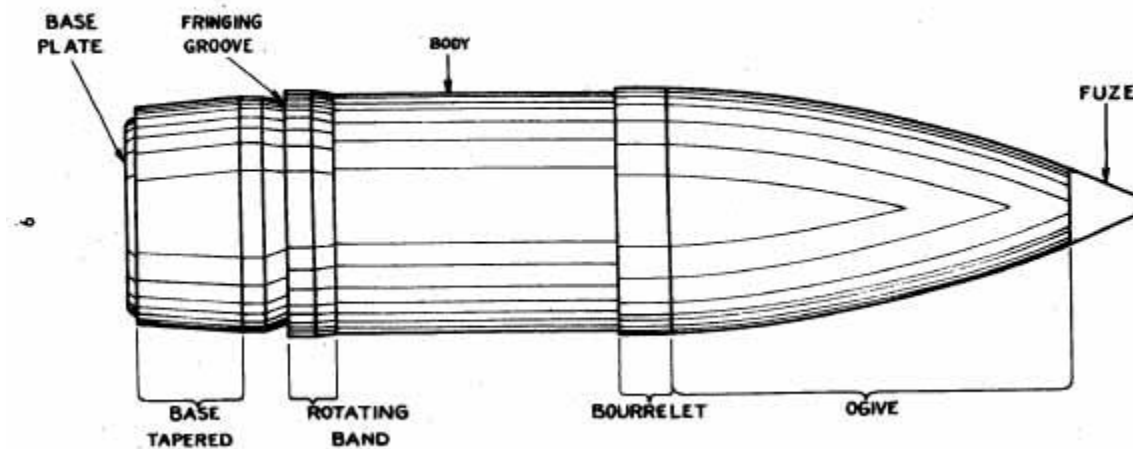
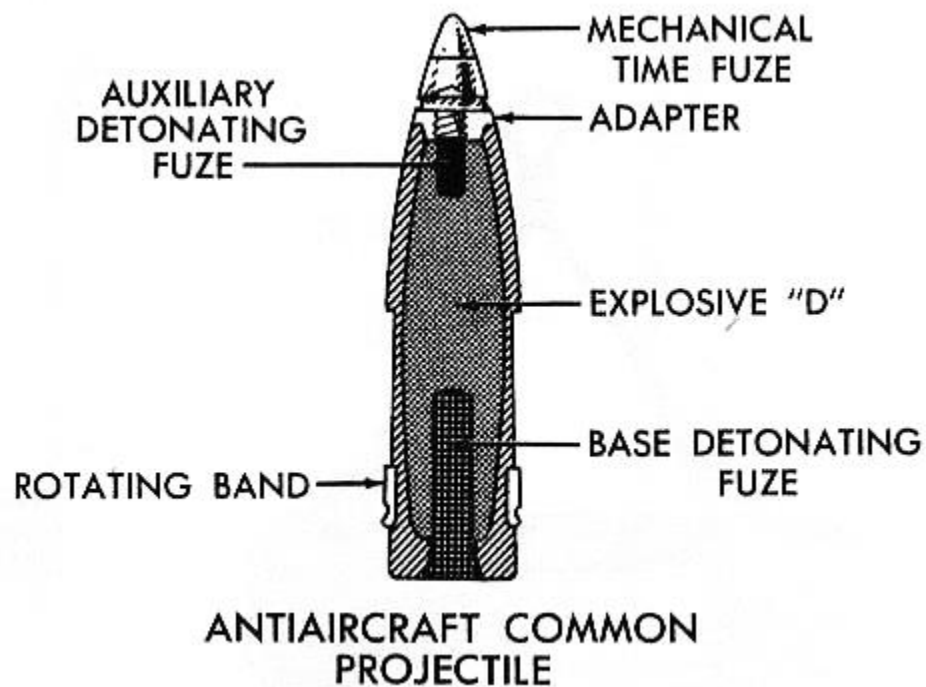
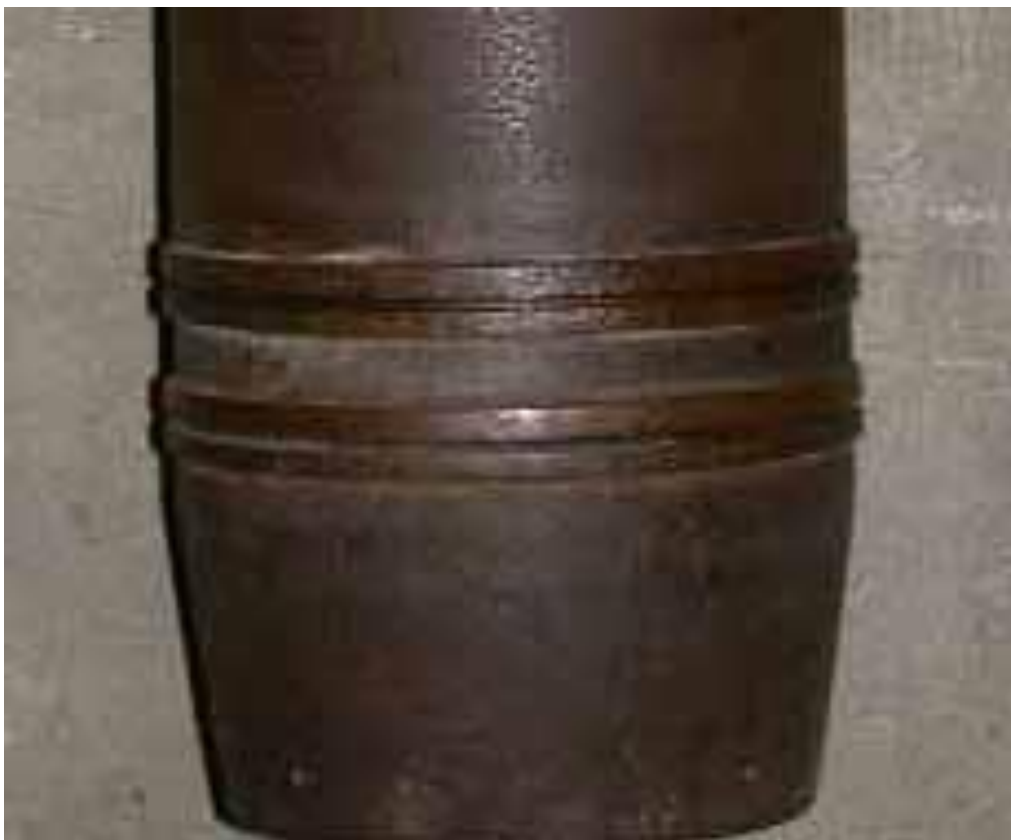
This item has no manufacturing information. It is constructed in multiple components made of iron, lead and copper (Photographs 27 -29 and Figures 5 & 6). This appears to be a 5" artillery shell without its fuse attached.² The tapered base meets the body of the shell where a pair of "rotating bands", or "driving bands" are located. Dimensions for a typical WWII-era 5" /38 caliber shell were 127mm wide by 680mm long (5" x approximately 24.4"). It is not clear if this is a WWII-era shell or an earlier shell (example, the 5" /51-caliber gun was common from around 1907 through the 1920s, or the 5" /25-caliber gun common from the 1920s through WWII, and the 5" /38-caliber gun was in service from 1934 to 2008). This is possibly a shell of German manufacture. The presence of dual driving bands may provide the basis for a more definitive identification, but would need to be further by a historic munitions expert to determine any additional information. This research is not recommended as munitions was not an activity associated with the Gowanus Canal. This item may also have been a training round or something brought back from Europe as a memento. The Clean Earth had the shell reviewed and it was determined to not have any explosives in the round. Even though the shell has been determined as safe, it is recommended to appropriately discard the item as there is no indication that munitions transport or storage was an activity conducted along the Gowanus Canal. Munitions storage was more likely conducted on Governor's Island, at one of the many navy or army bases in Brooklyn or other appropriate areas in the vicinity.

Measurements: Length 23" Width 5"

Photograph 27 – Miscellaneous cylindrical object

Photograph 28 – Miscellaneous cylindrical object. Top view.

Figure 5 – External munition shell diagram. Sourced from Cartridgecollectors.org.

Figure 6 – Internal diagram of munition shell. Sourced from Cartridgecollectores.org

Photograph 29 - Example of two driving bands on an artillery shell. Source from Cartridgecollectores.org

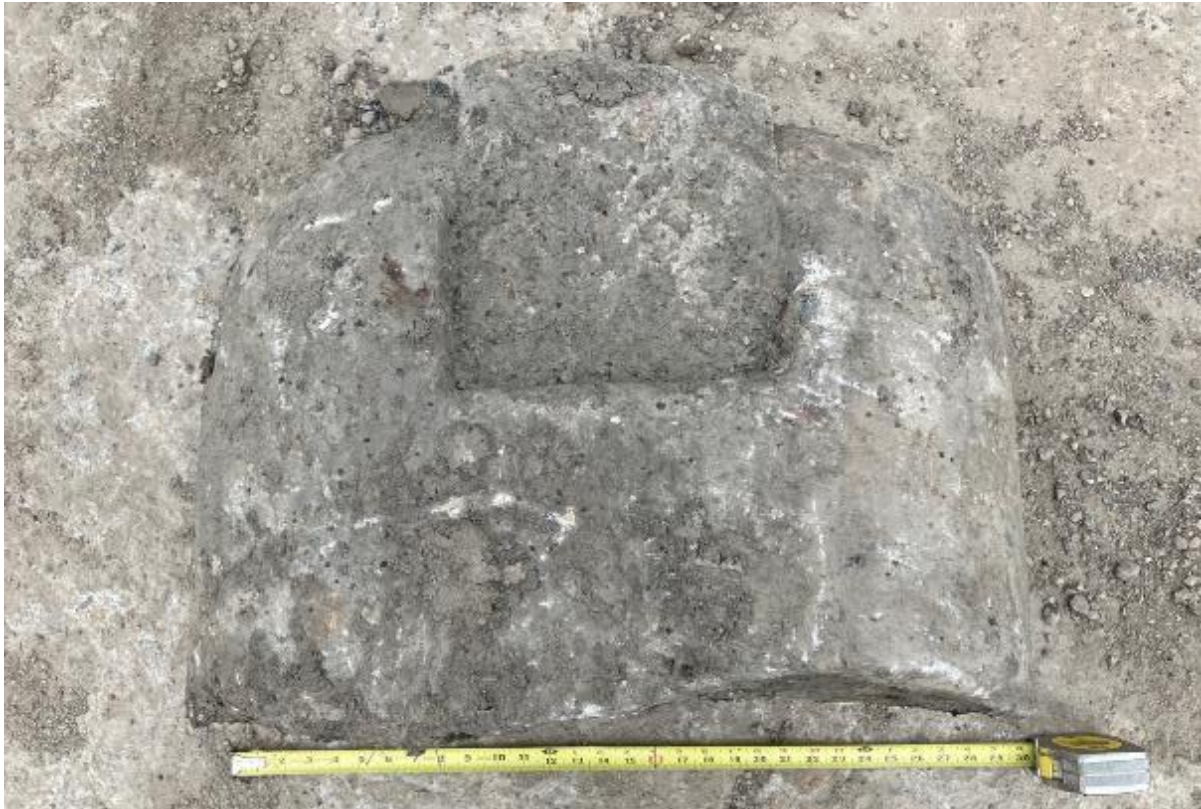
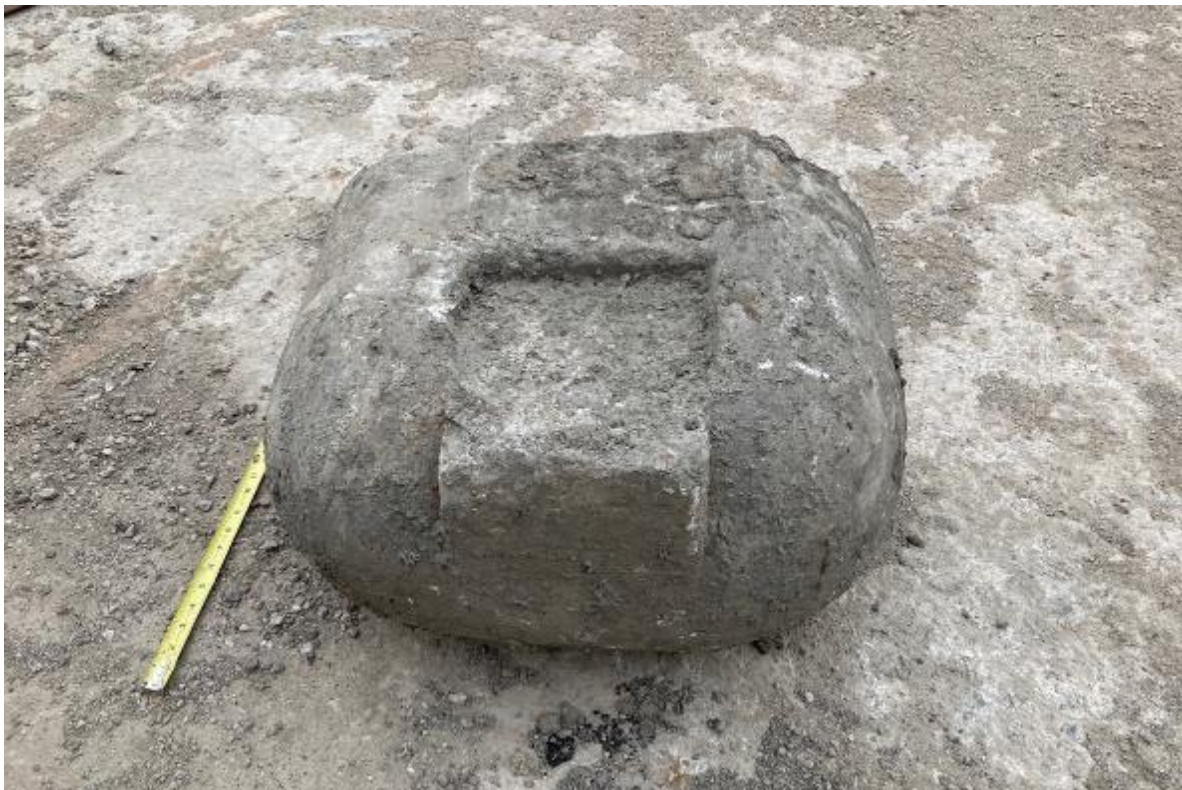
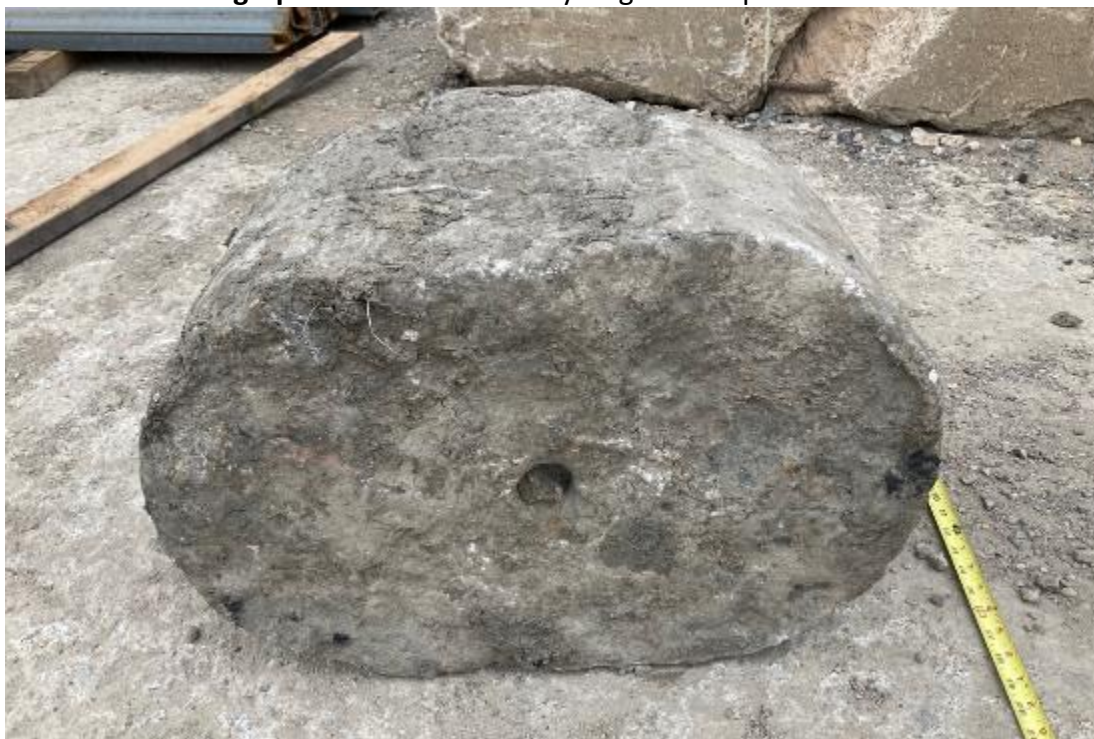
This gray stone block was recovered after the review process was completed and set aside by Clean Earth personnel (Photograph 30). It was recorded during the final object review. The lozenge-shaped block appears to be a broken-off portion of a larger stone. It contains a square carved out area on its face (Photograph 31) and round hole in the center (Photograph 32). This item may have been used in construction, as a base for items or materials or one of many other functions.

Measurements: Height 28" Width 30" Depth 16"

Photograph 30 – Stone masonry fragment. Front view

Photograph 31 – Stone masonry fragment. Square notch view

Photograph 32 – Stone masonry fragment. Broken bottom view.

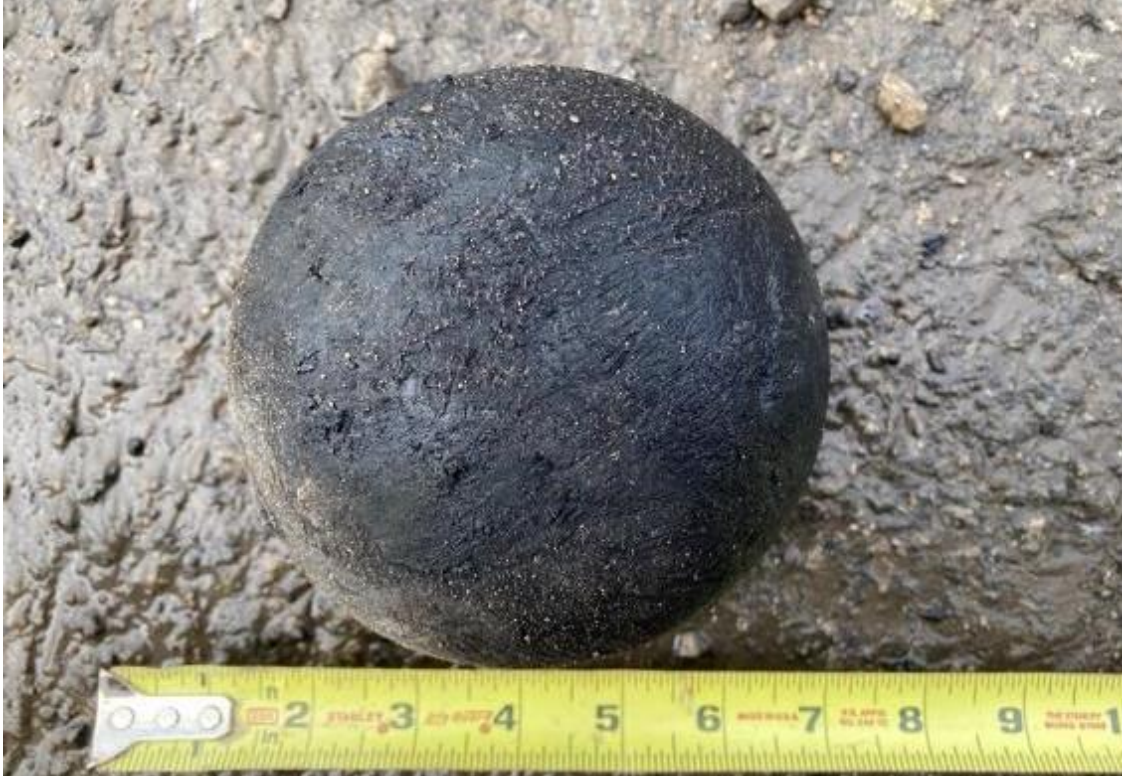
Six-inch diameter solid wooden ball (Photograph 33). No markings, impressions or other information. The ball could be a toy or sports item (bocce ball) or it could have been used in manufacturing, however, without any markings, it is impossible to tell its exact function. Furthermore, it is made of wood, a porous material, and is possibly contaminated.

Photograph 33 – Solid wooden ball.
