**GOWANUS CANAL SUPERFUND SITE
RTA1 REMEDIAL CONSTRUCTION
Water Quality Monitoring Weekly Data Summary**

PERIOD: July 1, 2024 – July 5, 2024

Date of Report: July 9, 2024

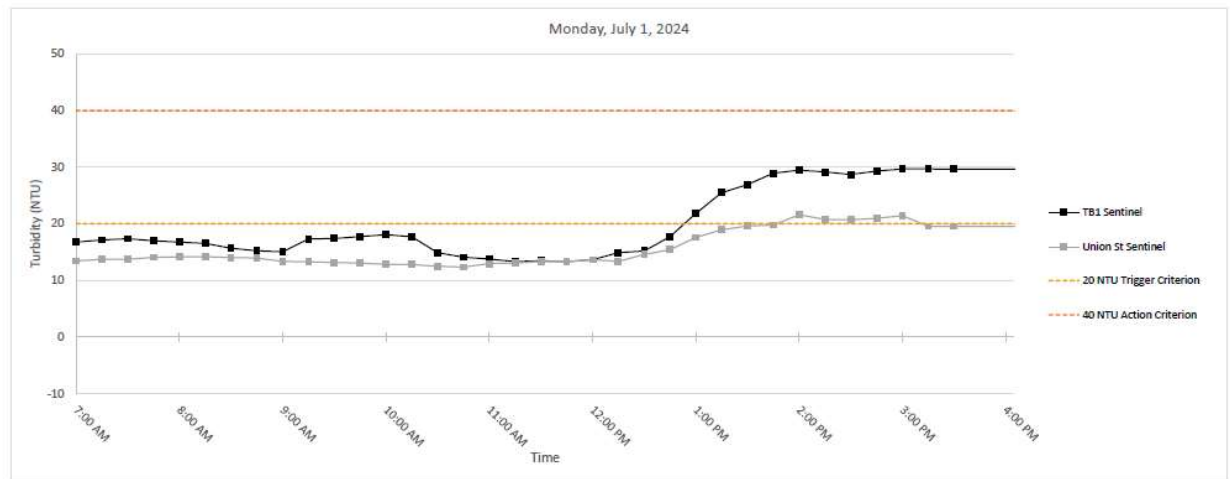
Figure 2. Hourly rolling average turbidity readings on Monday July 1, 2024, from 7 AM to 3:30 PM.

Note: During the reporting period, ambient buoy readings were excluded due to erroneous recordings occurring after work hours. Elevated turbidity levels were observed in RTA1, unrelated to construction activities, and persisted both before and after active construction.

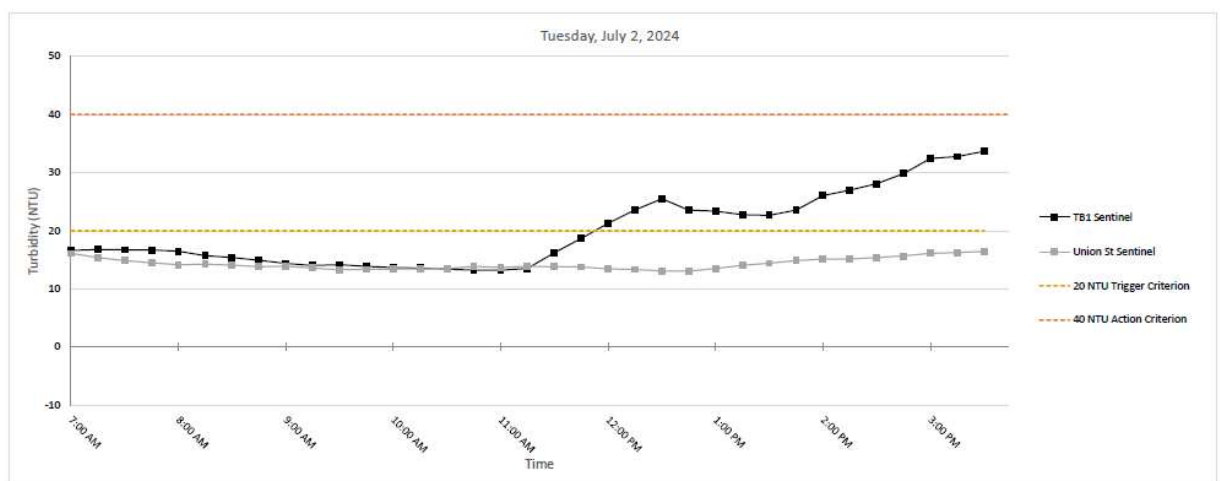
Figure 3. Hourly rolling average turbidity readings on Tuesday, July 2, 2024, from 7 AM to 3:30 PM.

Note: During the reporting period, ambient buoy readings were excluded due to erroneous recordings occurring after work hours. Elevated turbidity levels were observed in RTA1, unrelated to construction activities, and persisted both before and after active construction.

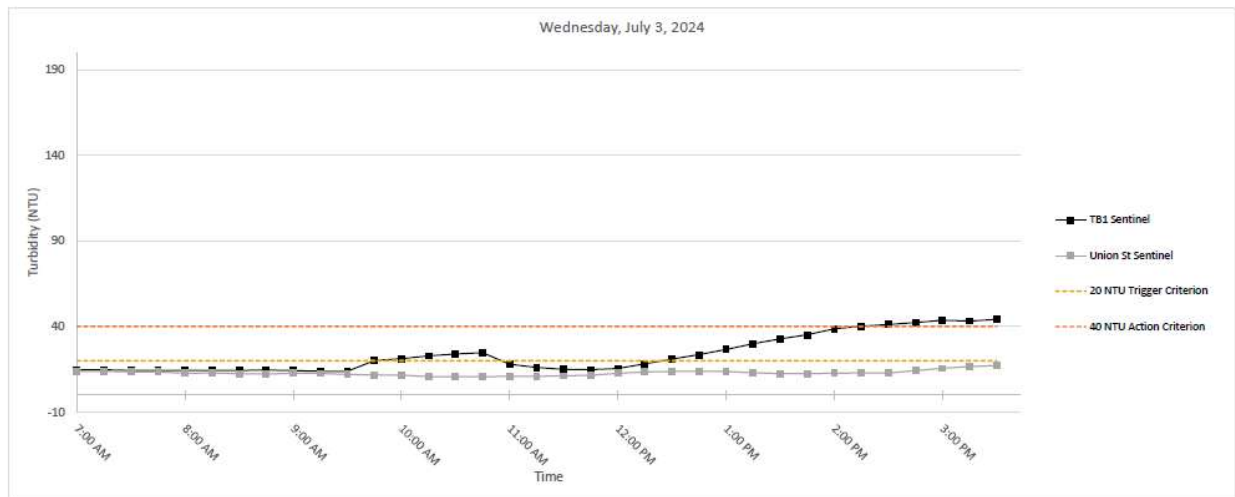
Figure 4. Hourly rolling average turbidity readings on Wednesday, July 3, 2024, from 7 AM to 3:30 PM.

Note: During the reporting period, ambient buoy readings were excluded due to erroneous recordings occurring after work hours. Elevated turbidity levels were observed in RTA1, unrelated to construction activities, and persisted both before and after active construction.

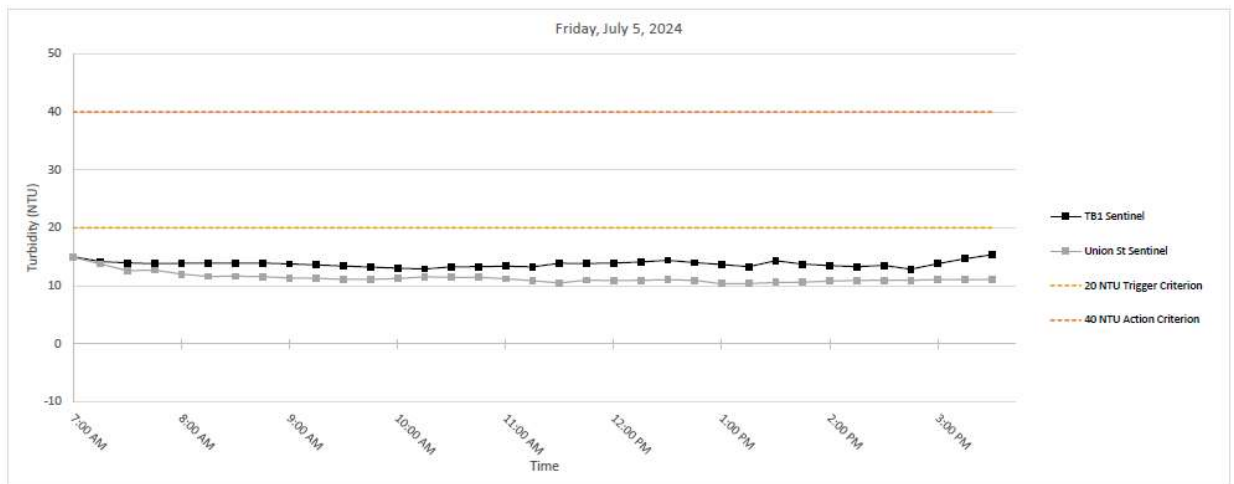
Figure 5. Hourly rolling average turbidity readings on Friday, July 5, 2024, from 7 AM to 3:30 PM.

Note: During the reporting period, ambient buoy readings were excluded due to erroneous recordings occurring after work hours. Elevated turbidity levels were observed in RTA1, unrelated to construction activities, and persisted both before and after active construction.

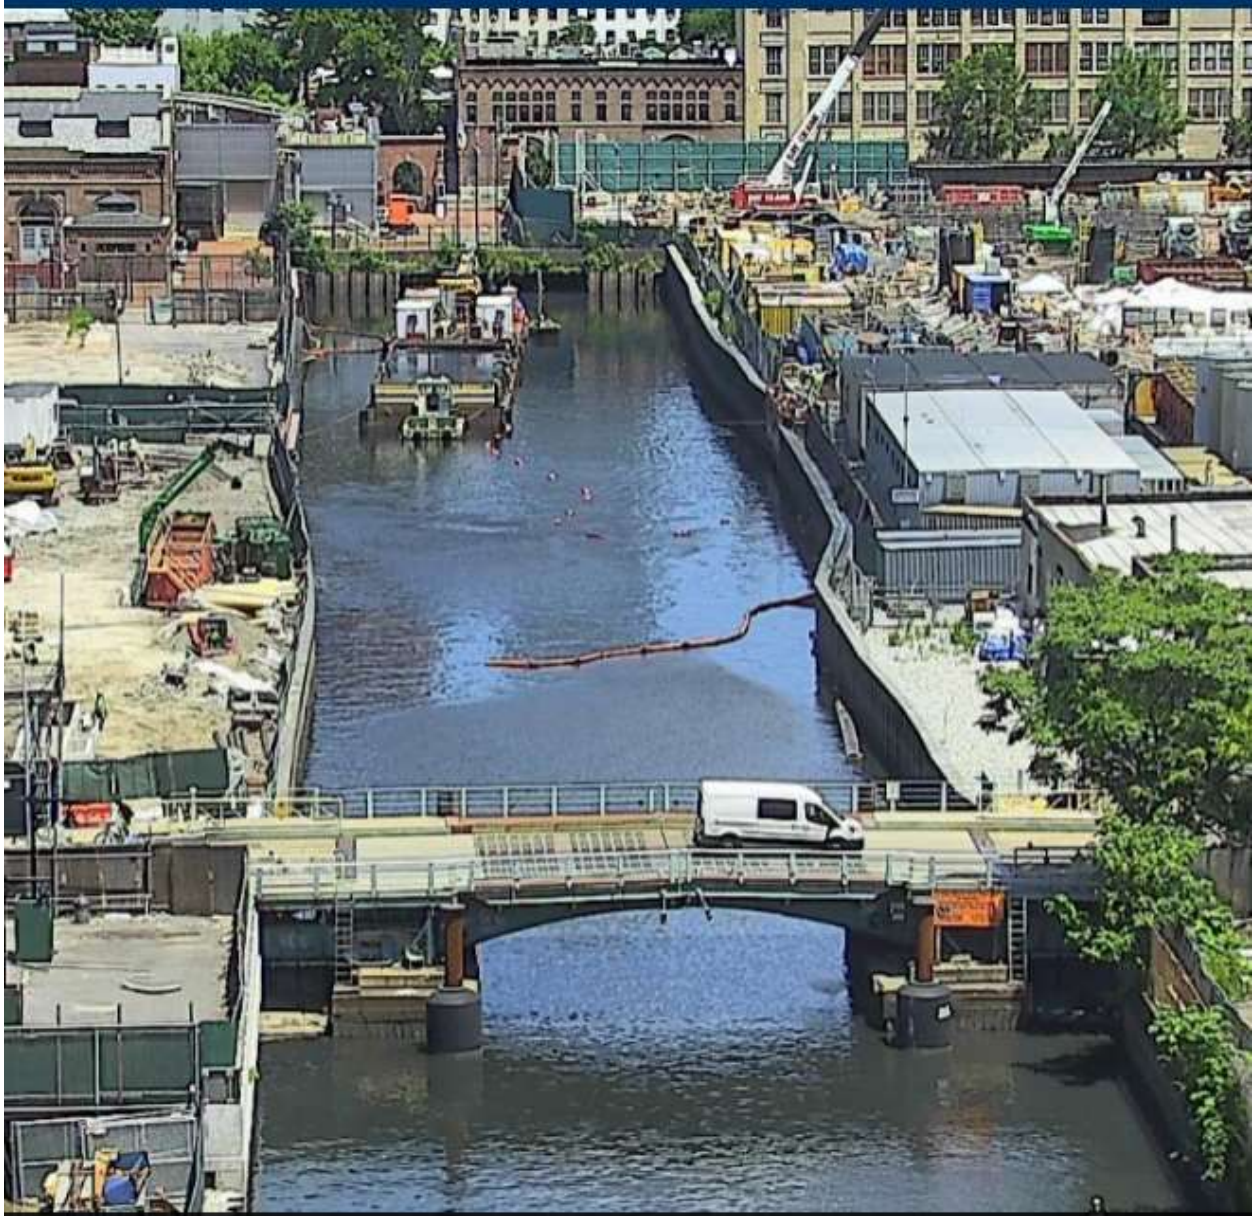
The dark discoloration of the water in RTA1 was noted north the Union Street Bridge and north of 3rd Street Bridge periodically throughout the week. Sulfurous odors were detected north of Third Street Bridge throughout the week.

Figure 6 – July 1, 2024. Canal water with a dark coloration observed north of the Union Street Bridge. Turbidity unrelated to construction activities also observed.

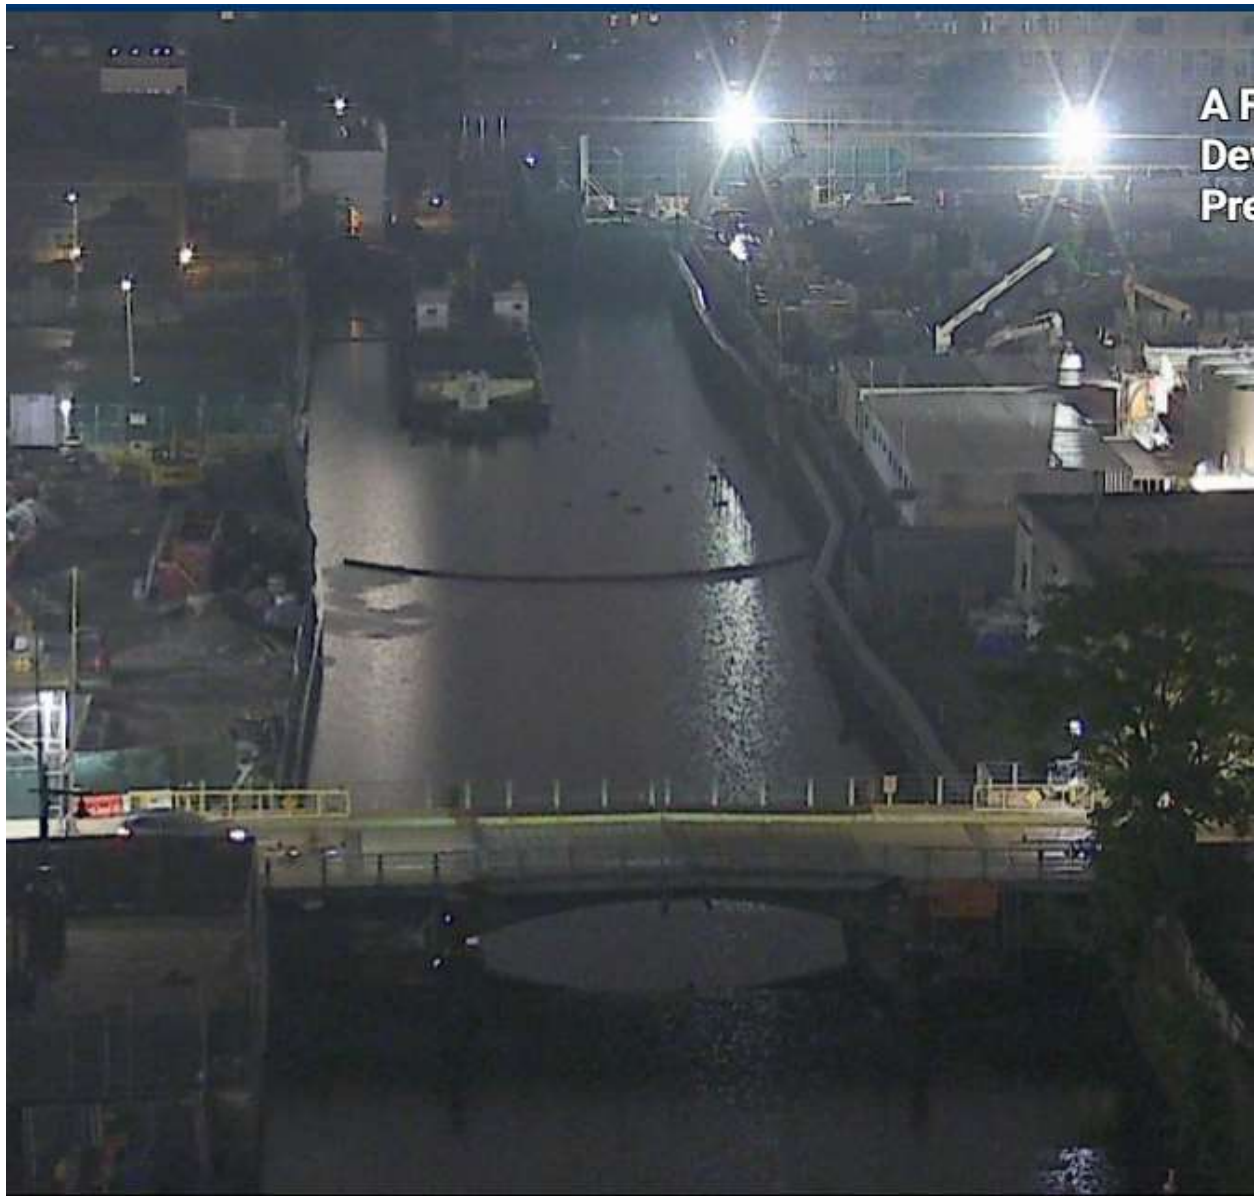
Visual indications of elevated turbidity unrelated to construction activities were observed throughout the reporting period. Sheens were observed during construction activities at the Flushing Tunnel and were contained by two turbidity curtains and oil absorbent booms. Sheens in other areas of RTA1 were minimal. A rainfall event which triggered a CSO discharge occurred on Thursday, July 4 between 10:30PM and Friday, July 5 at 3:00AM.

Figure 7- July 4, 2024. Rainfall event.
