Memorandum

RE: Memo #5- Summary of visit to Cashman Yard, Staten Island, NY, on August 7, 2024

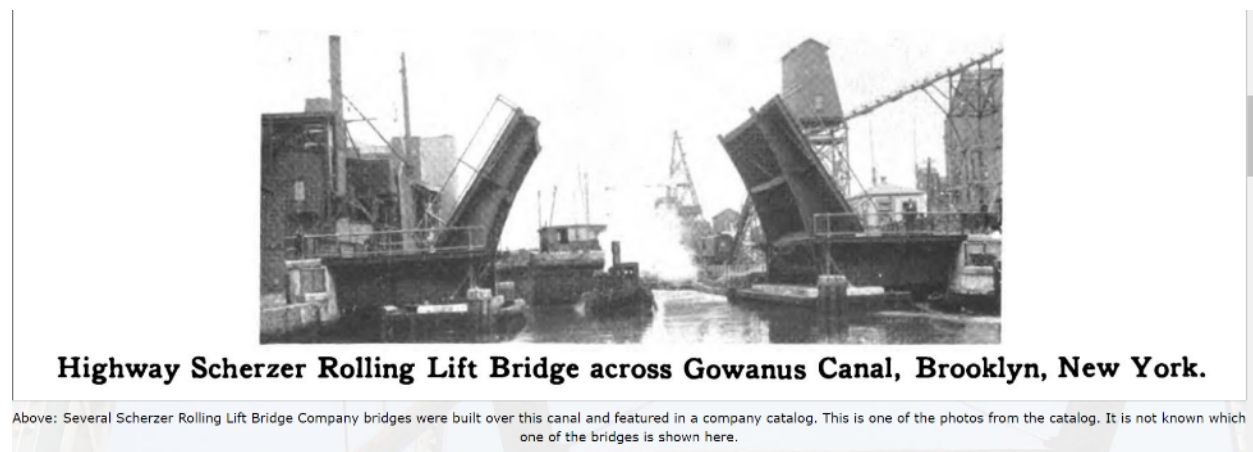
Figure 1. Historic photo of a bridge similar to the 3rd St Bridge, early 20th century

The 3rd St bridge was built in 1903 or 1905 (records differ) and was constructed of steel girders and concrete. As stated on historicbridges.org: "This is one of two surviving rolling lift bascule bridges on this canal which are among the oldest such bridges in the country". Figure 1 shows a bridge of this type in action. According to the National Bridge Inventory Data sheet from 2019 ([chrome-extension://efaidnbmnnnibpcajpcgiclfindmkaj/https://historicbridges.org/newyork/3rdstreetbridge/nbisheet.pdf](https://efaidnbmnnnibpcajpcgiclfindmkaj/https://historicbridges.org/newyork/3rdstreetbridge/nbisheet.pdf)) the 3rd St Bridge was reconstructed in 1982 and is not eligible for the NRHP.

Documentation, including photographs and the plans for this type of bridge, do not show any use of a metal framing like the one found in the Canal.

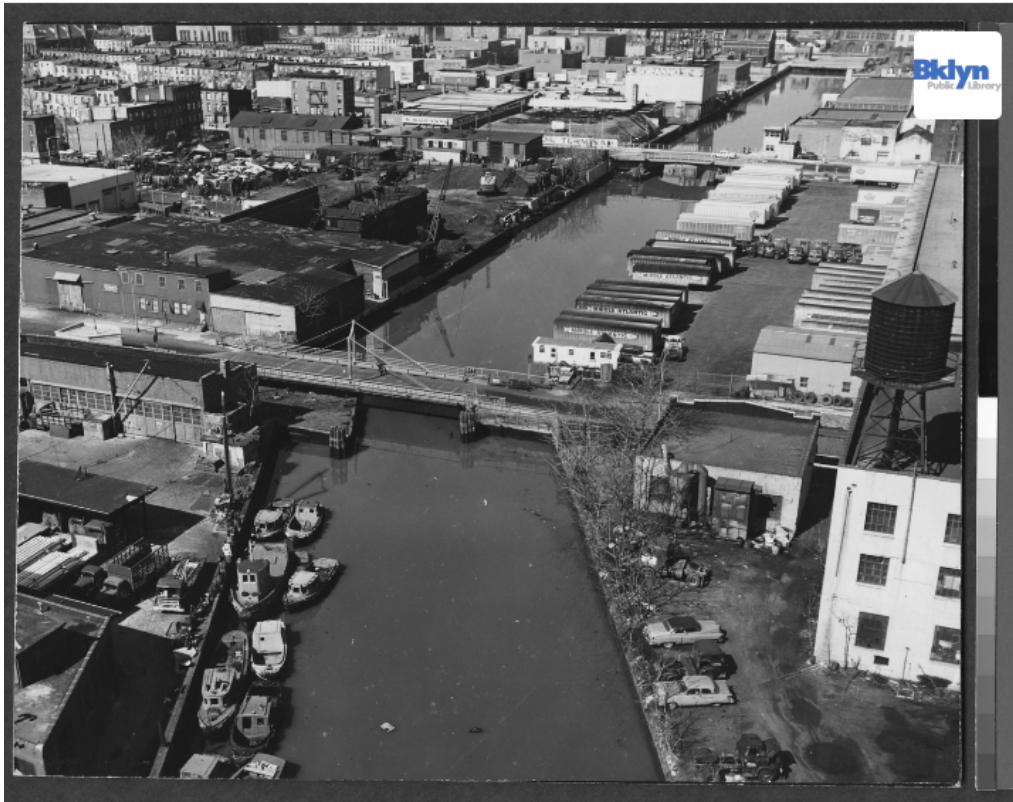
Figure 2. Photo from the mid to late 20th century showing the Carroll St Bridge in midground, looking north. Note the temporary structures on the east bank of the canal and the metal roof bus garage on the west (<https://www.urbanarchive.org/stories/1iAGXpKNYNB>).

The bridge closer to the location of the find is the Carroll St Bridge (Figure 2). This bridge was built in 1889 with a steel frame and timber deck. According to the National Bridge Inventory Data Sheet from 2009 ([chrome-extension://efaidnbmnnnibpcajpcglclefindmkaj/https://historicbridges.org/newyork/carroll/nbisheet.pdf](https://efaidnbmnnnibpcajpcglclefindmkaj/https://historicbridges.org/newyork/carroll/nbisheet.pdf)) this bridge is eligible for the NRHP. This bridge is of a unique design and is one of only three extant in the country. Part of the span is attached to a set of rails and can be slid out to allow for water traffic to pass through the space. While this bridge does have an overhead gantry (Figure 3) made of a steel webbing, it differs in its construction from the one found in the Canal.

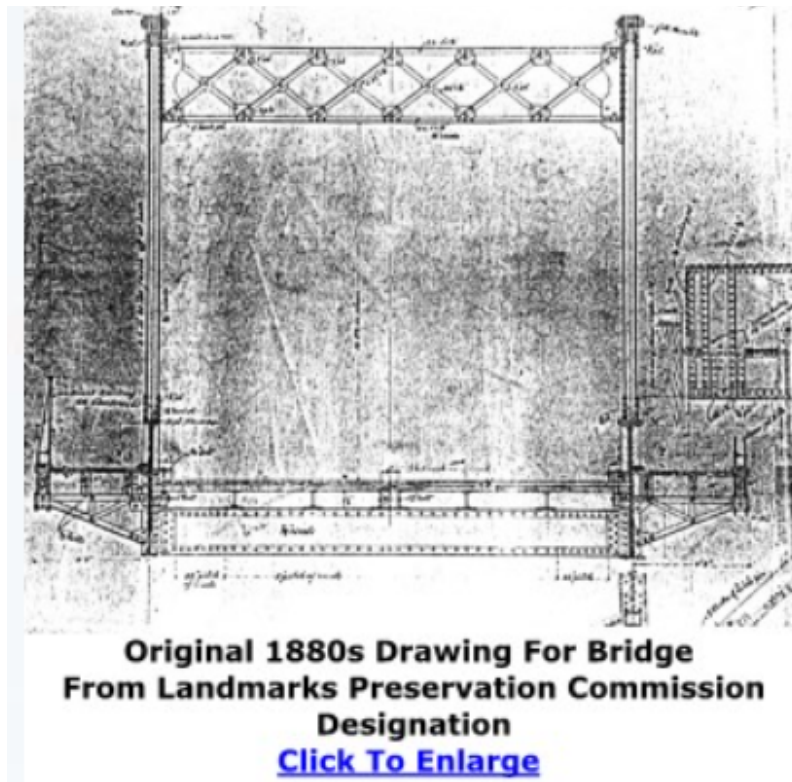
Figure 3. Detail of overhead gantry on Carroll St Bridge

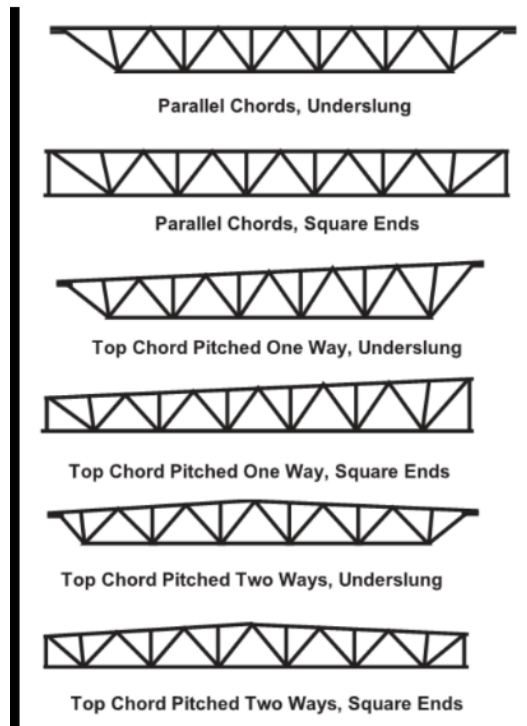
Figure 4. Diagram of open web steel joists, also known as k series

Upon further review of the item pulled from the Canal, it was determined that the truss is a k series steel joist (See Figure 4). These have been produced since the late 1920s into today for the purpose of holding static loads on structures like roofs. With that probable interpretation in mind, there is a strong possibility that this item is not related to either of the two bridges but rather came from one of the now razed buildings located on the upland parcels adjacent to the Canal. Figure 2 gives an idea of the types of buildings that were prevalent in the area during the 20th century that were constructed of steel structures like the one found in the Canal. K series joists are still popular construction materials for industrial buildings, temporary buildings, or partial structures like pole barns.

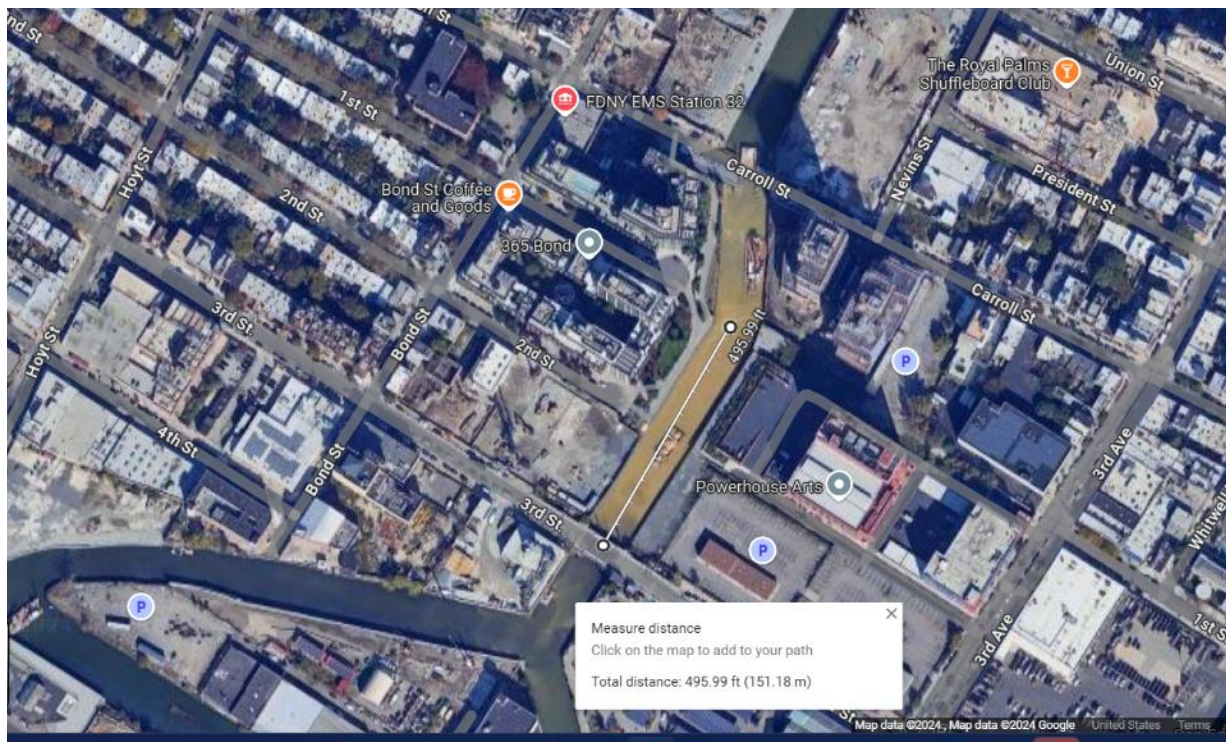
The condition of the joist and its location within the canal makes it difficult to definitively attribute it to any structure within the area, let alone the nearby bridges. The origin of the joist could be from a number of industries that lined the canal in that area. Previous occupants of this section of the canal includes lumbar and coal yards, a feed mill, and oil works. Many of these industries would have had steel construction buildings, most of which are not extant on the landscape today. Additionally due to its simple rivet construction, it is difficult to date its construction to the period of significance. Because of the nebulosness of the origins of the joist, it is recommended that it not be retained as an object of local interest.

Figure 5. Approximate location of the joist find (Google Maps, 2024).
