# GOWANUS CANAL SUPERFUND SITE RTA2 REMEDIAL CONSTRUCTION Water Quality Monitoring Weekly Data Summary

PERIOD: July 15, 2024 – July 19, 2024

Date of Report: July 22, 2024

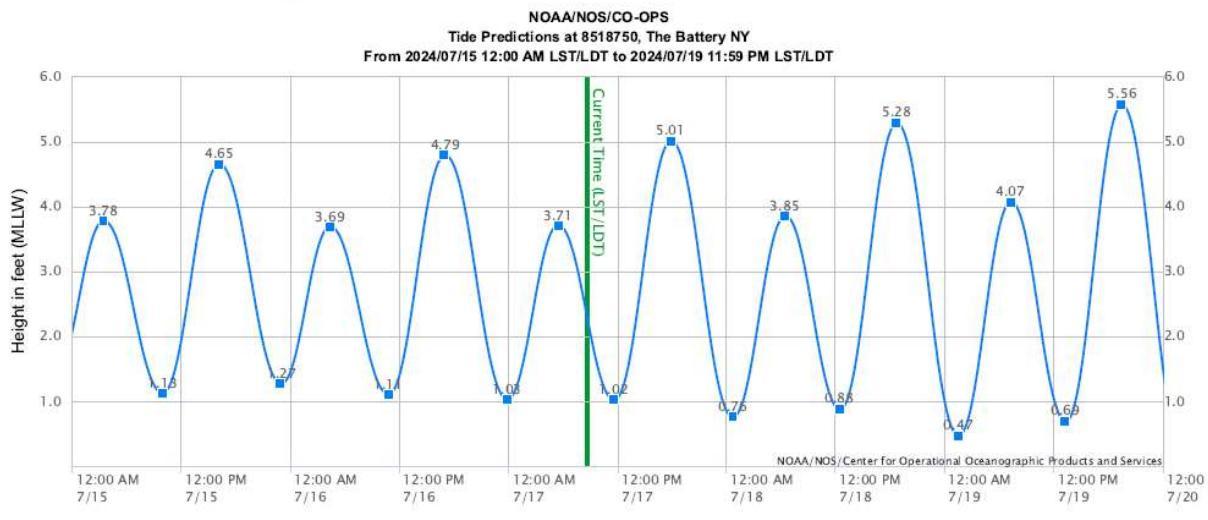
Figure 2- Tidal Chart for reporting period.

Note: The interval is High/Low, the solid blue line depicts a curve fit between the high and low values and approximates the segments between. Disclaimer: These data are based upon the latest information available as of the date of your request, and may differ from the published tide tables.

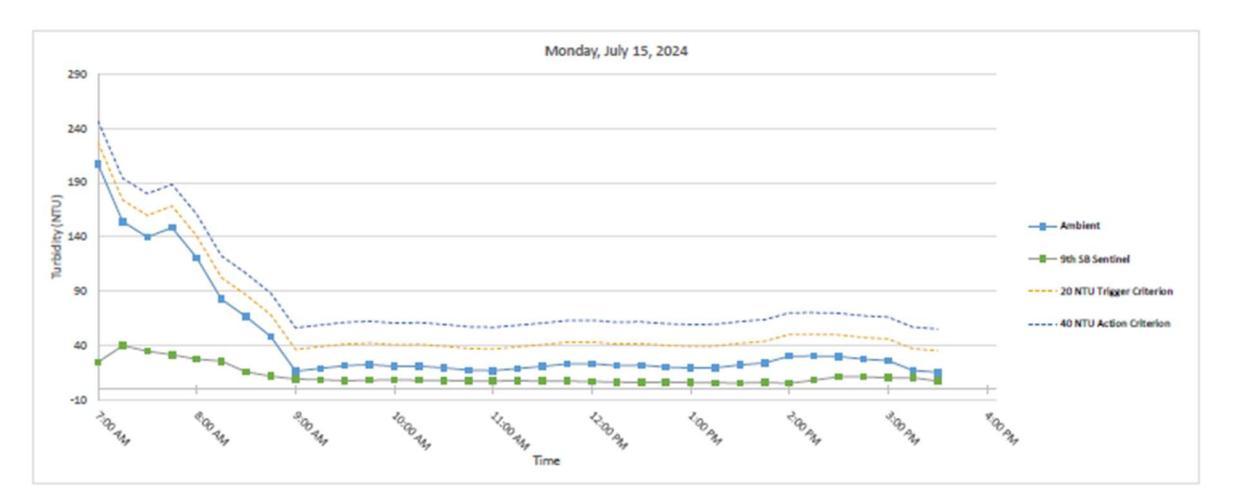
**Figure 3.** Hourly rolling average turbidity readings on Monday, July 15, 2024, from 7 AM to 3:30 PM.

Note: Elevated turbidity was measured throughout RTA2 unrelated to construction activities and was detected both before and after active construction.

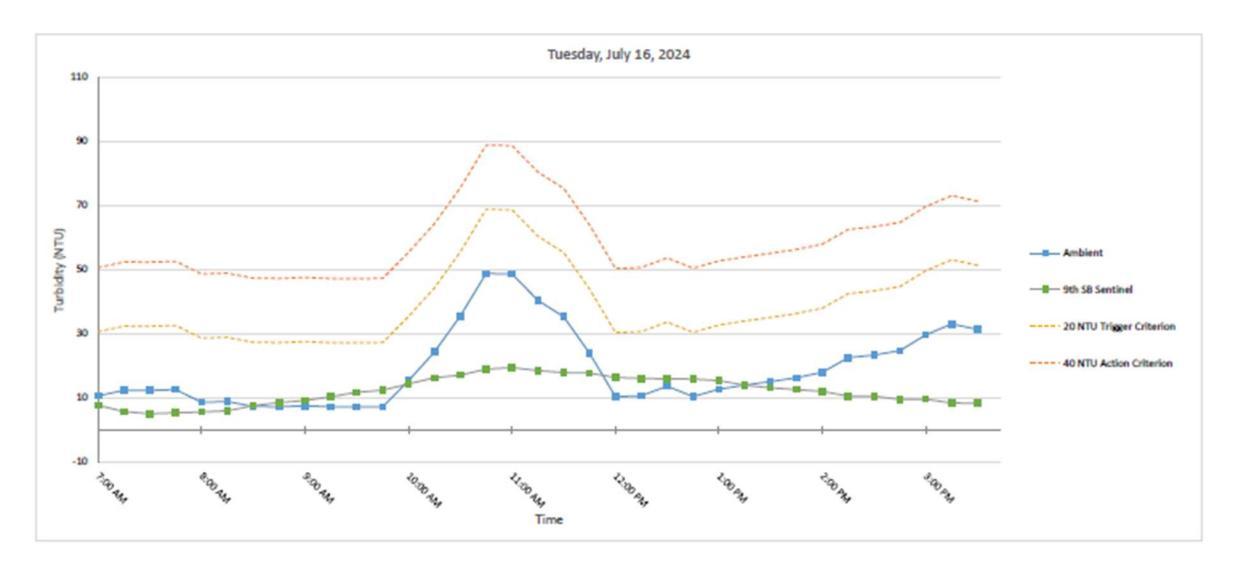
**Figure 4.** Hourly rolling average turbidity readings on Tuesday, July 16, 2024, from 7 AM to 3:30 PM.

Note: Elevated turbidity was measured throughout RTA2 unrelated to construction activities and was detected both before and after active construction.

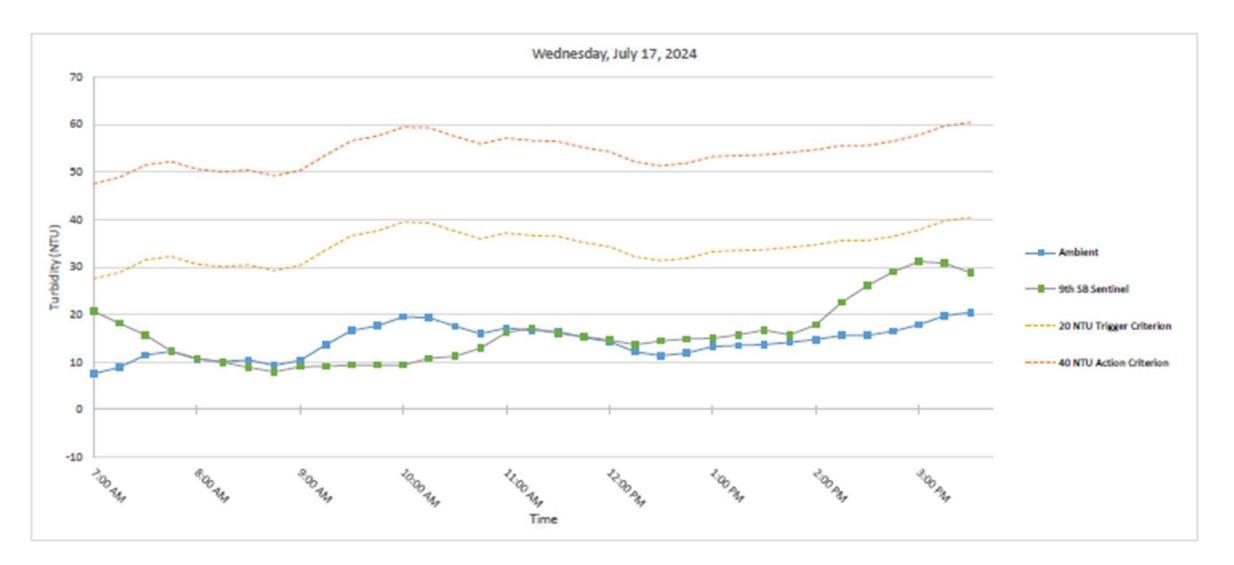
**Figure 5.** Hourly rolling average turbidity readings on Wednesday, July 17, 2024, from 7 AM to 3:30 PM.

Note: Elevated turbidity was measured throughout RTA2 unrelated to construction activities and was detected both before and after active construction.

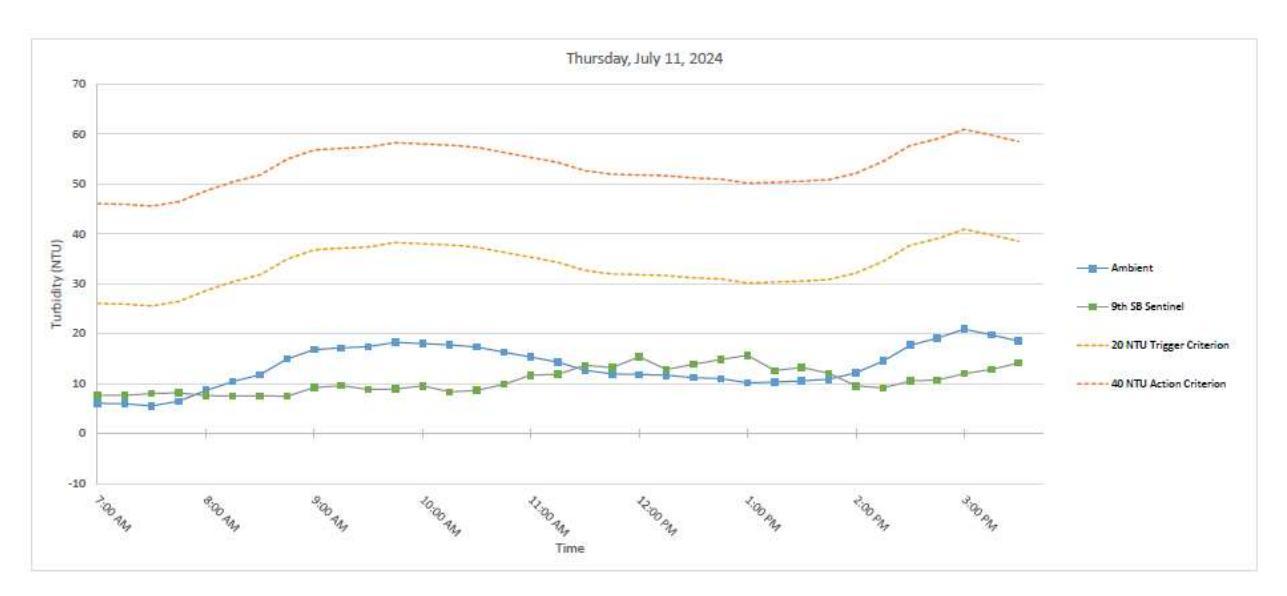
**Figure 6.** Hourly rolling average turbidity readings on Thursday July 18, 2024, from 7 AM to 3:30 PM.

Note: Elevated turbidity was measured throughout RTA2 unrelated to construction activities and was detected both before and after active construction.

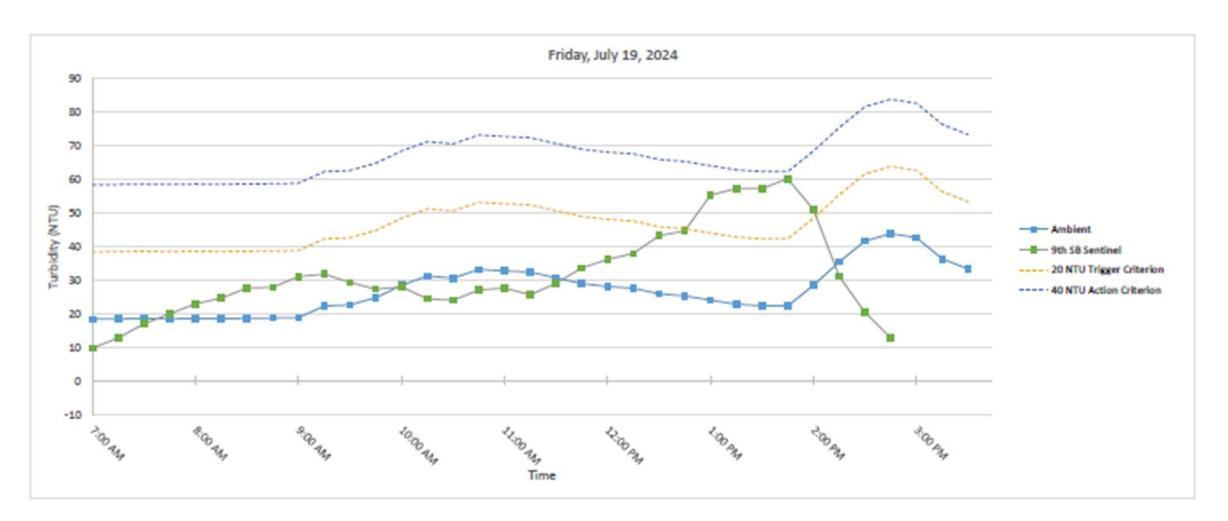
**Figure 7.** Hourly rolling average turbidity readings on Friday July 19, 2024, from 7 AM to 3:30 PM.

Note: Elevated turbidity was measured throughout RTA2 unrelated to construction activities and was detected both before and after active construction.

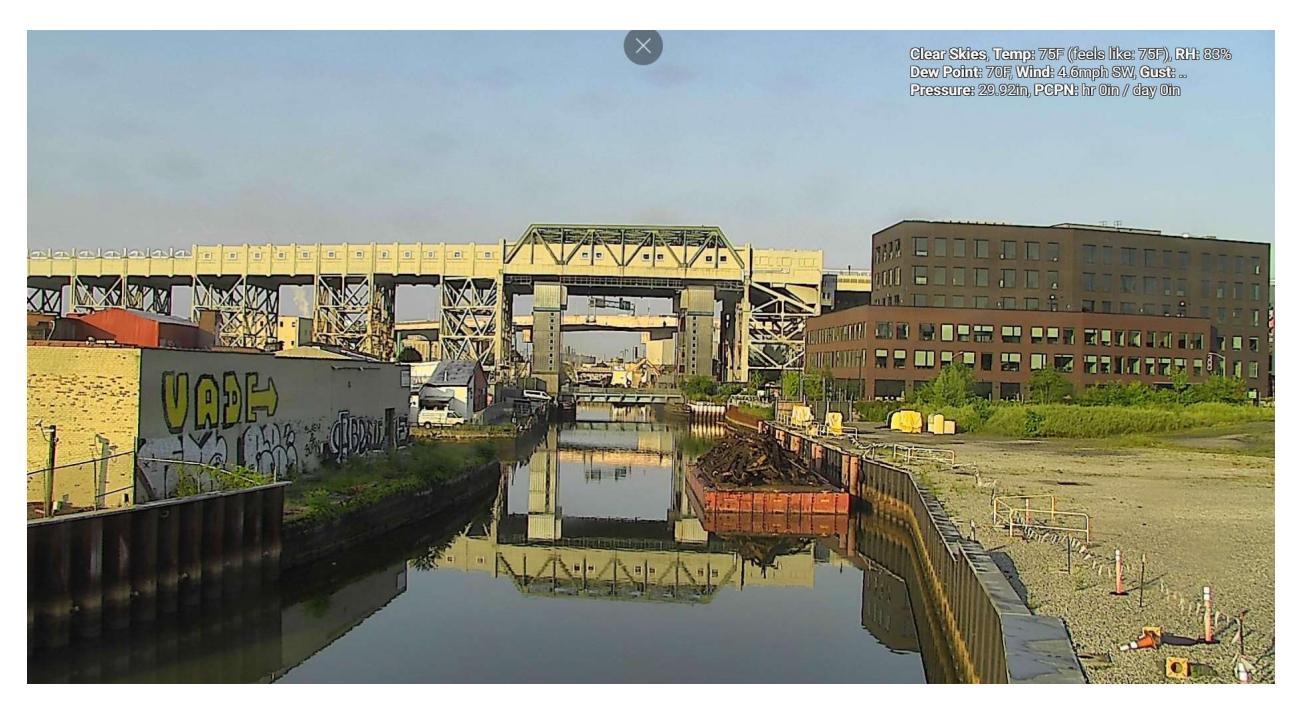
**Figure 8 – July 15, 2024.** General Conditions in Canal north of 9<sup>th</sup> Street Bridge prior to work activities at 7:07AM.
